Technical report

ULM A-012/2022

Accident on 29 May 2022 involving a Tecnam P92 aircraft, registration EC-HZC, in the municipality of Rodezno (La Rioja)

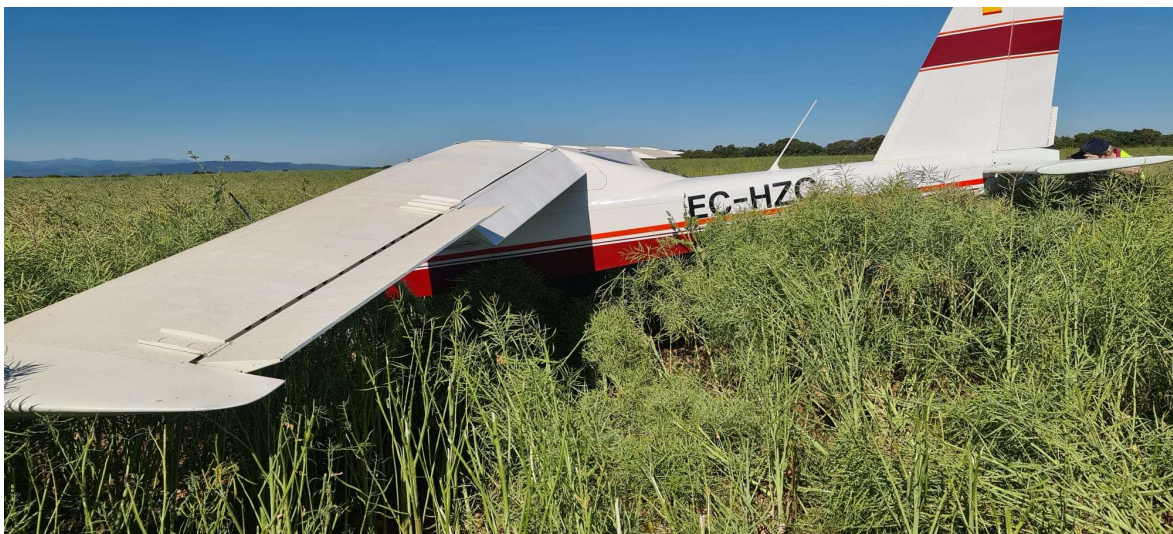
Illustration 4 Aircraft on the rapeseed field

The aircraft made an emergency landing on a densely vegetated rapeseed field with growth up to approximately 1.5 m high. According to the pilot's statement, he saw two possible landing fields and chose the one planted with rapeseed. Just before the landing, the pilot noticed the height of the vegetation, which was not evident from the air.

The following image shows a close-up of the aircraft in its final position and the height of the vegetation. It also shows that the aircraft landed with maximum flaps.

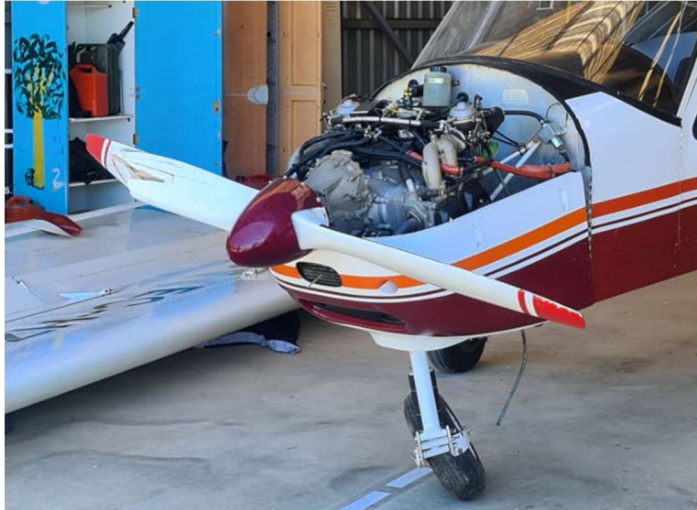
Illustration 5 Condition of nose leg and propeller

The emergency landing in a rapeseed field fractured the aircraft's landing gear nose leg and damaged its propeller. Its wings also sustained impacts from the vegetation.

The impact with the vegetation fractured the aircraft's nose leg and damaged one of the propeller blades without breaking it completely.

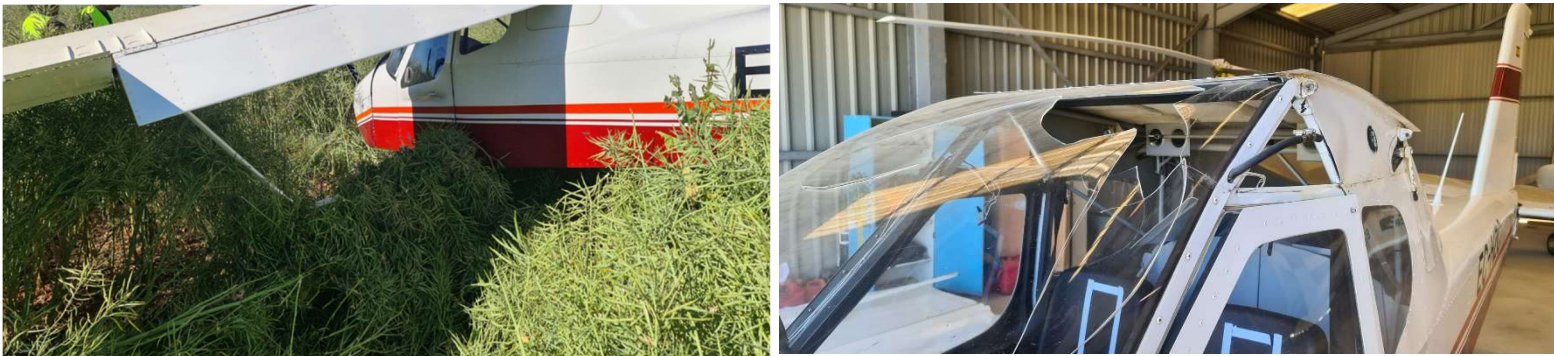
Illustration 6 Final condition of the strut and windscreen

The left wing strut also fractured, causing the left wing to flex downwards and break the windscreen. The pilot's door was rendered unusable.

The fractured strut caused the left wing to bend downwards, rendering the pilot's door unusable and blocked. As a result, the pilot was forced to evacuate the aircraft through the co-pilot's door.

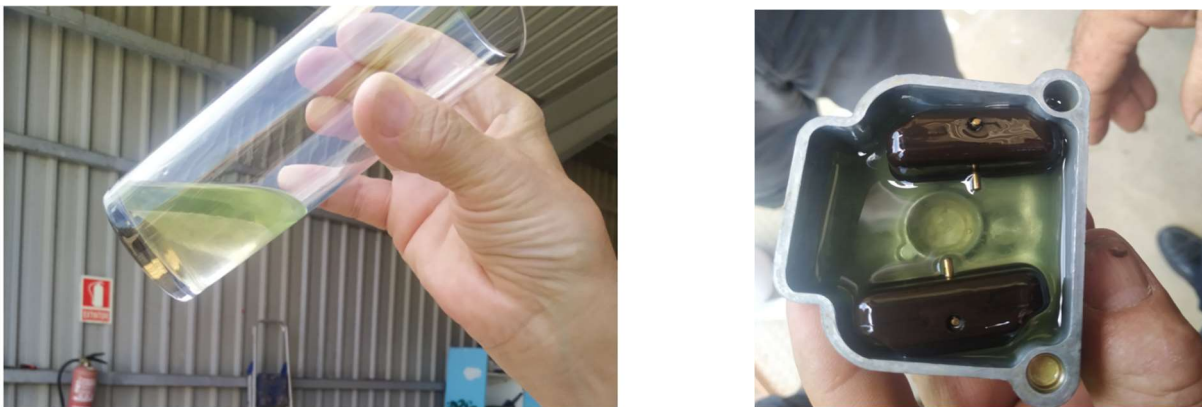
Illustration 7 Presence of water in the carburetors

Water was found in both of the two carburettor float bowls. There was also evidence of the presence of water in the fuel line to the carburetors. The following images show the contents of the float bowl, which when collected in a glass, clearly show the separation into both fuel and water.

On the day of the accident, moments before the engine shutdown, the pilot opened the right-hand fuel valve. The water held in the right fuel tank reached the fuel line and flooded both carburettors, causing the engine to stall.

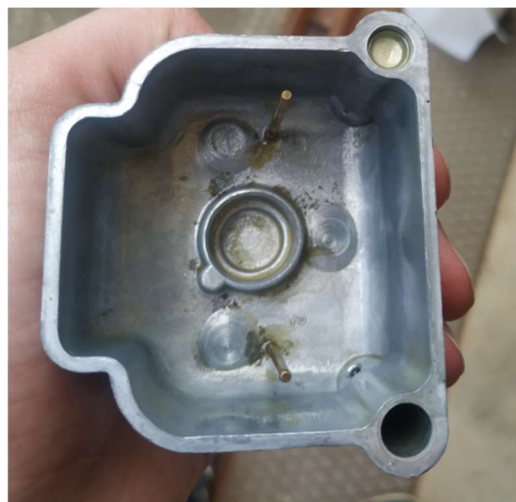
Illustration 8 Rust marks in the carburettor float bowls

In addition, rust marks were observed on the bottom of the float bowls, confirming the presence of water at the base of the carburettor.

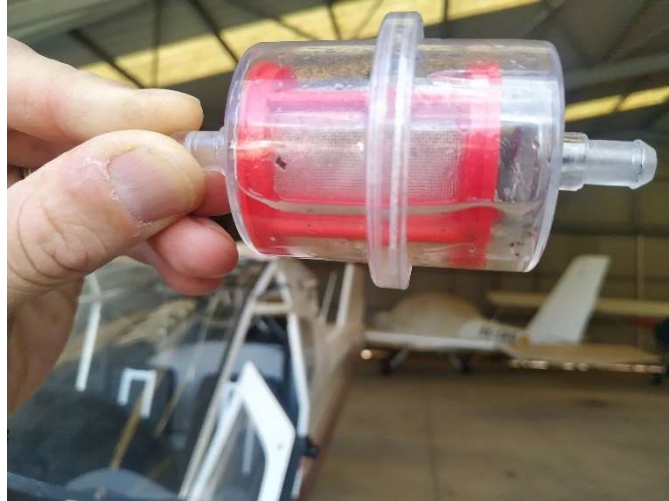
Illustration 9 Presence of water in the fuel filter

The fuel filter is located where the fuel lines from the two wing tanks meet. Once both fuel lines are unified, the fuel passes through the filter and into the gascolator before going to the carburettor bowls.

A considerable amount of water was found in the fuel filter when it was disassembled, as shown in the following image.

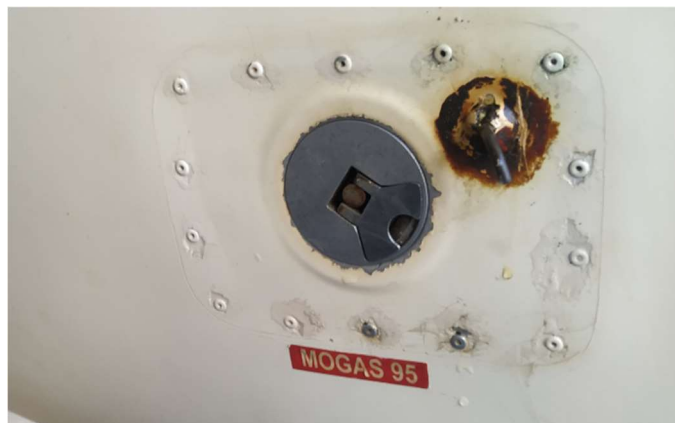
Illustration 10 Fuel tank access plate

The external access to the fuel tanks on the wings consists of an aluminium plate over a glass-fibre tank. On this external face, there were signs of corrosion on the metal part of the overflow.

There were no signs of interior corrosion on either the glass-fibre or aluminium parts of the tank. However, there was a considerable amount of water inside the fuel tank on the right wing.
