# Technical report

## ULM A-029/2022

Accident on 01 October 2022 involving a RANS COYOTE II S 6ES VF EC912 aircraft, registration 32GX, in the municipality of El Álamo (Madrid).

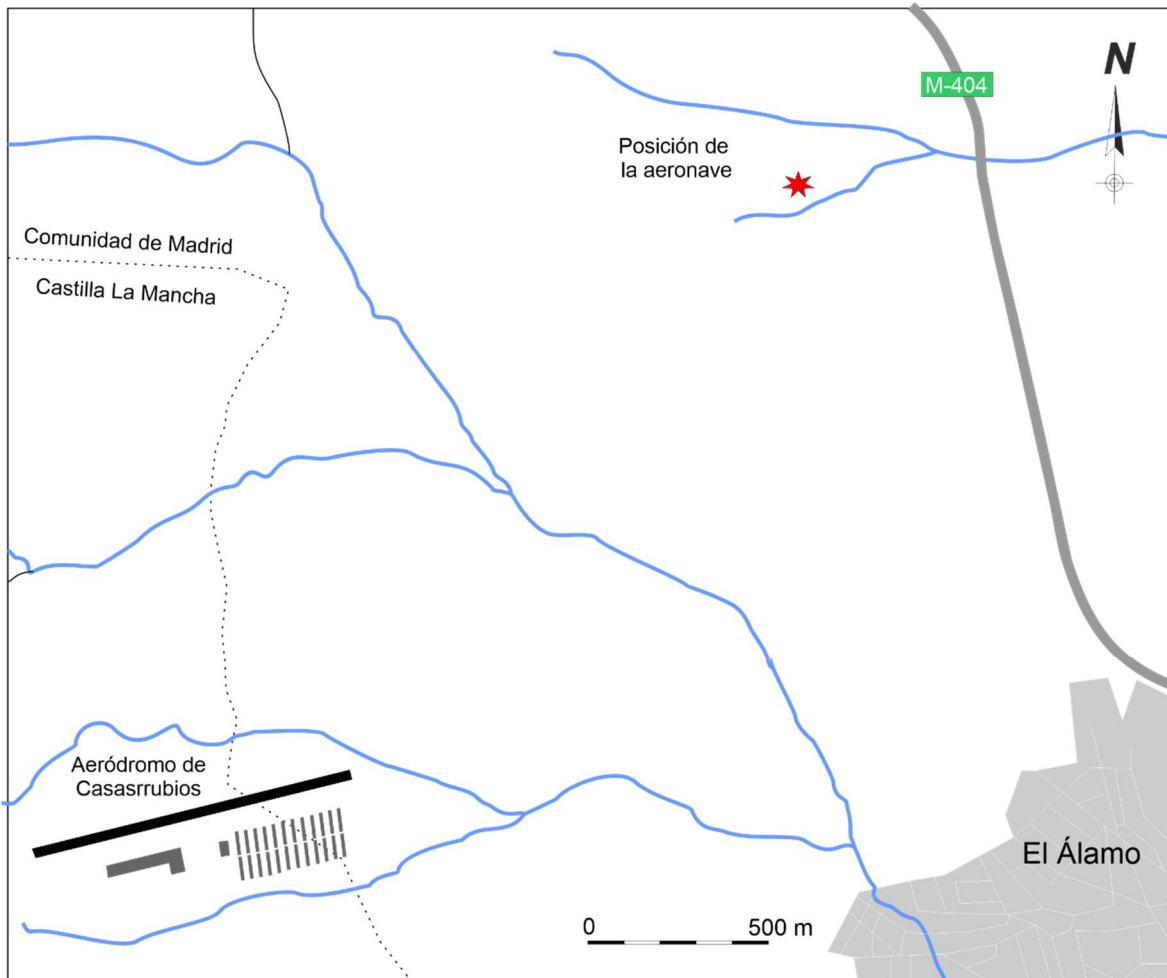
After touching down, the aircraft taxied over the terrain smoothly until it crossed a small raised ridge, at which point the right main landing gear leg collapsed, and it then slid along the ground before coming to a complete stop.

**Fig. no.1. - Sketch showing the location of the aircraft**

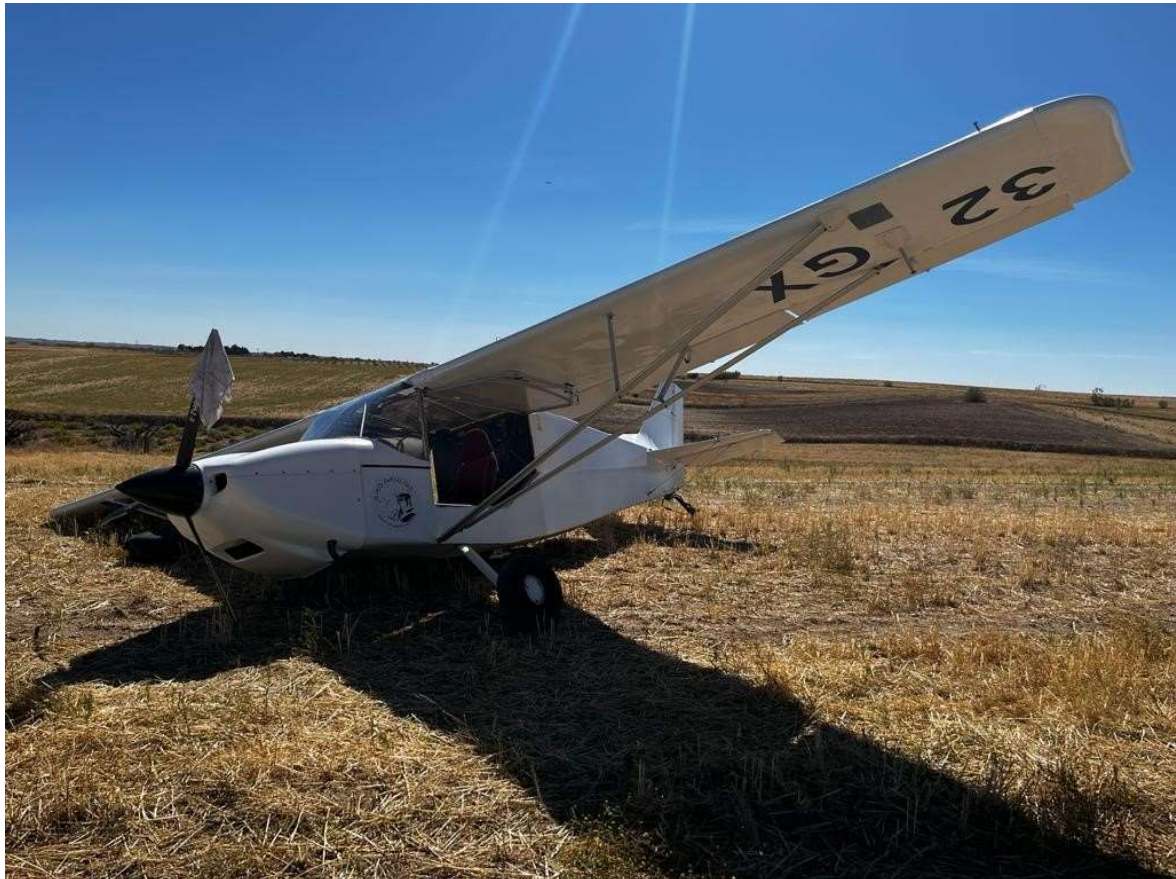
***Fig. no. 2 - Aircraft in its final position***

It had come to rest with the lower part of its fuselage, left main gear leg and right-hand wing tip touching the ground.

There were cracks in the right-hand underside of the fuselage and on the end of the right wing, which was also deformed. The right main gear leg was broken and separated from the aircraft.

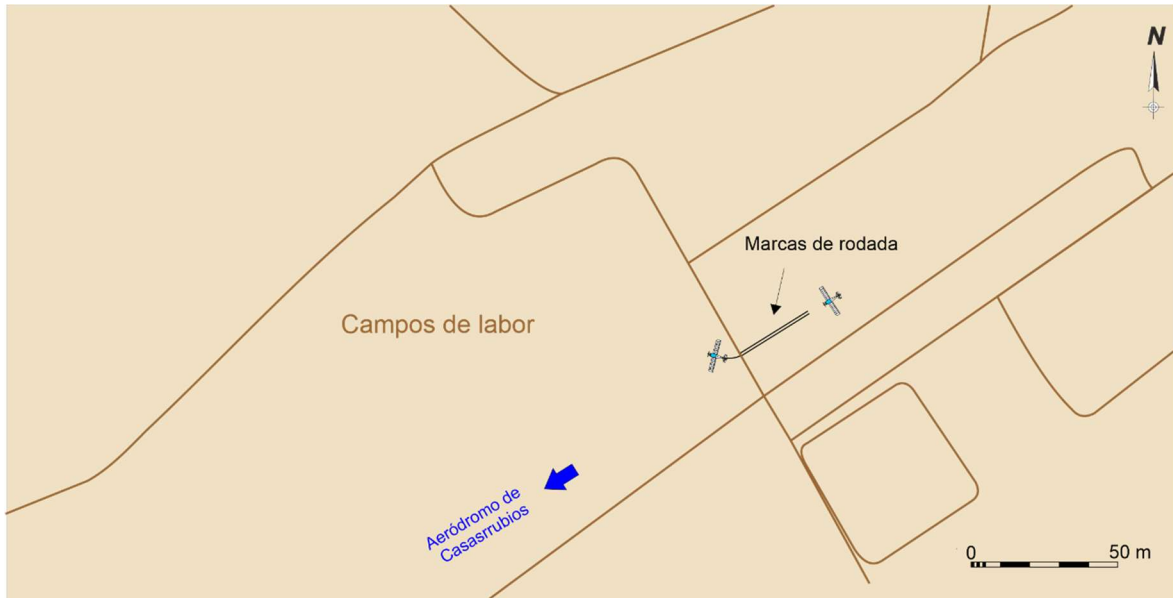
The tracks on the ground were spread over a length of 36 m. The first section consisted of two lines running parallel to one other up to the intersection with a slight ridge running transversely to the aircraft's direction of travel. The second section consisted of more pronounced marks covering the remaining 9 m to the aircraft's final location.

**Fig. no. 3 - Detail of the track marks on the ground**

The layout of the tracks on the ground corresponds, in the first 27 m section, to the main landing gear wheels making contact with the ground during the initial taxi. In the second 9 m section, the marks were made by the fuselage as it dragged along the ground after the right landing gear leg collapsed on hitting the ridge.

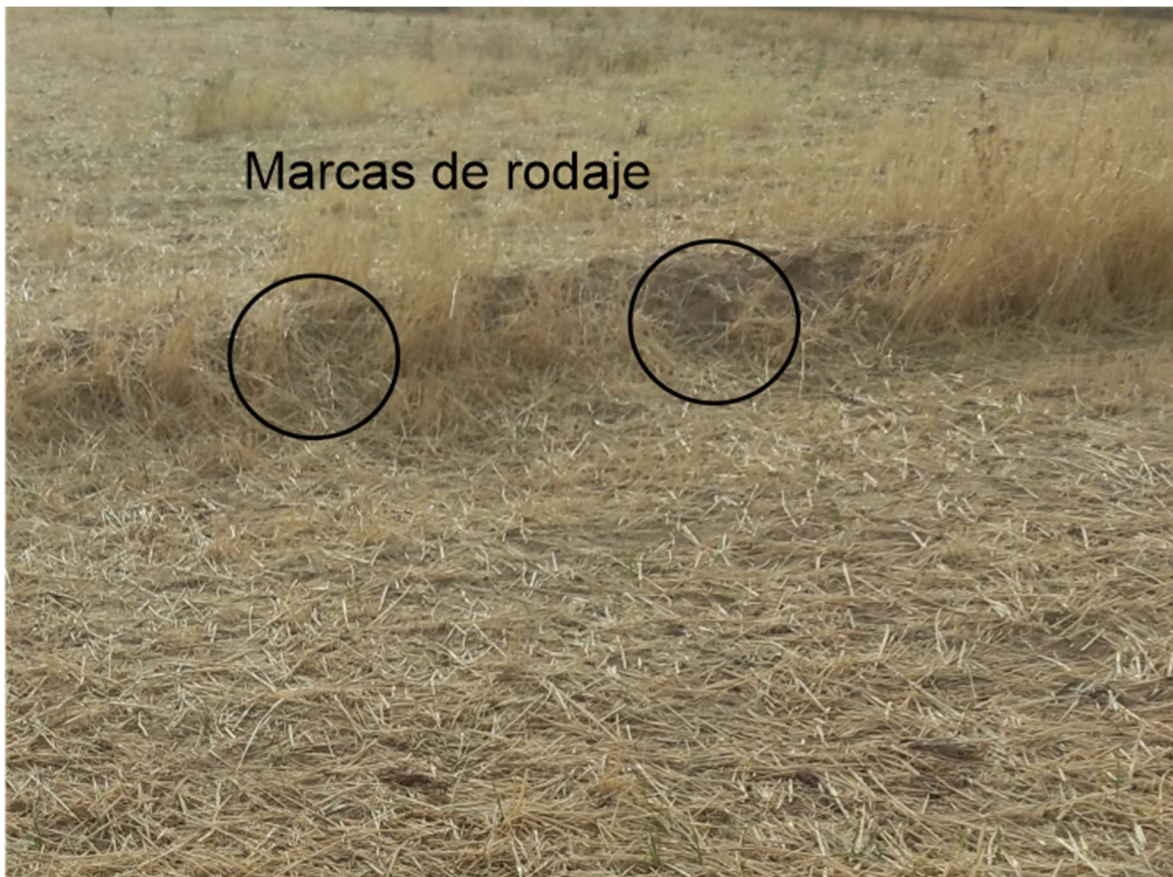
**Fig. no. 4 - Detail of the track marks on the ridge**

According to the pilot's statement and as suggested by the tracks on the ground, the operation, including the touchdown, proceeded normally until the aircraft encountered a ridge while taxiing, which caused the right landing gear leg to collapse.

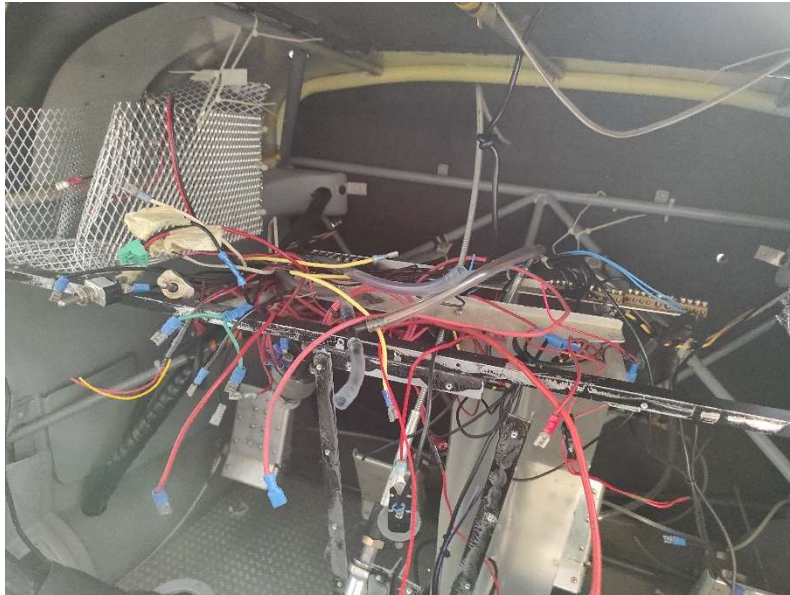
At the time of accessing the wreckage, the aircraft had been disassembled and prepared for transport. The cockpit instruments were removed prior to notifying the CIAIAC of the accident, cutting the relevant electrical circuitry, altering the wreckage and interfering with the investigation.

*Fig. no. 5 - Condition of electrical circuitry inside the aircraft*

No further inspections of the condition of the wiring to the various instruments and the starter motor were possible since most of them had been tampered with and removed from the aircraft.
