Report ULM A-010/2014

Accident involving a ULM Moragon M1 aircraft, registration EC-EI3, south of the city of Gijón, Asturias (Spain) on Sunday, 8 June 2014

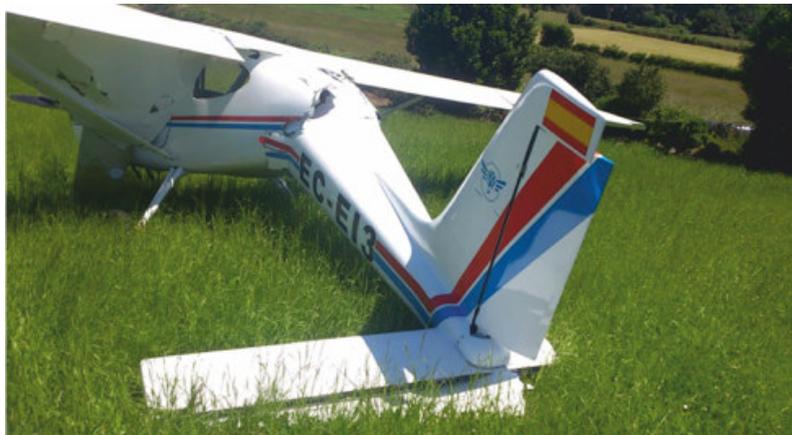
Figure 1. Ultralight aircraft after making an emergency landing on the field

The impact damaged the aircraft's left wing, tore off the right horizontal stabilizer and partially severed the fuselage aft of the cockpit. Neither the pilot nor the passenger suffered any injuries.

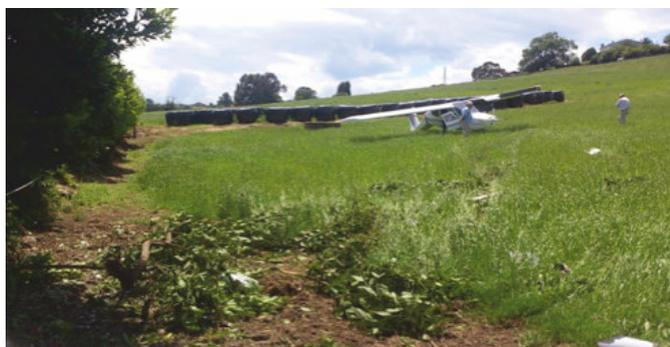
Figure 2. Trees and broken branches from the trees surrounding the field, and tracks from the airplane's gear on the ground

A few meters beyond the start of the field there were marks left by the landing gear wheels indicating that the airplane traveled some 30 meters before coming to a stop.

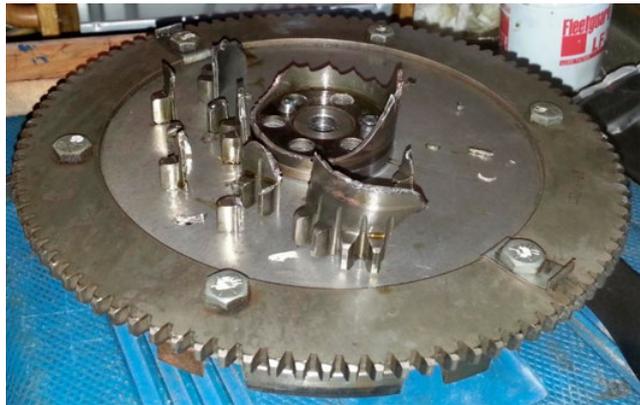
Figure 3. Flywheel and damaged cone gear

The plate at the rear of the engine supporting the alternator was removed, as was the flywheel and magnetic flywheel assembly, which are attached to the crankshaft by six screws. The 22-tooth cone gear, which transmits the motion of the crankshaft to a 44-tooth gear attached to the camshaft, and which also transmits the rotation to the rotors on the ignition distributors (see Figure 3) was broken.

When the cone gear fractured, it caused the crankshaft, the rear halves of the crankcases and the rear plate where the engine is attached to the ultralight to distort. No other abnormalities or damage were found in the engine that could have been related to a possible fault during its operation.

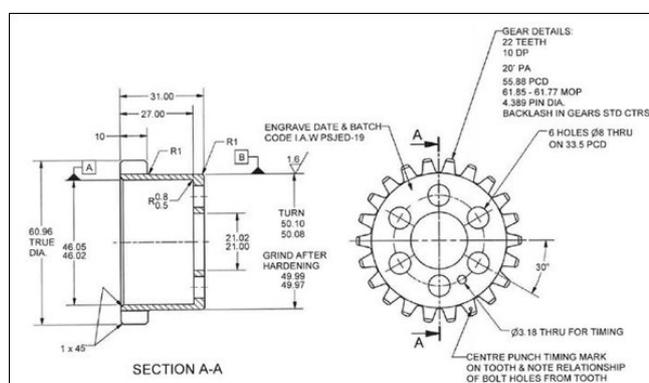
Drawing 1. 22-tooth gear, version used until 2004

The manufacturer confirmed that the component that broke, the 22-tooth gear, was not the part that had been mounted on the original engine on 06/12/2002. These differences can be seen in Drawing 1 and Figure 4. The owner of the ultralight added two holes with a smaller diameter than that on the six 8-mm diameter holes used for the fastening screws on the original part. The owner also replaced the original 3.18-mm diameter timing hole with one of the new holes.

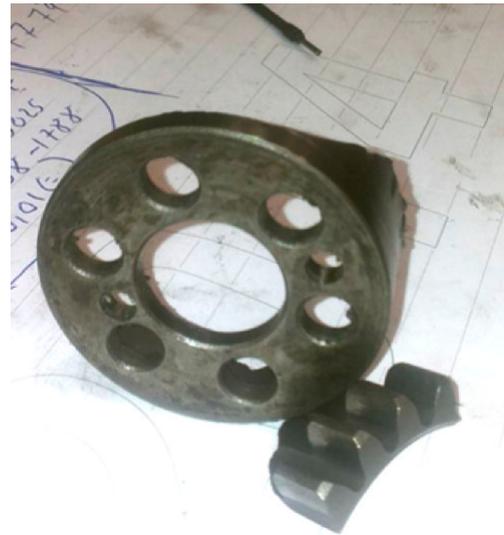
Figure 4. Broken gear installed in the engine

The fracture of the vertical wall of the conical gear and the ejection of several pieces of the gearing stopped the rotation of the camshaft and the ignition distributors for all four of the engine's cylinders.

The owner blamed the fracture of the gear on its small wall thickness, since the fracture grew over almost half of its circumference along the rubber seal. This hypothesis could not be confirmed.

As for the mark left by the rubber seal on the gear, this develops normally as the engine runs and has no effect on the material in the gearing or in the conical gear. The owner's hypothesis regarding the fracture surface can thus be ruled out.

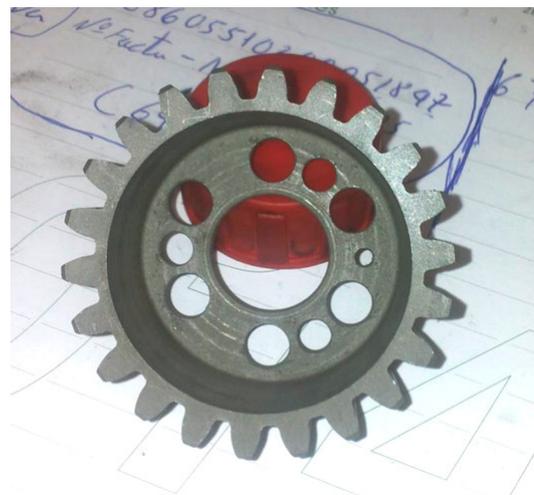
The flywheels are attached using six screws, which in the first engines in the 2200 series were 1/4" screws, while later engines in that and the 3300 series used 5/16" screws. A subsequent change to the most recent engines resulted in the use of 3/8" screws. The screws were later supplemented with three 6-mm diameter dowel pins, Figure 5.

Figure 5. New replacement gear

later to absorb the twisting force, and the gear wall thickness was increased by 1 millimeter.

In this Bulletin, the manufacturer recommends that all engines be upgraded to the latest specifications, with 5/16" screws and three dowel pins, at the next 2000-hr overhaul. The initial bulletin was republished in June 2011, Issue 2, replacing the first edition.

The manufacturer also stated that the preferred practice is not to drill these new holes for the dowel pins into the existing gear, but rather to replace the gear with the new version when maintenance is done on the engine.

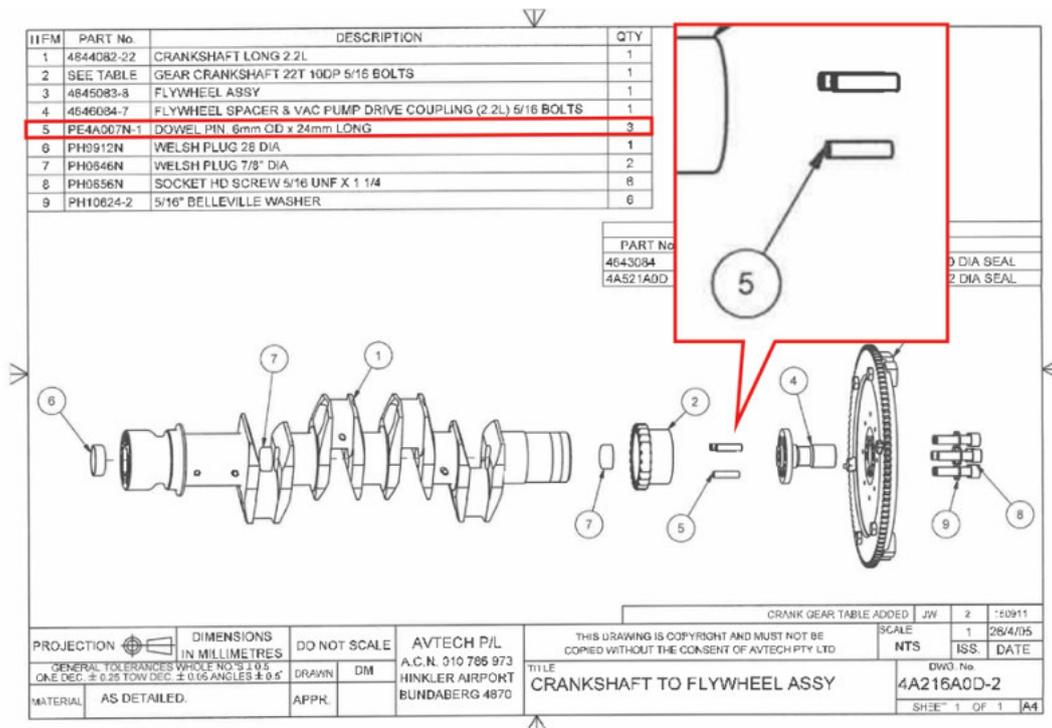
During said implementation, two holes were machined into the gear to enable the installation of the required 6-mm diameter dowel pins. This was done as per the instructions in the diagram for the crankshaft and flywheel assembly included in the manufacturer's Overhaul Manual (see Drawing 2). However, the owner, who machined the gear, misinterpreted the drawing, since both it and the descriptive text mention three dowel pins, as shown in the highlighted parts of the figure. As a result, the owner's modification of the gear was not as required by the Service Bulletin.

Drawing 2. Crankshaft and flywheel assembly, exploded view and description of the components
