Report ULM A-001/2018

Accident involving a Quicksilver
GT-500 ultralight aircraft,
registration EC-CJ7,
at the aerodrome of El Berriel in
San Bartolomé de Tirajana
(Las Palmas – Canary Islands –
Spain) on 12 January 2018

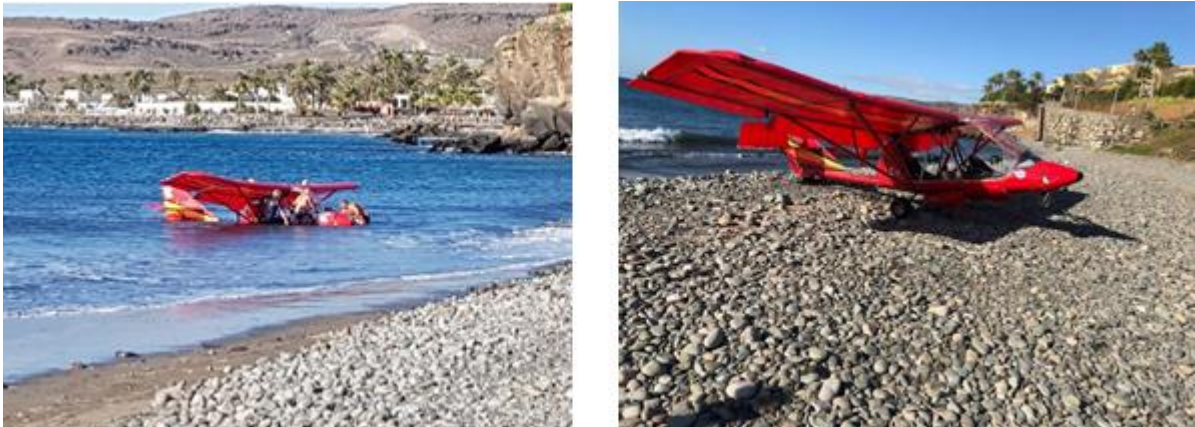
Figure 2. Photographs of the aircraft, in the water and on the beach.

- There was no damage to the fuselage structure, the engine mount or landing gear.
- There was damage to the leading edge and outer edge of the right wing. It looked bent, but the cloth covering the surface was not pierced.
- The left wing and the struts on both wings were undamaged.
- The actuating rods for the elevator controls were bent (right side) and broken (left side).
- The metal bulkhead located underneath the rear seat was bent and some rivets were missing. Another bulkhead located behind the rear seat was also bent.
- The main fairing, made of fiberglass, was completely broken. The points where it attached to the rest of the aircraft were in their proper positions.

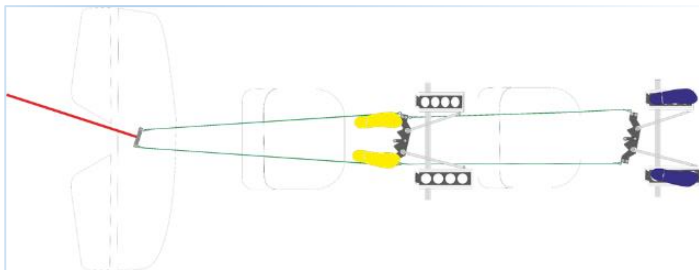
The yaw control system in the aircraft consists of two pairs of pedals and two bellcrank that are attached to each other and to the rudder using cables. The pedals at each seat are joined to the respective bellcrank via rods such that the entire assembly moves as one (see diagram in Figure 3).

Figure 3. Schematic of the aircraft yaw control system.

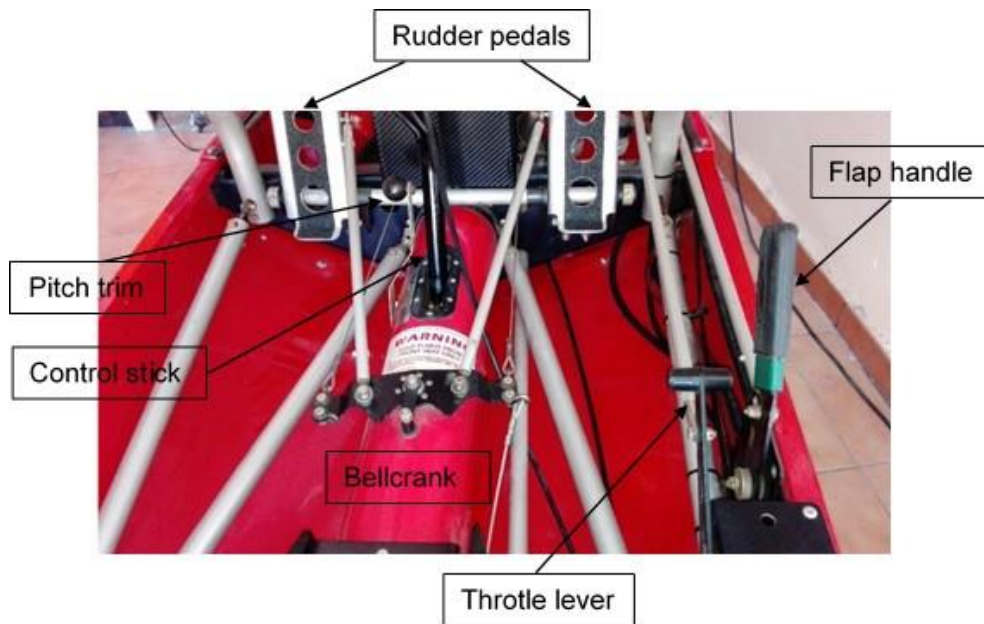
Figure 4 Floor of the rear compartment, between the two seats of the aircraft.

On the one hand, as described in 1.18.2, the layout of the system used to control the yaw of the aircraft and the location of its components, with a bellcrank situated on the floor of the fuselage, between the pedals and the seat, mean that if the passenger's

feet are improperly positioned, they could interfere with the bellcrank, preventing it, and therefore the yaw control, from moving.

It is recommended that **Quicksilver Enterprises Inc.**, as the owner of Type Certificate of Airworthiness No. 86-I, issued by Spain's Civil Aviation General Directorate, and No. TA1CH, issued by the Federal Aviation Administration (FAA) of the United States, take the appropriate measures, from the point of view of the aircraft's design, to avoid the possibility of having the yaw control system blocked due to the passenger's feet interfering with some of its components in aircraft of this type.

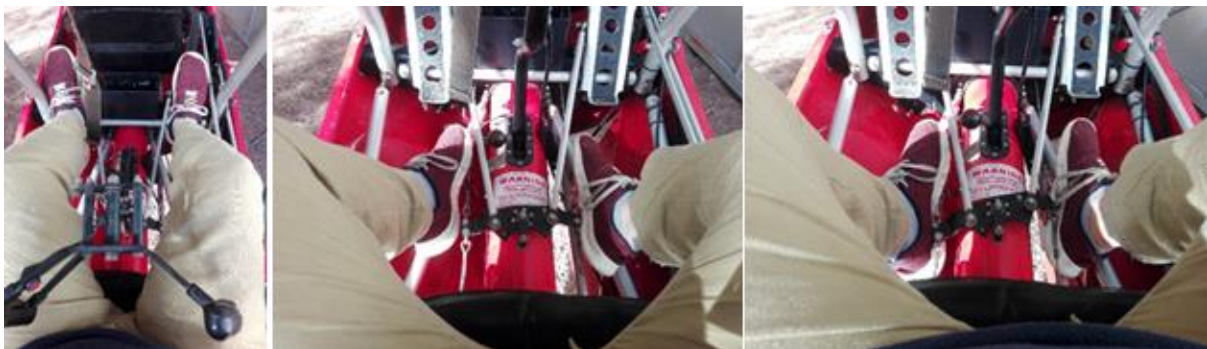
The sequence of photographs in Figure 5 shows a person seated in the rear seat of the aircraft. In the left image, the feet are resting on the pedals. In the central image, they are resting on the structural bars located directly in front of the seat. To avoid interfering with the bellcrank of the yaw control, the knees have to be kept apart and the feet pressed down on the bars. In the right image, the heels are next to the central tube of the fuselage structure and are interfering with the bellcrank, potentially impeding its motion.

Figure 5. Possible foot positions in the rear compartment

This indicates that the most probable scenario is that the passenger's feet inadvertently interfered with the yaw control, resulting in an abnormal flight attitude. The passenger focused on the control problem, not thinking of the possible cause and unaware that he was the source of the problem, and kept the control blocked until the aircraft landed on the water.

The probable cause of the accident was the inadvertent blockage of the aircraft's yaw control system by the passenger.

It is recommended that the **Federal Aviation Administration (FAA) of the United States**, as the authority responsible for the oversight of **Quicksilver Enterprises Inc.**, take the necessary actions to ensure that Quicksilver Enterprises Inc. take the appropriate measures, from the point of view of the aircraft's design, to avoid the possibility of having the yaw control system blocked due to the passenger's feet interfering with some of its components in aircraft of this type.

It is recommended that the **National Aviation Safety Agency (AESA)**, as the authority responsible for issuing the Certificate of Airworthiness for the QUICKSILVER GT-500 aircraft registered in Spain, review the process for issuing certificates of airworthiness for this type of aircraft in order to avoid the possibility of having the yaw control system blocked due to the passenger's feet interfering with some of its components in aircraft of this type.
