## Report ULM A-007/2019

Accident involving a Storm  
Century 04 aircraft, registration  
EC-ZTV, in the vicinity of the  
Casarrubios del Monte aerodrom  
(Toledo) on 30 April 2019

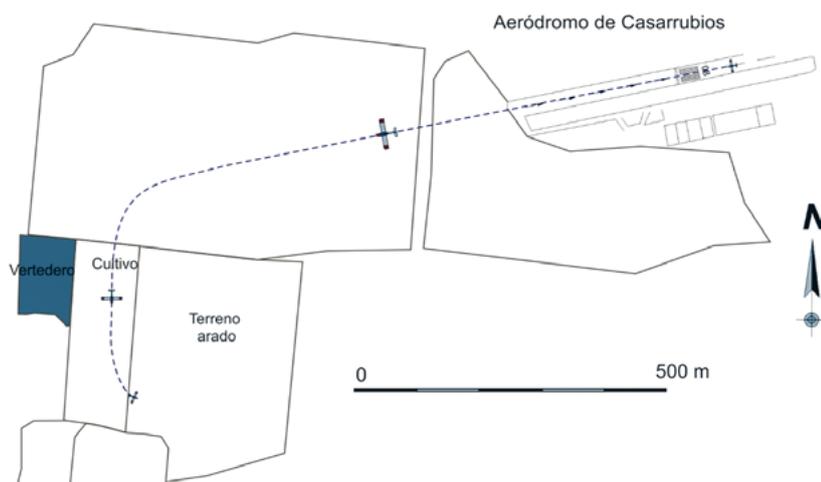
The aircraft landed practically parallel to the direction of the field and traveled some 40 m on the ground, constantly veering left during much of the landing run, until the landing gear eventually collapsed, causing the aircraft to stop in an adjacent field.

Figure 1: Path of the aircraft

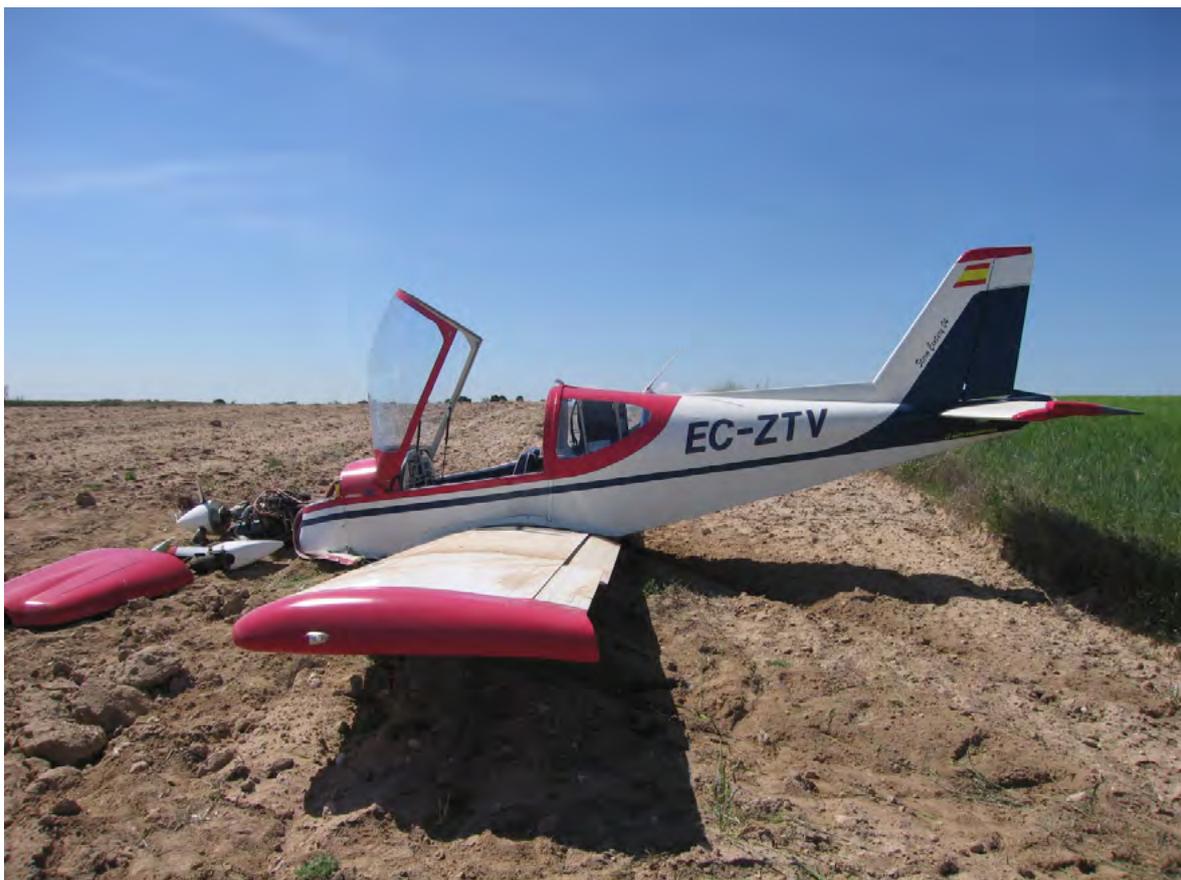
The damage to the aircraft consisted of fractures and deformations to the front underside of the fuselage, the landing gear, engine and cockpit interior. All three propeller blades were also broken.

The aircraft came to a stop in a field adjacent to where it had landed. Its ground was plowed and soft, in contrast to the cultivated, firm ground of the landing field.

Figure 2: Wreckage of the accident aircraft

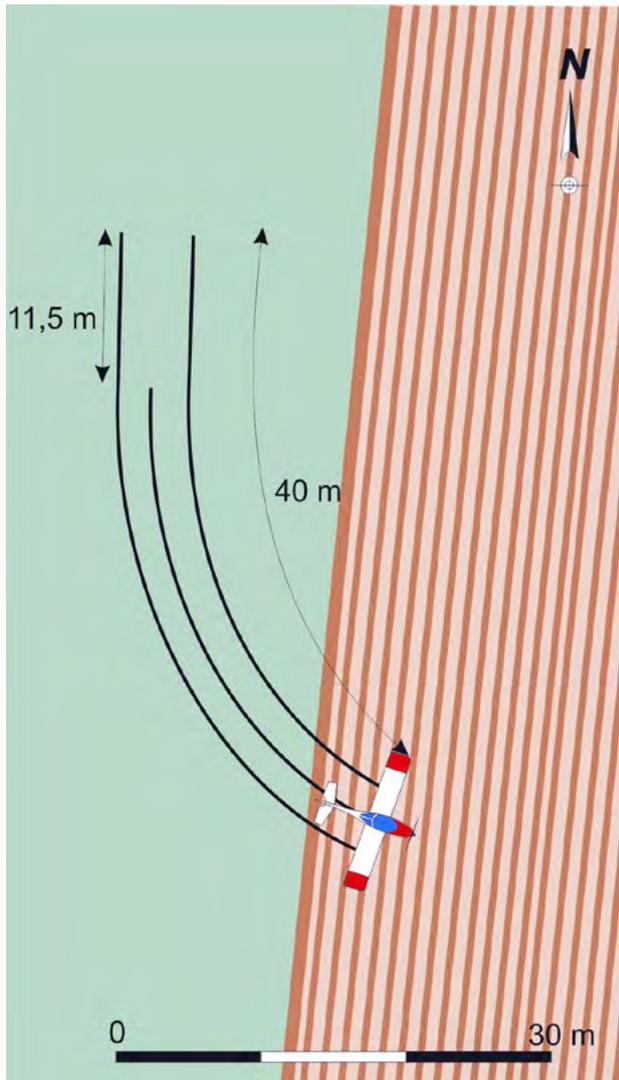
There were marks on the ground that indicated where the landing gear had made contact and the path traveled by the aircraft. The first marks were 11.50 m long and separated by 2 m. These were followed by a third mark, equidistant from the first marks. These three tracks were an additional 28 m long and continued to the point where the aircraft had stopped, at the start of the adjacent field.

The first set of marks was straight and almost aligned with the direction of the field. The second set, made after the nose wheel made contact with the ground, curved continuously to the left.

Figure 3: Marks on the ground

An analysis of the tracks found indicate that they were made when the landing gear wheels made contact with and then traveled along the ground. The first 11.5 m of the marks were left by the main gear, and the remaining 28 m with all three landing gear legs.

The aircraft's path on the ground was initially in a straight line, although it then curved constantly to the left for much of the landing run. This caused the aircraft to stop in an adjacent field, where the ground was too soft to allow the aircraft to continue traveling.
