Technical report

ULM-A-007/2020

Accident on the 21 June 2020, involving a Tecnam P2002 SIERRA aircraft, registration EC-FM8, in the municipality of Aibar (Navarra)

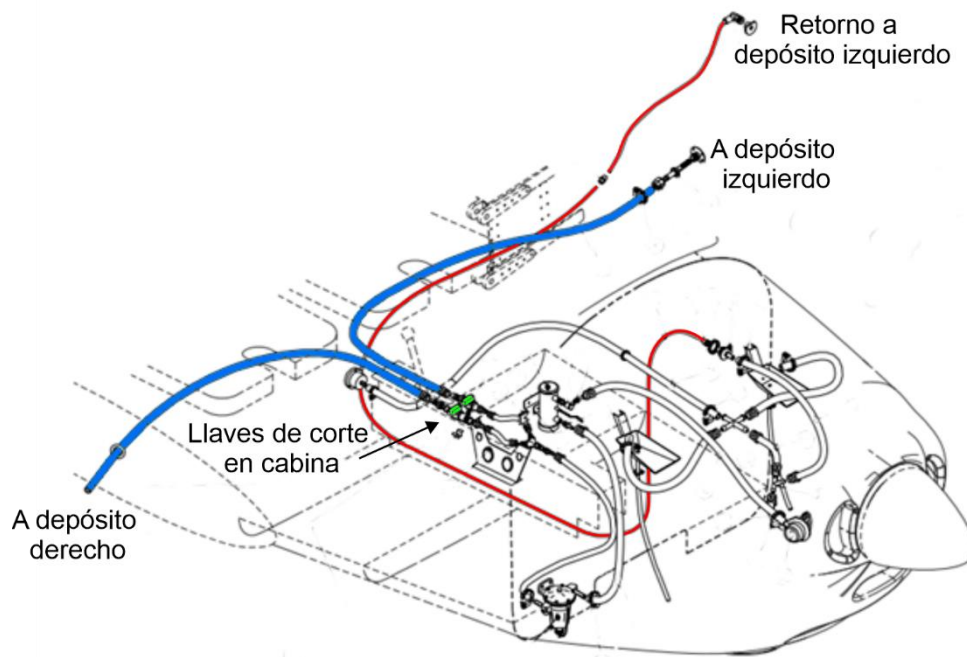
Fig. No. 1.- Diagram of the fuel system.

The fuel system diagram shows the supply pipes running from the two fuel tanks to the engine and a shut-off switch in the cabin, which is used to manage the differential fuel consumption of the two tanks.

It also shows the excess fuel return pipe, which carries excess fuel to the left tank.

Furthermore, the system's design returns the excess fuel pumped to the engine and not used back to the tank on the left wing only. This means that if the right tank is open, a part of its fuel is transferred to the left tank through the return system. Therefore, if the two tank valves are left open, the fuel is not consumed symmetrically, and the fuel level in the left tank may even increase.

In addition, leaving both fuel tank shut-off valves open without continuously monitoring the comparative levels between one tank and another could lead to a situation in which all the usable fuel in the right tank is consumed, and despite there still being fuel in the left tank due to the return system, the engine could absorb air from the right tank, thus impoverishing the mixture and causing it to cut out.

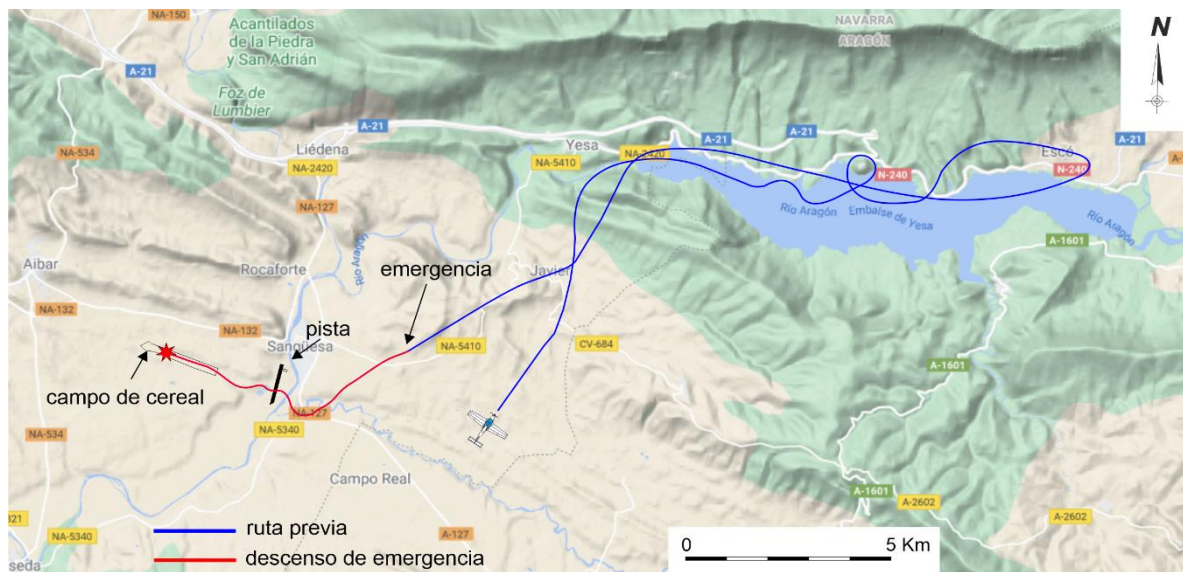
Fig. No. 2.- GPS trajectory.

The flight is first registered at the Tudela Aerodrome apron and then proceeds to ascend gradually during the first 70 km of the route. It then makes a steep descent toward the Yesa reservoir to fly over it and then begin the return to the Tudela airfield.

According to the data, when the aircraft was on the return leg, 108 km into the journey and at an altitude of 1,115 m (3,658.13 ft), it begins a continuous descent to the accident site and then remains there, at an elevation of 427 m (1,401 ft). Thus, it travelled 114 km in total.

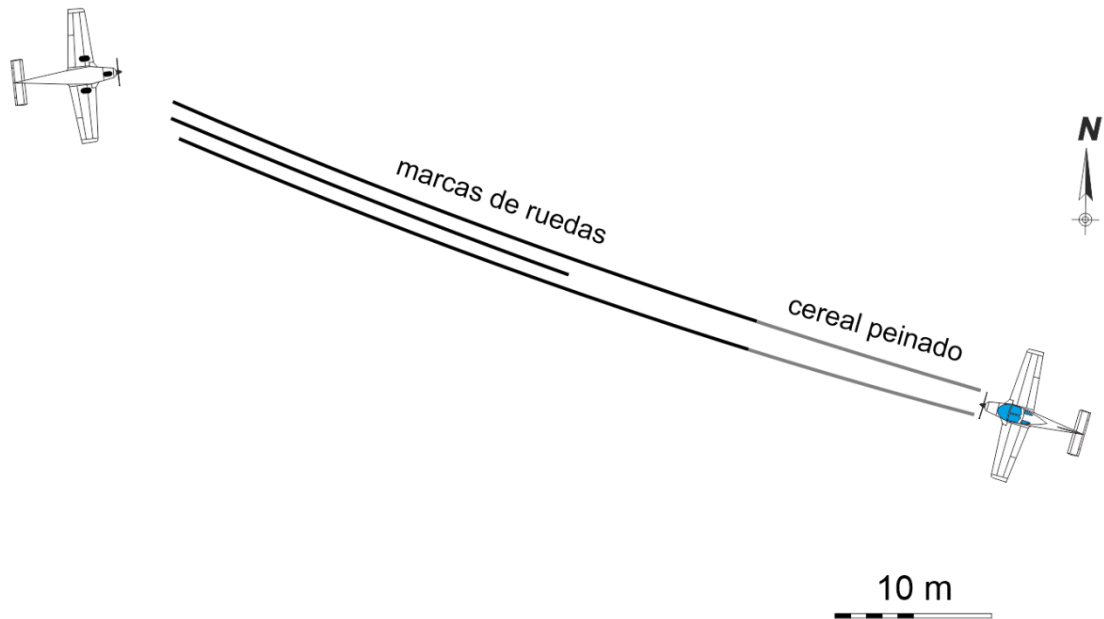
Fig. No. 4.- Track marks sketch.

On the ground, 55 m before the location of the wreckage, a 15 m section of crop 'combing' was visible, followed by two parallel 40 m-long tracks made by the main landing gear wheels as they rolled over the ground. Twelve metres after the start of the two parallel tracks, a third 28 m-long track appears, equidistant from the previous ones. This third track was made by the nose wheel as it travelled along the ground.

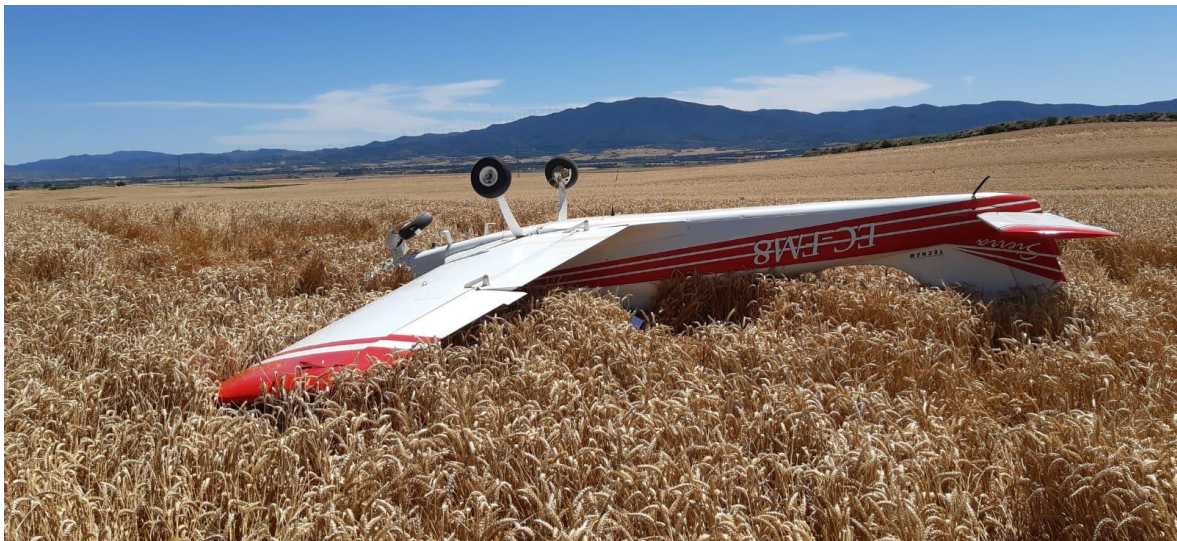
Fig. no. 5 - Aircraft in its final position.

The aircraft was found in an inverted position with an east-west orientation, in a 1,898 m long by 170 m wide unharvested cereal field with flat terrain and no appreciable slope.

The aircraft had fractures and deformities on its wingtips and on the rudder and upper part of its vertical stabiliser on the tail assembly. The lower part of the engine fairing and the cabin's methacrylate also sustained damage. The nose leg was bent, and two of the propeller blades were broken.
