Technical report

ULM A-009/2021

Accident on 22 May 2021,
involving a privately operated IRIS aircraft,
registration EC-XEA, in the vicinity of Bigastro
(Alicante, Spain)

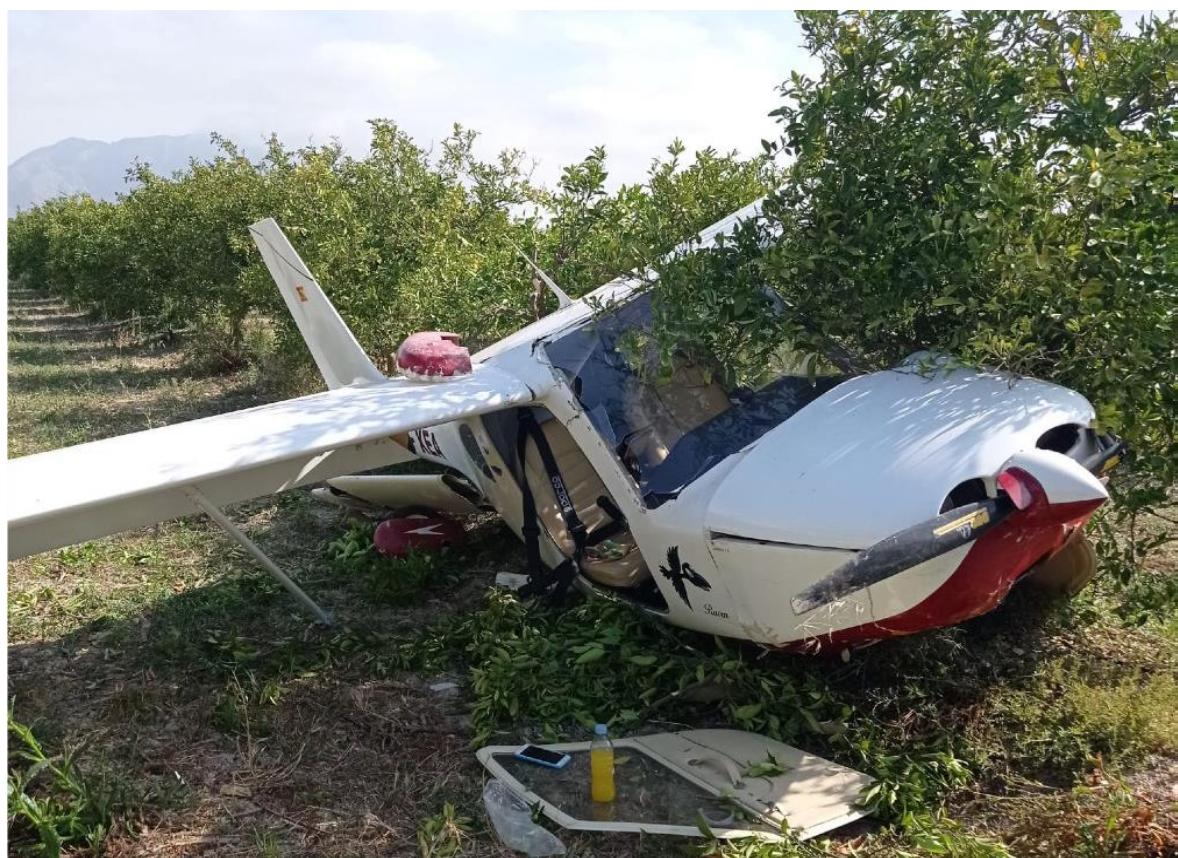
Photograph 1. Aircraft at the accident site

plane with “full flaps” and headed towards it to land. However, he eventually landed about 62 m short of it in the adjacent orange grove.

The aircraft hit some of the trees, incurring significant damage to the propeller, nose, landing gear, right wing, and horizontal stabiliser, causing fuel to spill onto the ground.

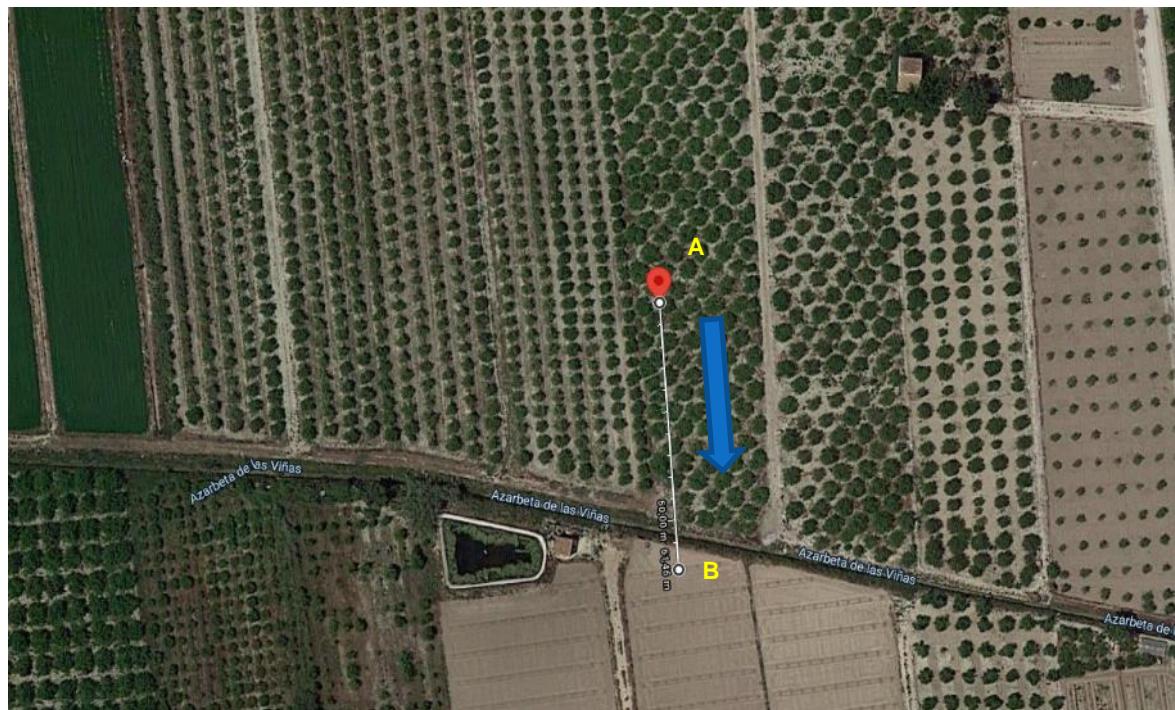
Photograph 3. Accident site

In photograph 3, it can be seen point A, which is where the aircraft impacted and stopped after the emergency landing. Point B, about 60 m from the crash site, is the closest point in the uncultivated field the pilot had been aiming for.

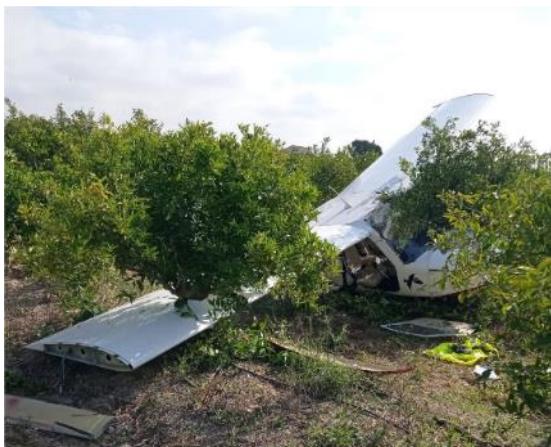
Photograph 4. Aircraft at the accident site

The pilot made the emergency landing in the direction of the crop, trying to land in the space between the rows of fruit trees but hitting the four that stopped the aircraft. Two of the trees were severed at the trunk, and the other two sustained branch damage. Spilt fuel was also observed on the ground.

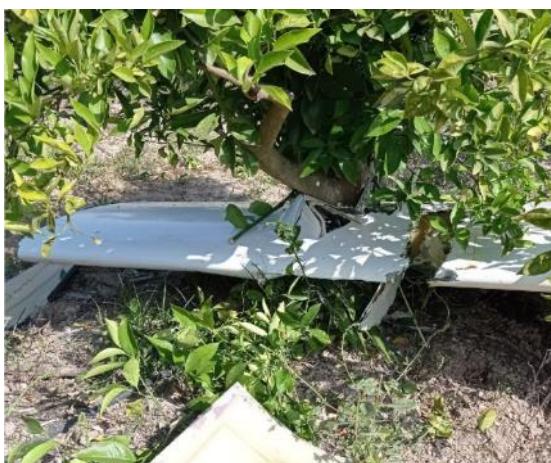
Photograph 5. Right wing

- Right wing: fracture with a transverse tear in the section located at 2/5 of its length, from the wingtip, completely detached. Deformed wing-root area. Flap at end near wing-root damaged with wing covering detached. Strut from the lower anchor to the fuselage detached.

Given the fracture in the right wing and the left side of the horizontal stabiliser, we can deduce that the aircraft was travelling with hardly any speed at all when it landed and stopped between two parallel rows of trees that impacted both sides of the aircraft without scattering debris around the field.

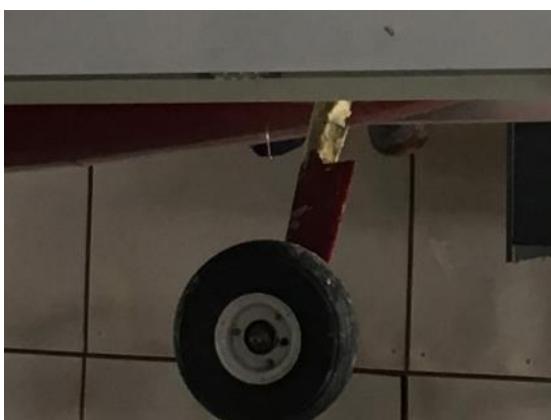
Photograph 8. Main landing gear

- Underside of fuselage deformed and scratched along its entire length.
- Nose landing gear: detached
- Main landing gear: right leg detached and left leg damaged.

The nose landing gear breakage occurred during the destabilised aircraft's initial impact with the ground and the trees, and the main landing gear sustained damage due to impacting various irregularities in the terrain. The damage and wreckage are consistent with these types of impacts.

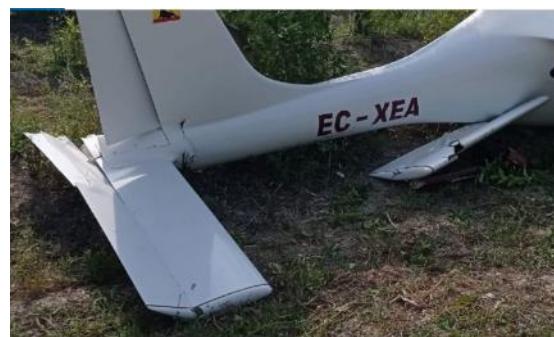
Photograph 7. Horizontal stabiliser

- Left wing: several minor impacts, particularly to the wing lower surface.
- Horizontal stabiliser: left surface with a central transversal breakage and detachment of the structure.

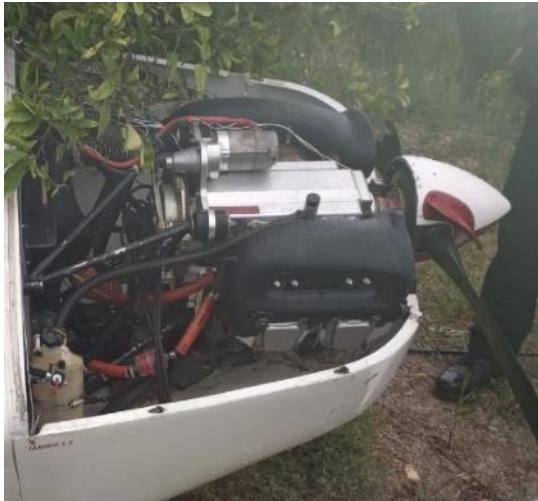
Photograph 9. Engine

- Engine: cowlings deformed.
- Propeller: one of the blades fractured in the first third of its length from the attachment. Minor impacts to the other blade.

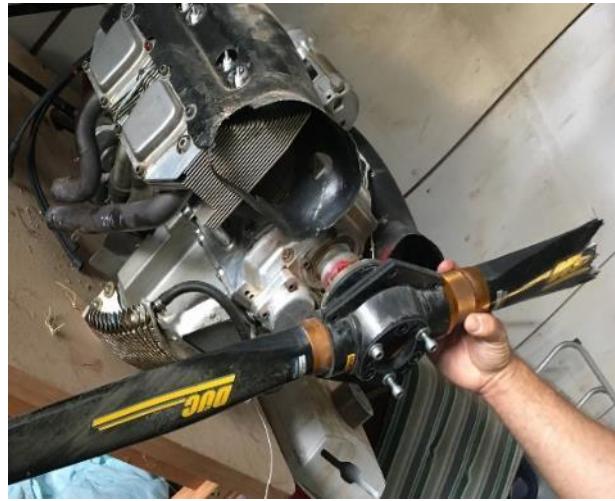
Photograph 10. Damaged propeller

The aircraft wreckage is consistent with the pilot's statement, and the damage to just one of the propellers proves that the engine was not running when the aircraft landed.

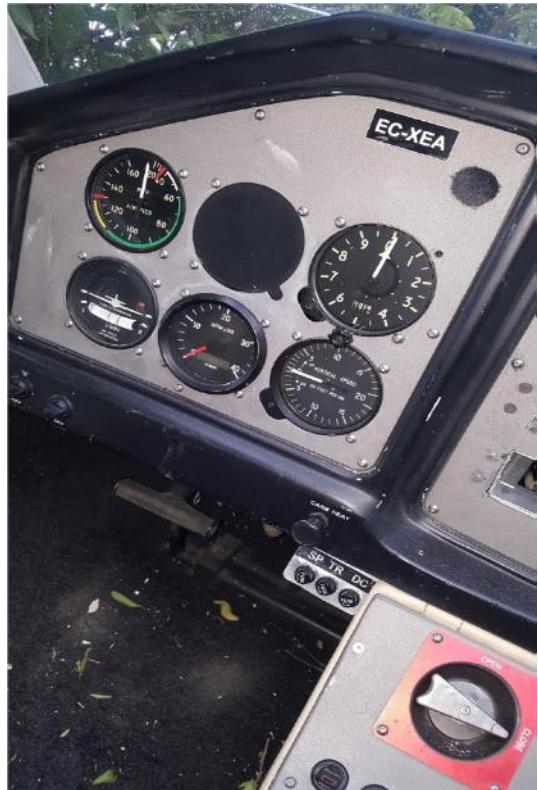
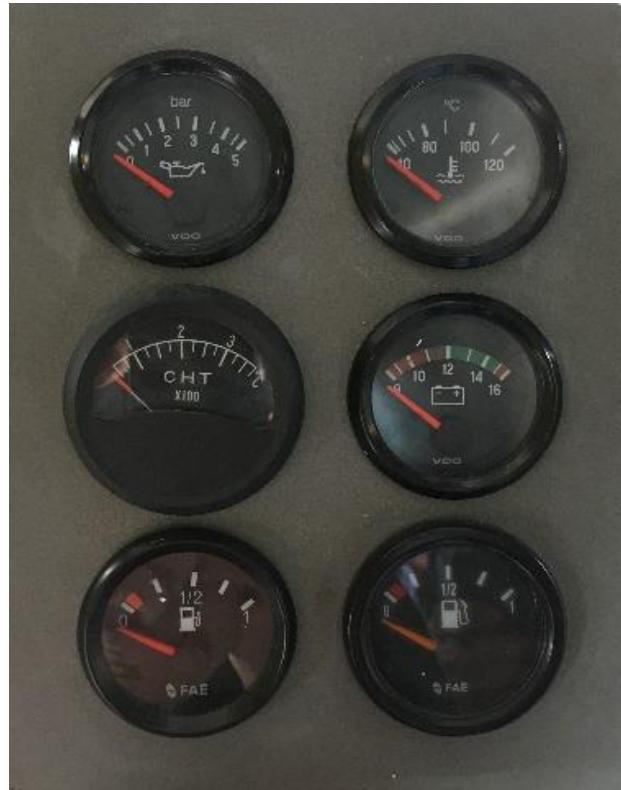
- Instrument panel: the fuel gauges showed the tanks were empty and the fuel valve was closed.

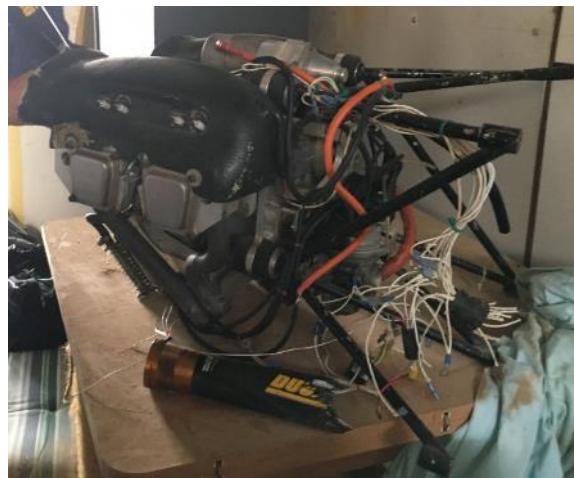
Photograph 13. Disassembled engine

The engine was found disassembled from its mount in the hanger at the LELG aerodrome, where it was inspected. There were no visible external impacts or deformations, the propeller was disassembled, and one of its blades was broken. There were no signs of oil or fuel leaks or spills.

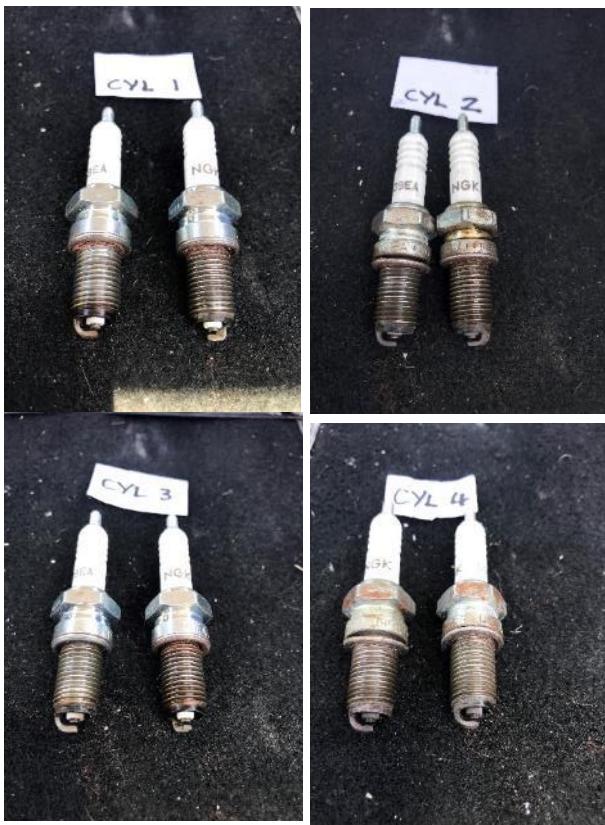
Photograph 14. Spark plugs from the accident

were no signs of engine overheating or mixture decompensation, and the mixture was neither too rich nor too lean as there were no traces of carbon, oil or melted droplets.

The spark plugs were disassembled. The pipettes were in good condition. Of the eight plugs, four were new, and four appeared to be older. The plugs for cylinders 1 and 3 had been replaced recently. All were the make and model recommended by the engine manufacturer, NGK D9EA.

According to the maintenance records, all 8 spark plugs were replaced with new ones 3 months before the accident. However, this is inconsistent with the findings of the post-accident inspection that found 4 appeared to have more wear than the others, which had only operated for 2 hours at the time of the event. The pilot eventually corroborated this fact. Nevertheless, the spark plugs were in good condition and calibrated adequately, so we can assume they were working correctly at all times.

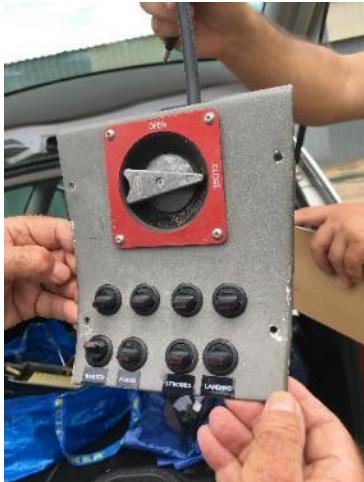
Photograph 15. Fuel shut-off valve

- Fuel shut-off valve: had only two positions, open and closed, and worked properly.
- Fuel filter: a mesh type filter in good condition.
- Gascolator: no presence of water and in good condition.
- There were cracks in the intake hose.

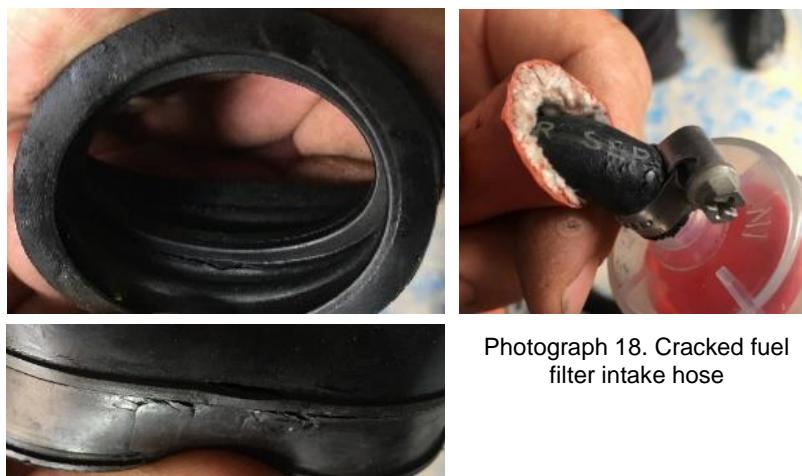
Photograph 17. Cracked intake hose

- Some sections of the fuel hoses were newer than others. Although the section between the fuel filter and the gascolator was protected by Stratoflex, it wasn't a tight fit and didn't reach the ends, where pores and cracks were visible. A vacuum test was carried out, and air entered, which showed that air was getting into the fuel circuit.

What could be verified was the presence of pores and cracks in the section of the fuel line between the fuel filter and the gascolator, as well as the deteriorated condition of the intake rubber, which could allow air to enter the fuel circuit and cause air bubbles to form. This effect reduces the effectiveness of the fuel pump, sending less pressure and causing the engine to stop.

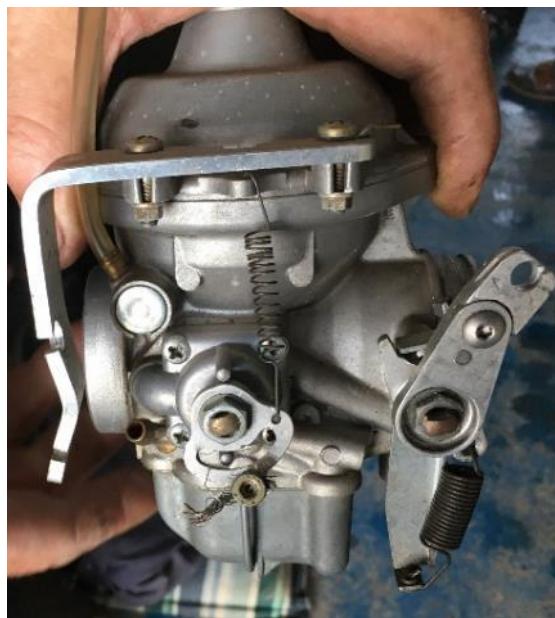
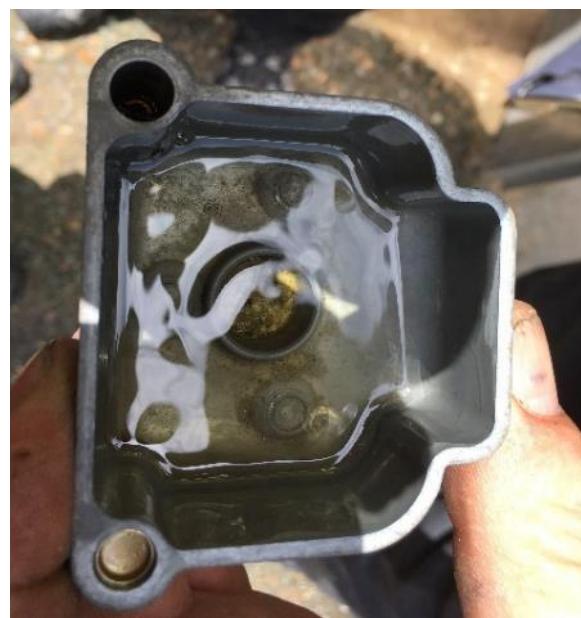
- The overall condition of the carburettor was adequate; it was clean and fitted correctly. The carburettor float bowl contained fuel, and there was no dirt or contamination of any kind.

However, as it could have fallen into the float bowl when the aircraft was transferred to the hangar, this does not prove there was fuel in it at the time of the accident. The needle was found to be worn.

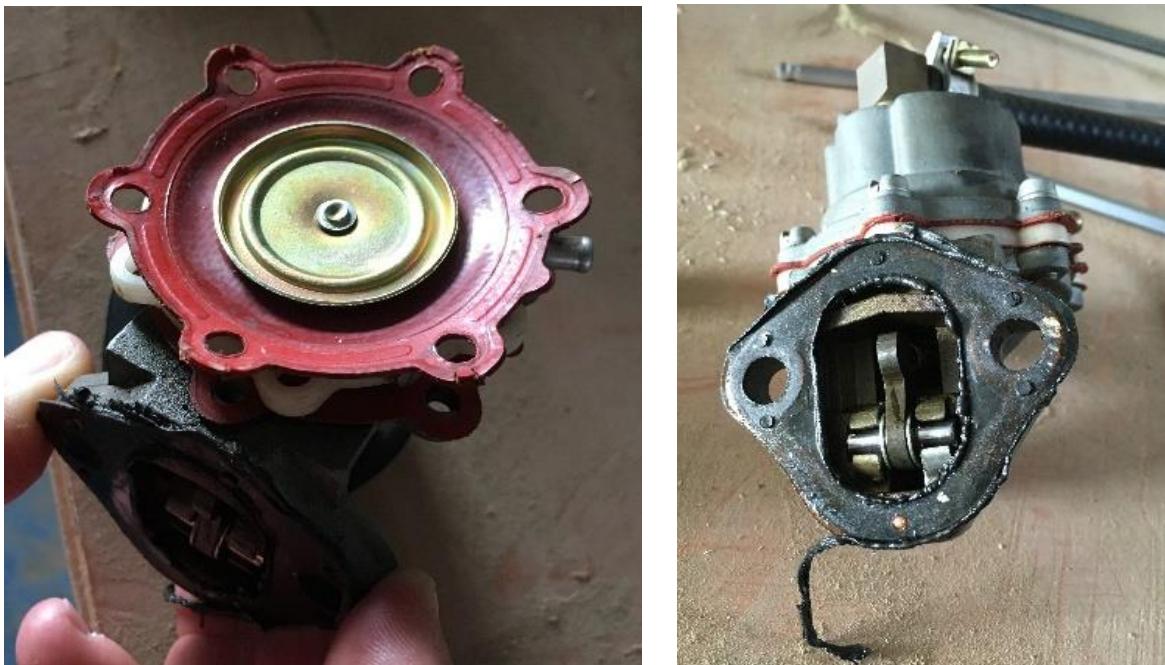
Photograph 21. Fuel pump

- The overall condition of the fuel pump was acceptable, and although the sealing gaskets were deformed, they functioned correctly.
