Technical report

ULM A-012/2021

Accident on 12 June 2021, involving a
TECNAM P-92 ECHO aircraft, registration EC-FK6,
operated by Ignagua Center, S.L., at
Casarrubios del Monte Aerodrome (Toledo, Spain)

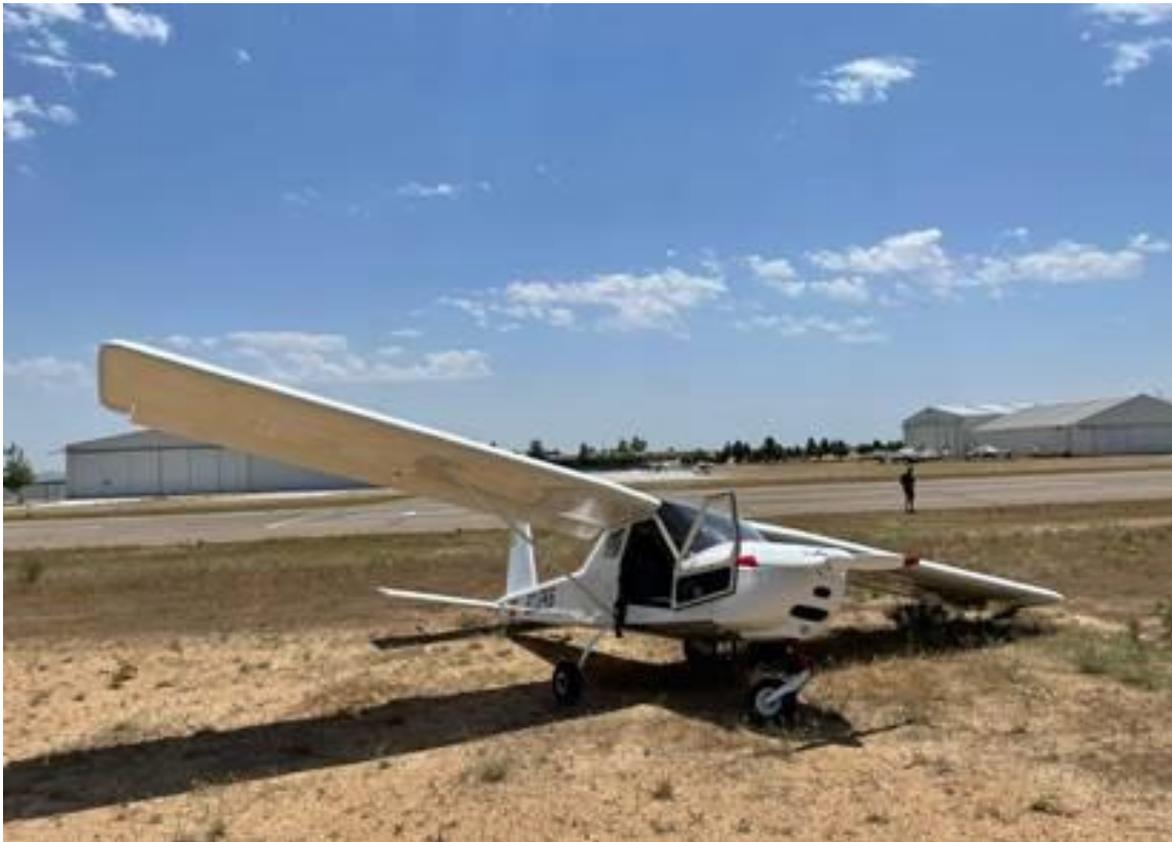
Photograph 1. Aircraft at the accident site

Pilot and passenger, both uninjured, exited the aircraft by their own means and observed that the left underside of the horizontal stabiliser was eroded and the left main landing gear leg was bent under itself.

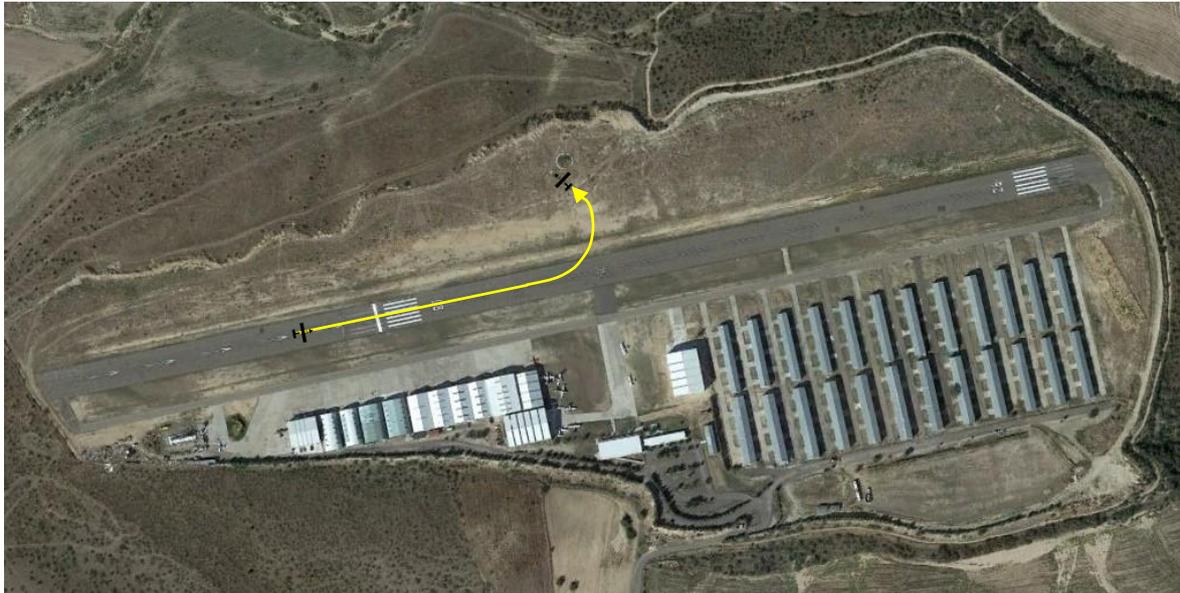
Photograph 4. Trajectory of the aircraft during the accident at Casarrubios del Monte Aerodrome

The aircraft veered off course and came to a stop, as shown in photograph 4. According to the aerodrome's video recordings, it touched down almost at the end of the first third of the runway and travelled approximately 175 m in 8", which means its speed was approximately 75 km/h.

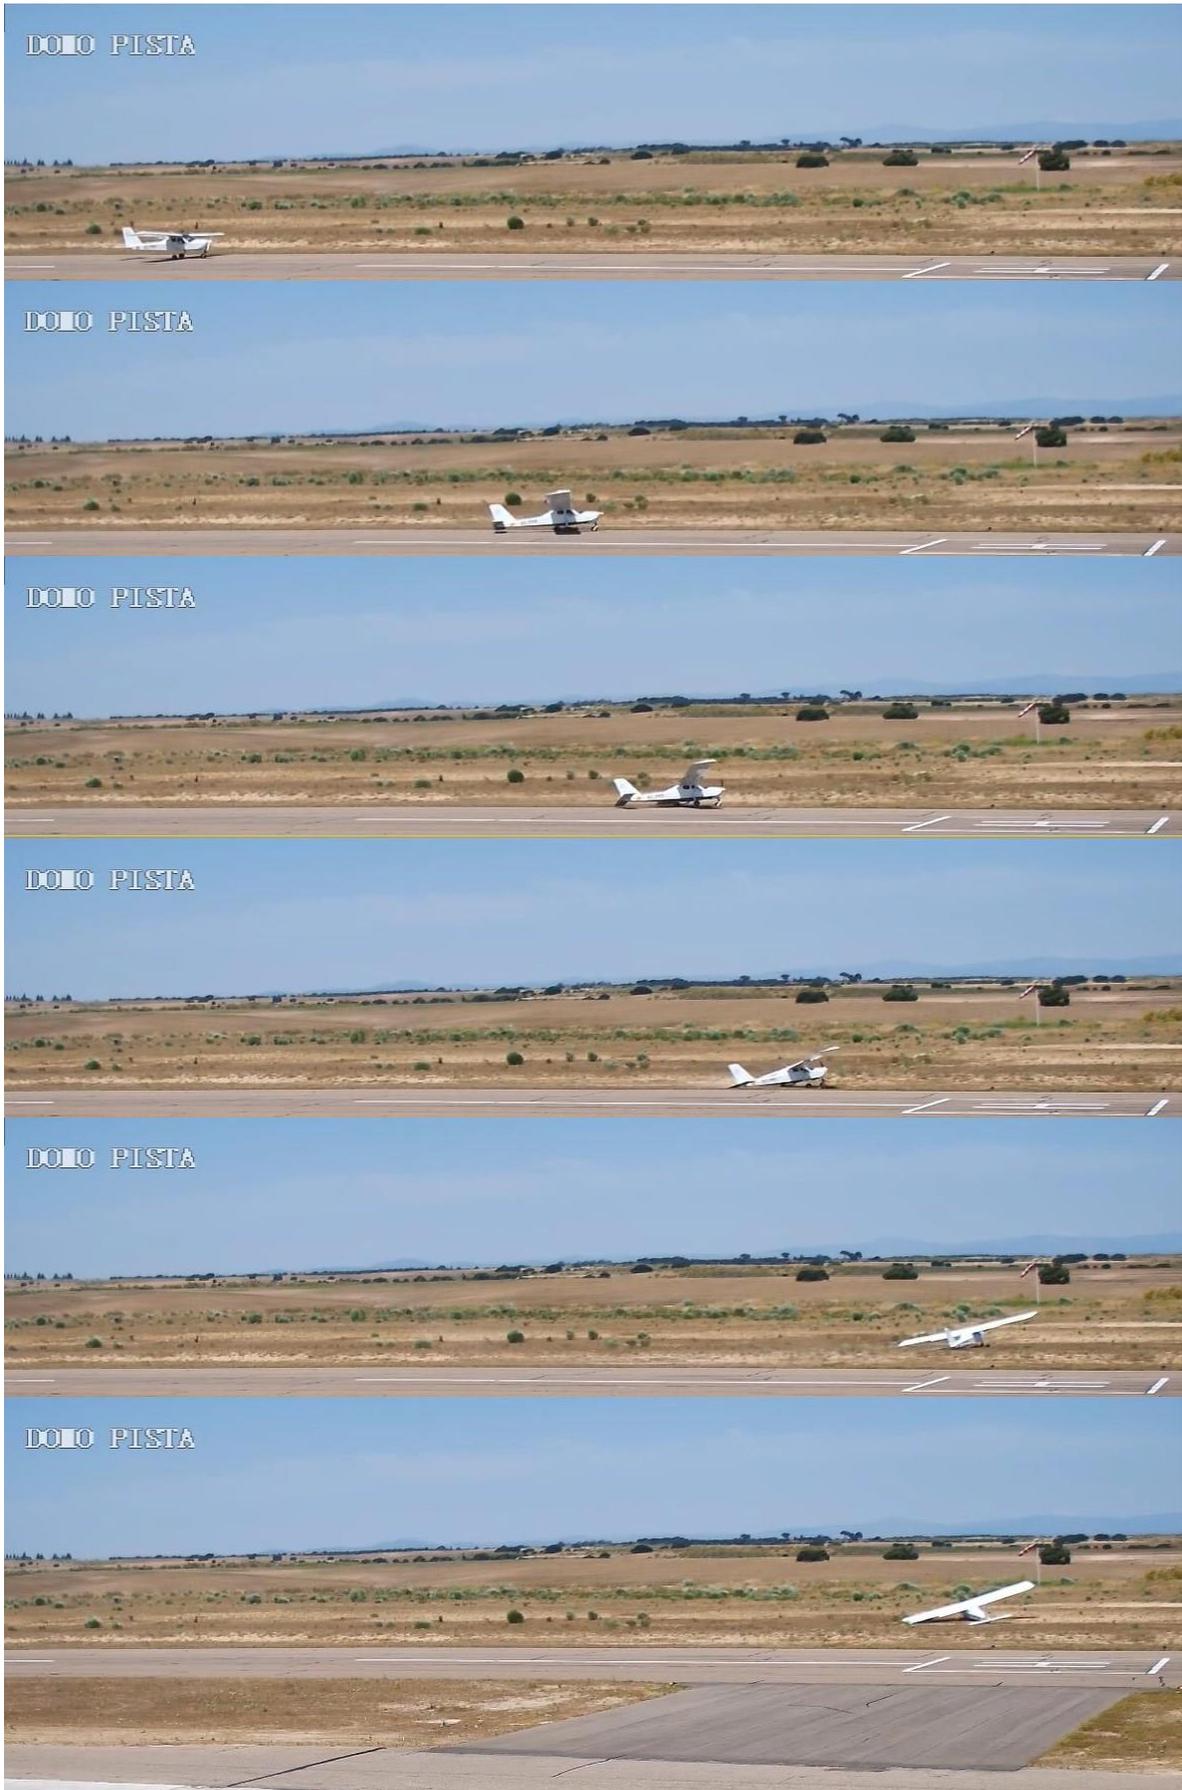
Photograph 5. Extract of the video footage showing the aircraft's trajectory.

The pilot's statement is consistent with the aerodrome's video recordings, which show, presumably when the pilot applied the brake, the aircraft veering gradually to the left at the same time as its left side sinks, causing the failure and bending of the left main gear leg.

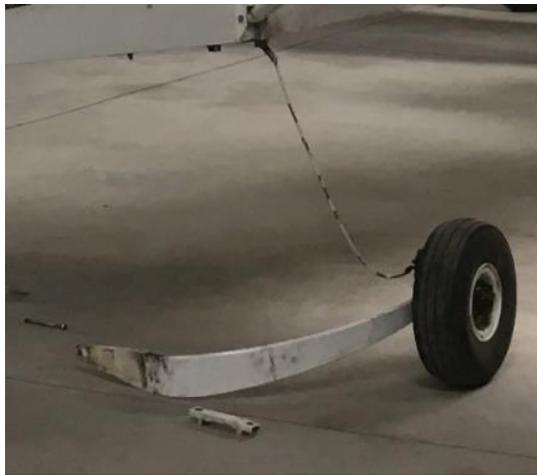
On exiting the aircraft, the pilot observed that the left leaf spring had partially detached and was bent backwards in the direction of travel. The central attachment bolt and its nut had come loose. The bolt was retrieved, but the nut could not be located. The lateral attachment bolts were deformed but still attached to the fuselage, and there were signs of material wear in their threads.

Photograph 6. Left leaf spring with wheel and bracket

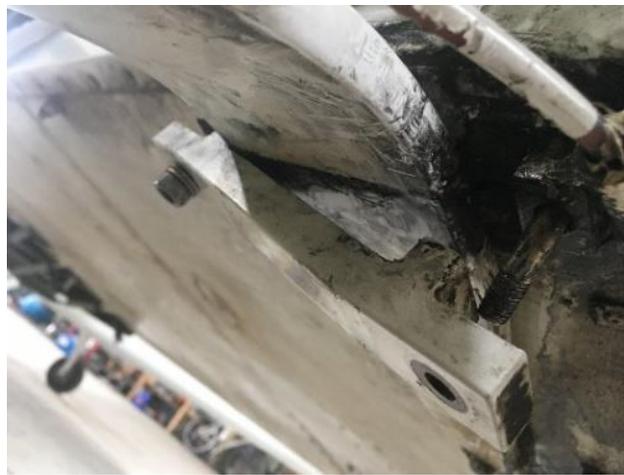
Photograph 7. Attachment of bracket to left leaf spring and fuselage

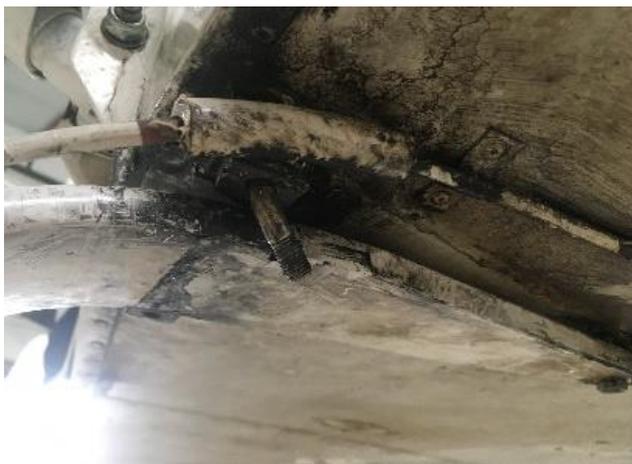
Photograph 8. Left leaf spring to fuselage lateral attachment bolt

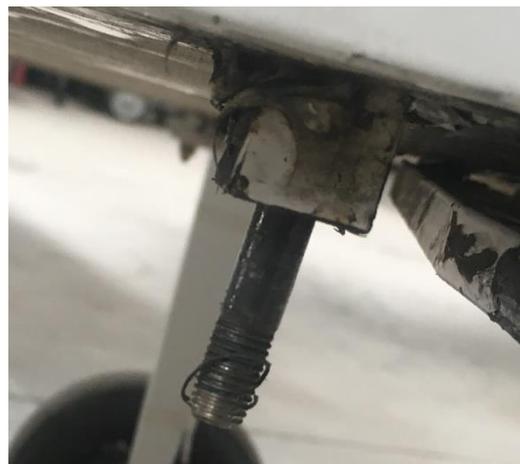
Photograph 9. Material wear to left leaf spring to fuselage lateral attachment bolt

In turn, the detachment of the central nut allowed the leaf spring to rotate towards the fuselage, opening the bracket, moving and buckling the lateral attachment bolts as a result, which, subjected to this strong traction force with their nuts correctly tightened, became deformed and sustained material wear before finally separating completely from their nuts.

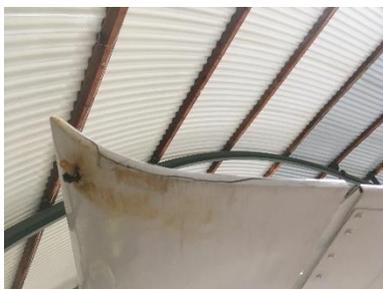
Photograph 10. Damage to underside of the left wing

The damage to the aircraft is consistent with the pilot's statement and the aerodrome's video recordings. As the aircraft slowed down, the left wing lowered until it hit the ground and continued to drag along it. As a result, it sustained damage to its underside and the left horizontal stabiliser.

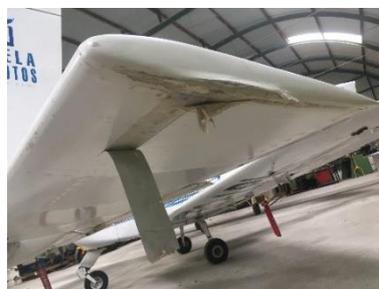
Photograph 11. Damage to the left underside of the horizontal stabiliser

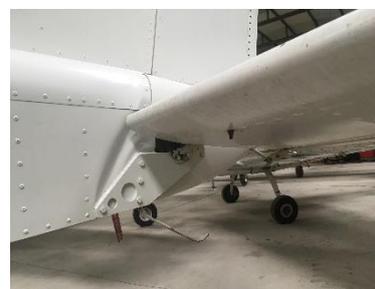
Photograph 12. Damage to the attachment of the left horizontal stabiliser

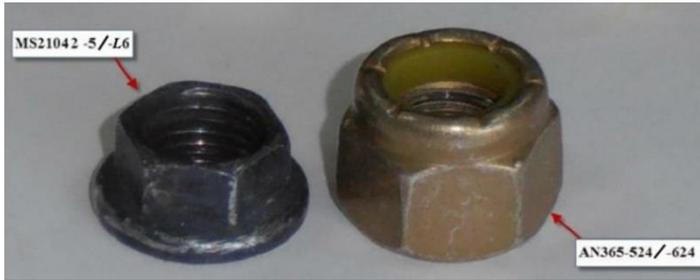
Photograph 13. Old and new self-locking nuts according to SB No.66

The self-locking nuts used were the ones recommended by the aircraft manufacturer, which, in its latest service bulletin dated 09/07/2012, SB No.066 ed.2 rev.1, indicated the need to substitute the old nuts for the new, improved ones with p/n: AN365-524A for the lateral bolts with p/n: MS20005-24 and p/n: AN365-624A for the central bolts with p/n: MS20006-64.

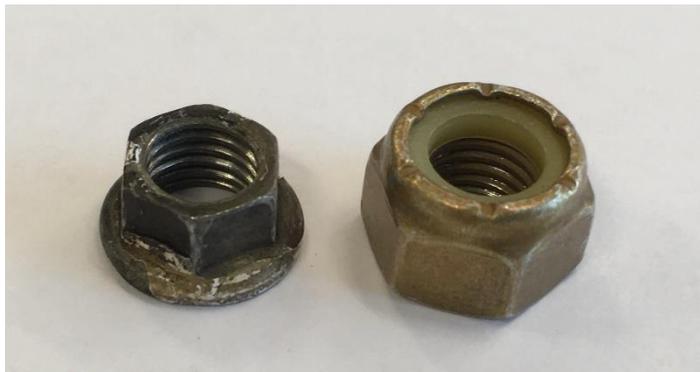
Photograph 14. Old self-locking nut used by the maintenance workshop involved in the incident and new nut used in the accident aircraft

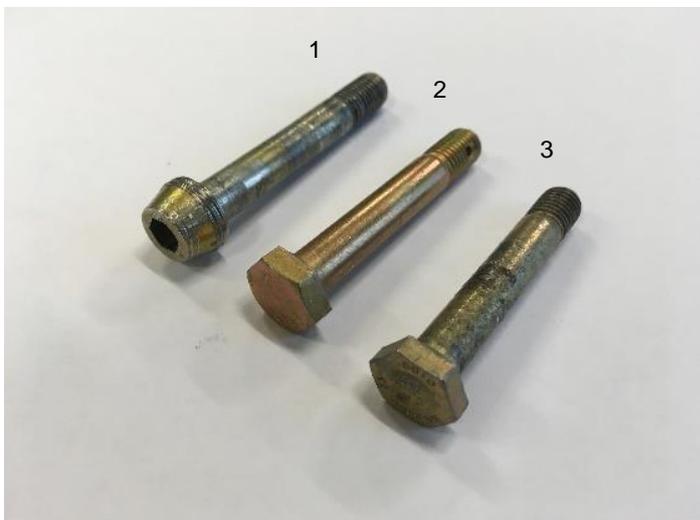
The inspection found that different bolts had been used. Some were p/n: MS20006, others were NAS6605-23, and in some cases, the bolts were unmarked, and the part number could not be identified.

Photograph 15. Main landing gear leaf spring attachment bolts

Bolts 1 and 3 in Photograph 15 are the bolts used in the accident aircraft. One of them is p/n: MS20005-24, as recommended, and on the other is p/n: NAS6605-23, which measures 4.84 cm long without the head.

Number 2 is a new bolt provided and commonly used by the maintenance workshop, which is not one of the bolts recommended by the aircraft manufacturer.

In regard to the type of bolts used, the inspection found that they did not correspond to the aircraft manufacturer's specifications. This may have led to play between the parts causing vibrations and further contributing to the loosening and eventual detachment of the nut.

REC 49/21: It is recommended that Ignagua Center, S.L. ensure the appropriate tools are used for maintenance tasks involving a torque specified by the aircraft manufacturer, as well as that guarantees that the technical specifications of the components involved are those required by the aircraft manufacturer.

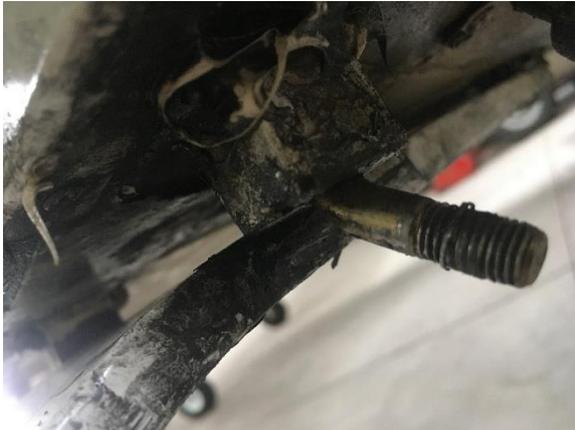
The bolts showed signs of distortion in various directions, with sectional constriction. These deformities were produced by excessive pulling forces in an axial direction and bending forces at approximately 30° from said direction. The stress caused one of the bolts to break.

The following photographs show the deformation of the lateral bolts and the material wear caused by intermittent excess traction and friction stress between the nut and the bolt.

Photograph 16. Left leaf spring lateral bolt 1 attached to the incident aircraft

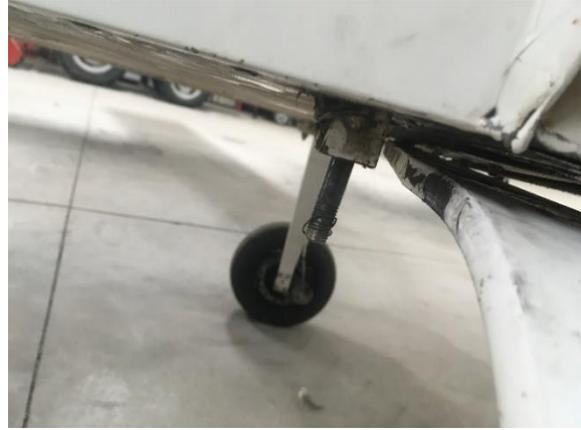
Photograph 17. Left leaf spring lateral bolt 2 after its removal from the incident aircraft

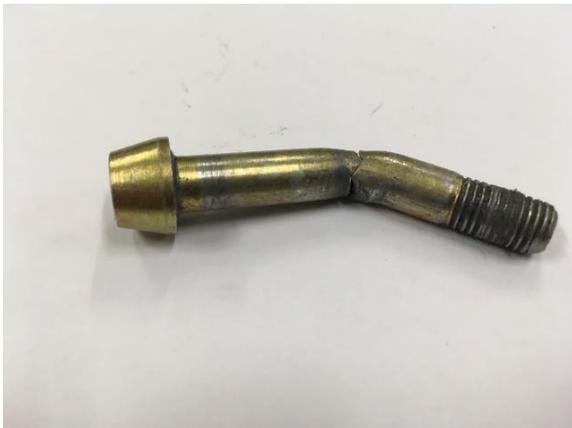
Photograph 18. Left leaf spring lateral bolt 1 after its removal from the incident aircraft

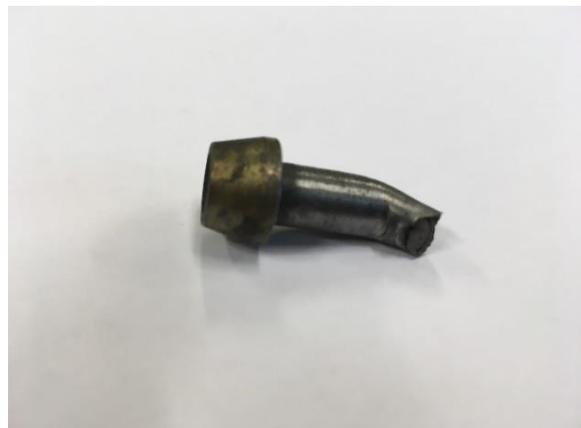
Photograph 19. Top half of severed lateral leaf spring bolt 2 after the incident
