Technical report

ULM - A-015/2020

Accident on the 13 November 2020 involving an ICP BINGO aircraft, registration EC-EJ8, in the municipality of Turre (Almería).

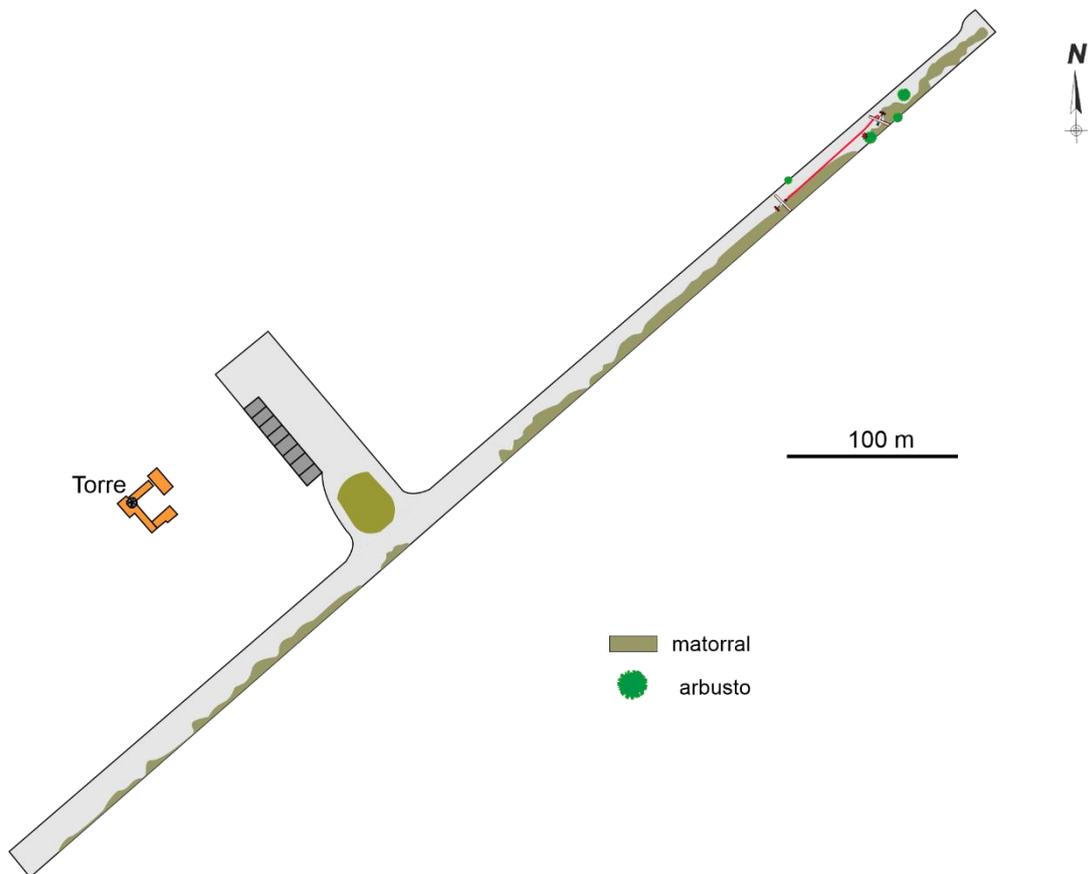
The aircraft made an emergency landing on the last section of runway 05 at an abandoned aerodrome located in Paraje de Cortijo Grande in Turre (Almería).

Fig. No. 1.- Diagram of the runway and location of the aircraft

Of the 690 m of runway, the last 380 m had low vegetation on the right side, reducing the available width without actually preventing an aircraft from taxiing on it, except for the last 90 m, where the extent of the vegetation, both in terms of its height and density, made that section completely unusable. Therefore, it can be stated that, while not in good condition, 600 m of the runway was usable and available to make a safe landing.

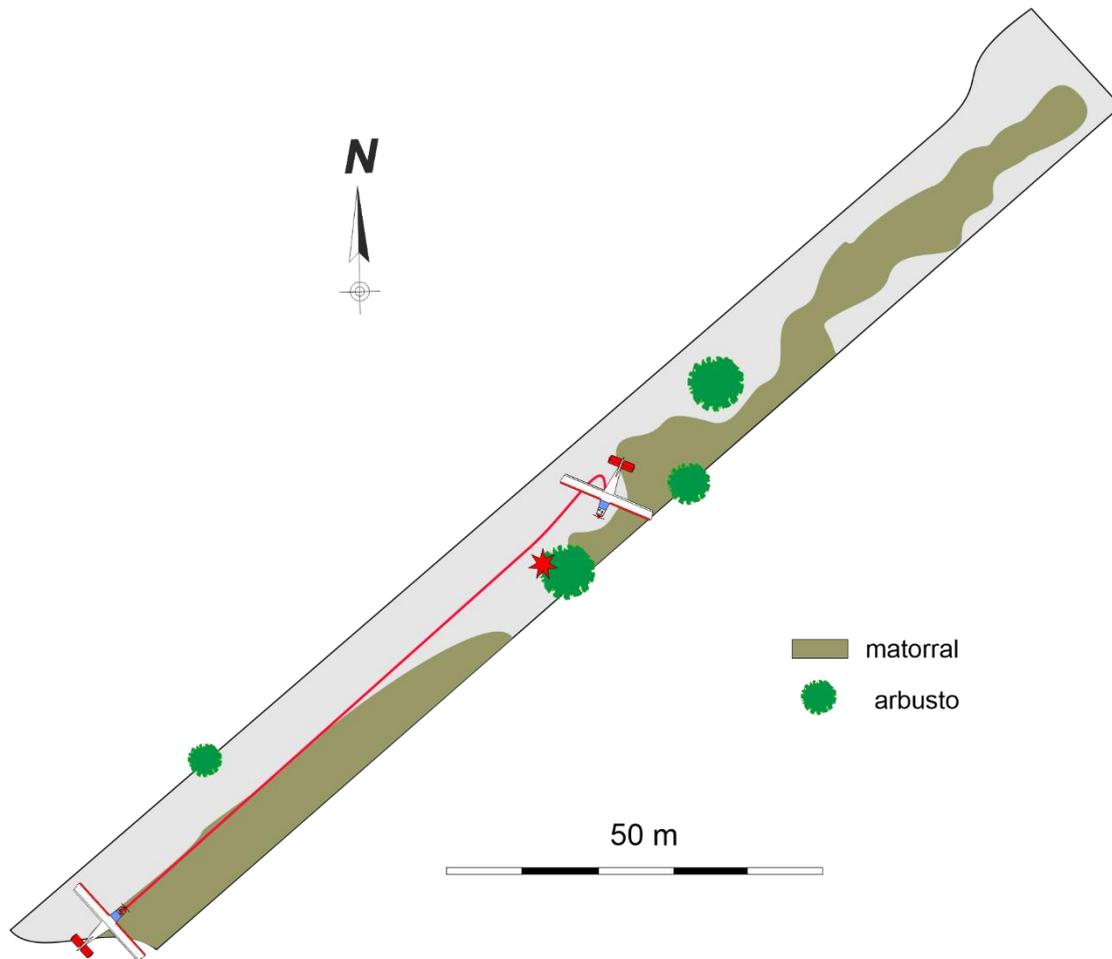
The aircraft stopped between some bushes to the right-hand side of the end of the runway, facing in the opposite direction to which it landed.

Fig. no. 2 - Detail of the emergency landing area

Some of the vegetation on the right side of the section prior to where the aircraft stopped was crushed, which is consistent with the aircraft's wheels having rolled over it.

As regards the aircraft, it was found between some bushes about 80 m from the end of runway 05, facing in the opposite direction to which it had landed, with damage along the full length of the leading edge of its right wing.

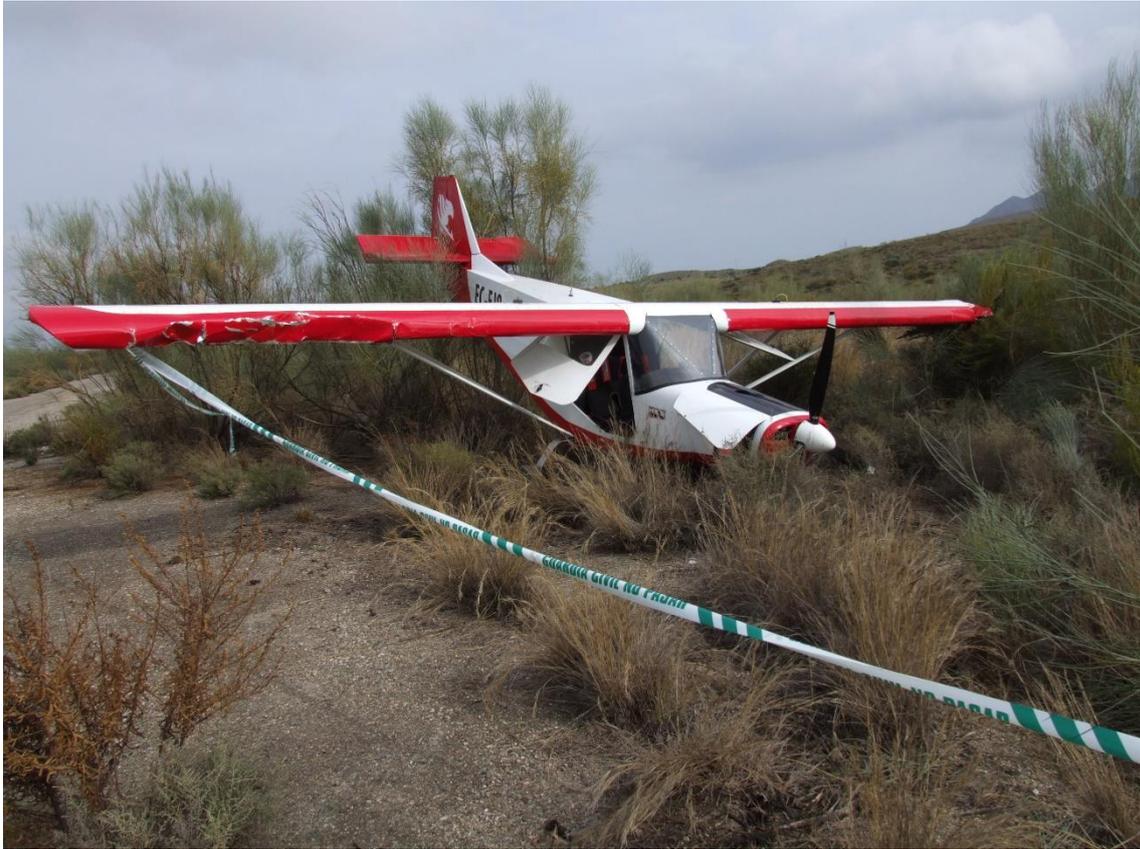
Except for the nose wheel, which had detached and was found 3 m away, the aircraft was intact.

As a consequence of impacting the vegetation, the aircraft sustained significant damage to its nose leg, right wing (particularly its leading edge), left wingtip, and the horizontal stabiliser on the tail assembly. Creases and fractures were also observed on the engine fairing and doors. The tips of two of the propeller blades were damaged.

Fig. no. 3 - Frontal view of the aircraft's condition
