## Final Report ULM A-020/2018

Accident involving an Aerospool  
Dynamic WT9 aircraft, registration  
D-MEFU, in Valdecebro (Teruel, Spain)  
on 22 November 2018

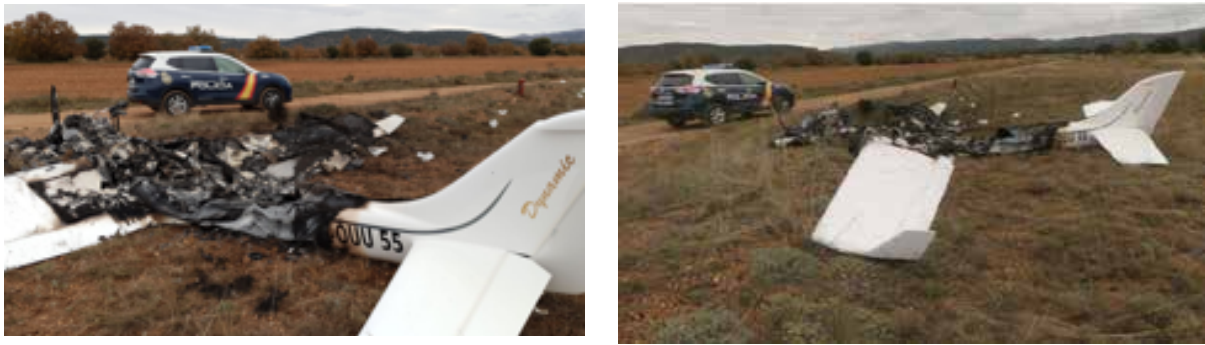
Fig. 1: Photographs of the aircraft after the accident

This initial inspection revealed that the aircraft had tried to land and seconds before touching down, the main landing gear was entangled with the metal cable, causing the accident.

The aircraft was almost completely burned, with the exception of much of its left wing, the rear part of the aircraft and the tail section.

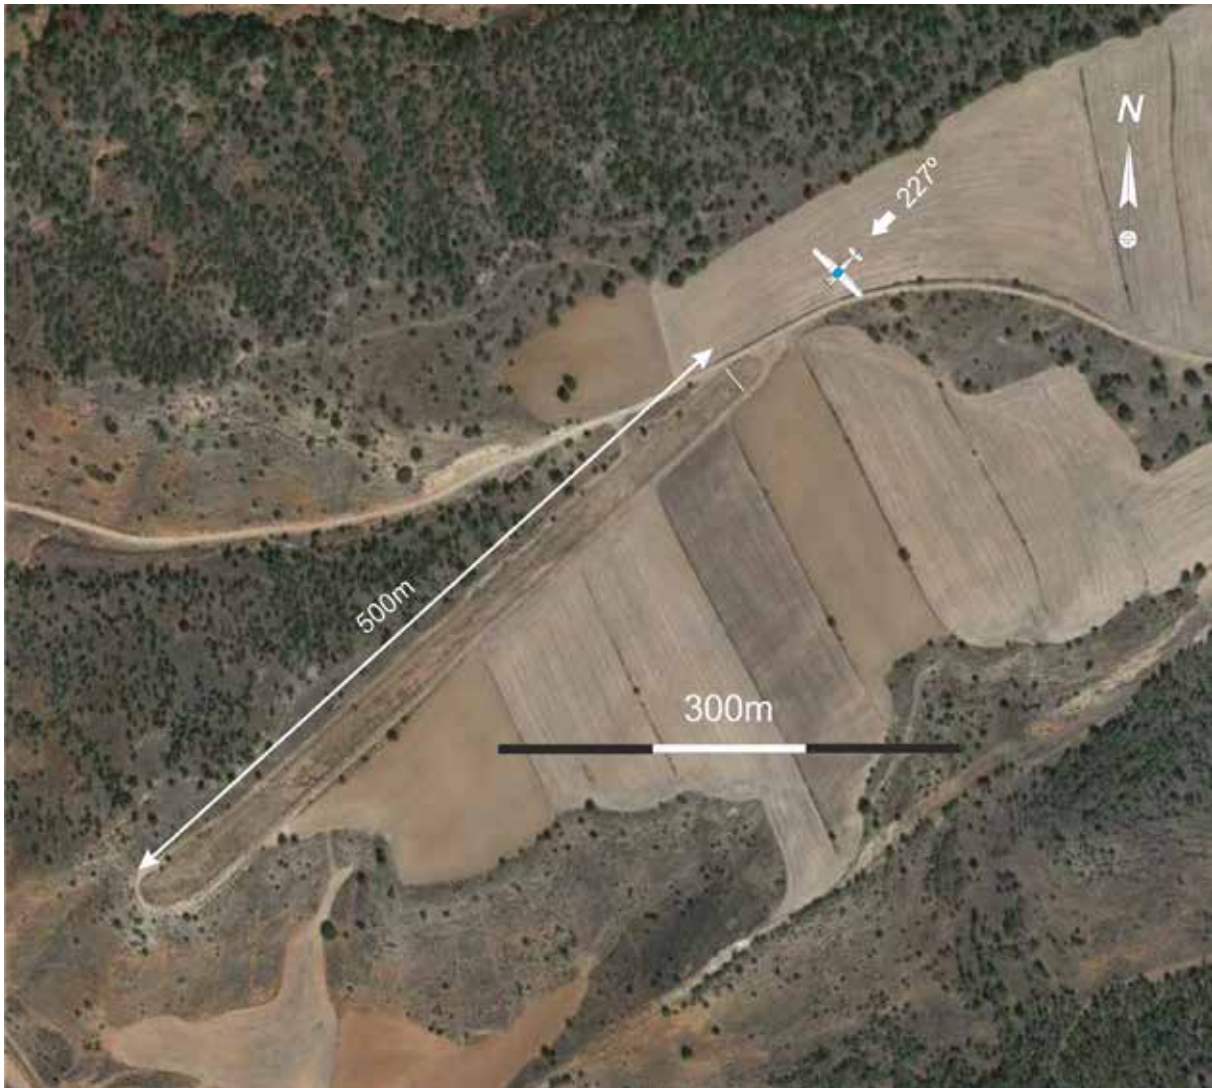
The property, used years ago as a landing strip, was on flat and level ground some 500 m long that is currently barren, with small shrubs and bushes typical of the local flora. An inspection of the full length of the strip did not reveal any indications, such as tire tracks, to suggest that it had been used recently by landing or departing aircraft. It is on an approximate heading of southwest-northeast.

At what would be the northeast threshold of the runway there were two metal posts anchored to the ground. Hanging from their top ends and connecting the posts was a thick, metal cable, attached to the posts using eyelets. The posts were about 15 m apart, spanning the width of the strip, and were intended to keep vehicles from entering it.

Fig. 2: Aerial image of the property and position and heading of the aircraft on its final approach

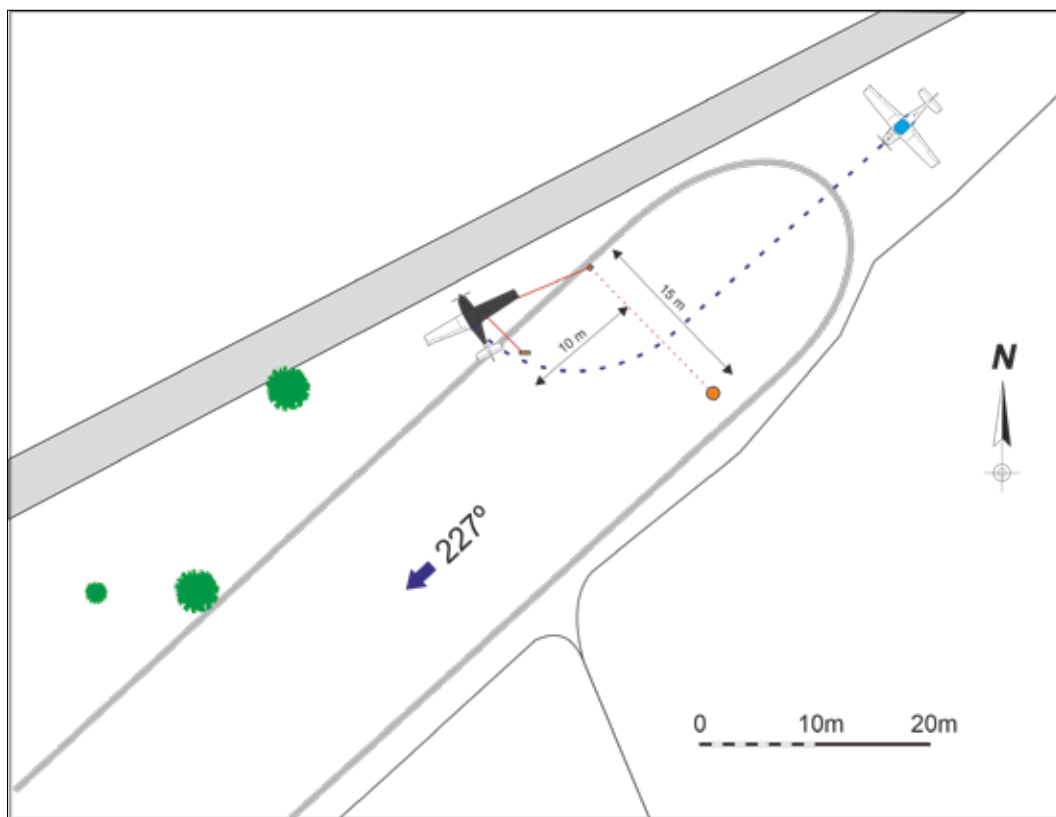
Some 10 m away from the two posts, on the landing strip proper, next to the nearby path, was the aircraft, with part of the propeller and the engine at the boundary between the path and the small mound that serves to separate the two areas, and which stopped the forward motion of the aircraft as it landed. The right wing was angled toward the northeast and the left wing toward the southwest.

Fig. 3: Diagram showing position of aircraft wreckage

The impact occurred as the aircraft was landing on a southwesterly course (approximately 227°), when its main gear was entangled in the strong, metal cable that was used to close off the property.

As a result of this contact, the left post (in the forward direction of motion of the aircraft) was ripped out, which caused the aircraft to travel in a semicircular motion, anchored around the fixed right post (which remained in place), before coming to a stop against the small mound that separated the runway from the adjacent path.

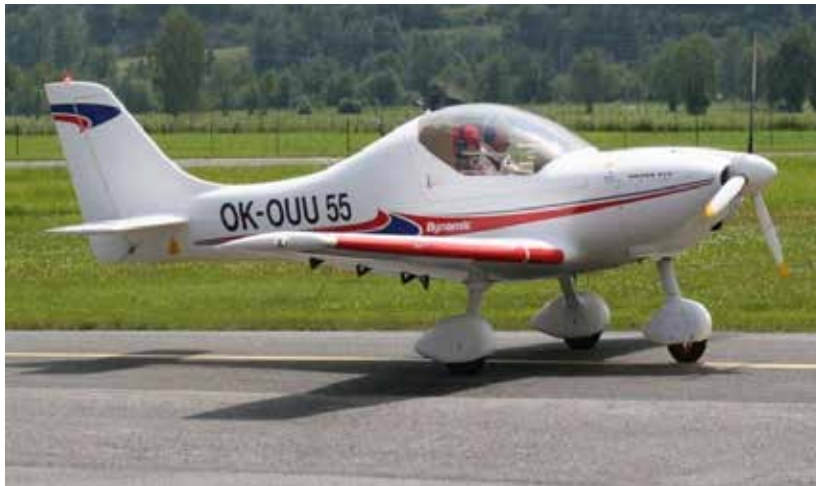
Fig. 4: Aircraft OK-OUU 55

The German police confirmed that this aircraft was at the aerodrome of Reidelbach (Germany), and also verified that this aircraft looked different from the one found in Valdecebro, both in terms of its color and the shape of the wings (specifically, the accident aircraft had winglets, and the one in Germany does not).

This all served to confirm that the wreckage did not belong to the original aircraft with registration OK-OUU 55, and that this registration had been illegally copied onto the accident aircraft, whose actual registration was then still unknown.

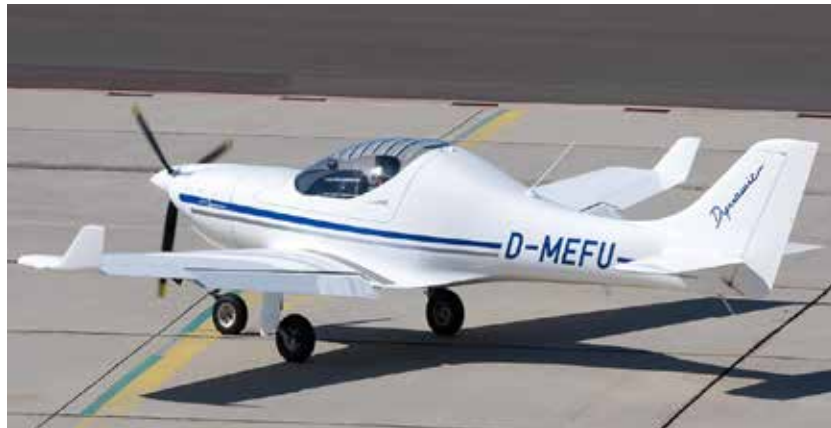
Fig. 5: Aircraft D-MEFU

The photo below shows the winglets, which match those found on the accident aircraft.
