CIAIM-13/2015 REPORT

Collision between CELSIUS MUMBAI and WISBY ARGAN in the Bay of Algeciras on 11 October 2014

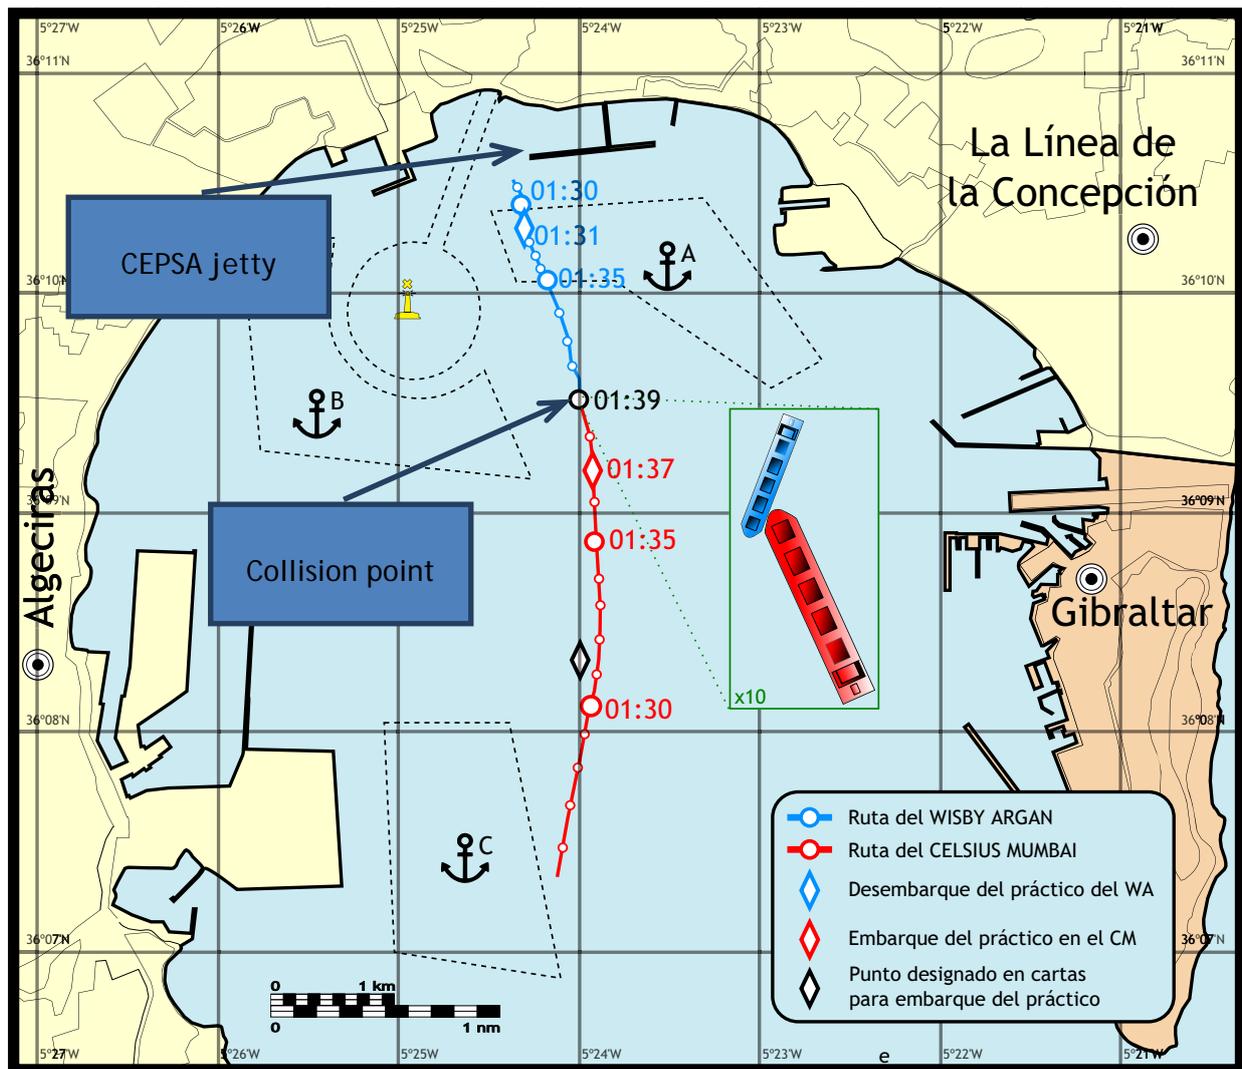
Figura 4. Location of the accident and ship course prior to collision

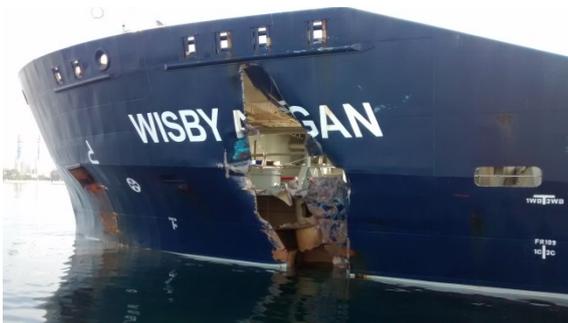
The collision caused some damage on WISBY ARGAN's port bow, being the hull perforated above and below waterline and in the bulkhead deck area, which particularly affected the structure of one of the ballast tanks. CELSIUS MUMBAI's bulb forepeak and starboard side in way of n°6 water ballast tank were undergoing some deformation.

Figura 5. WISBY ARGAN damage

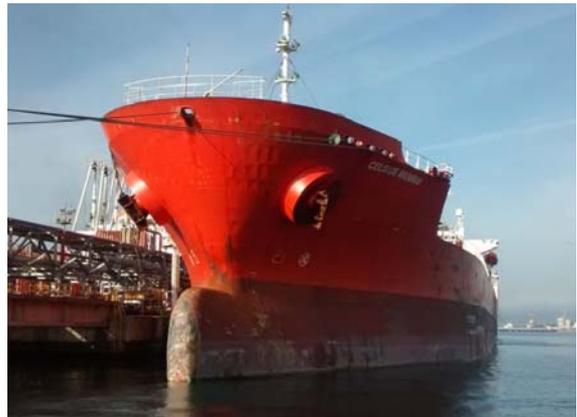
Figura 6. CELSIUS MUMBAI moored after the accident. No significant damage is noticed

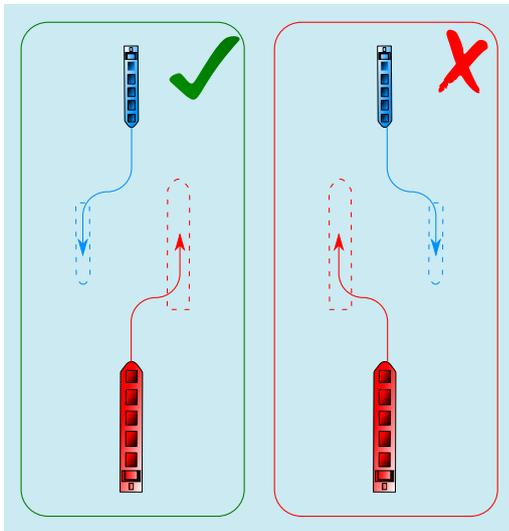
Figura 7. Head-on situation

In fact, WISBY ARGAN initially complied with this rule. However, the action was aborted by yawing to the opposite side as a result of the VHF radio communications held between her chief officer and CELSIUS MUMBAI. At first, CELSIUS MUMBAI did not alter her course until she finally turned portside at
