Report IN-044/2013

Incident on 11 December
2013, involving an ATR 72-212
aircraft, registration EC-LFA, while
landing at the Tenerife-North Airport
(Santa Cruz de Tenerife, Spain)

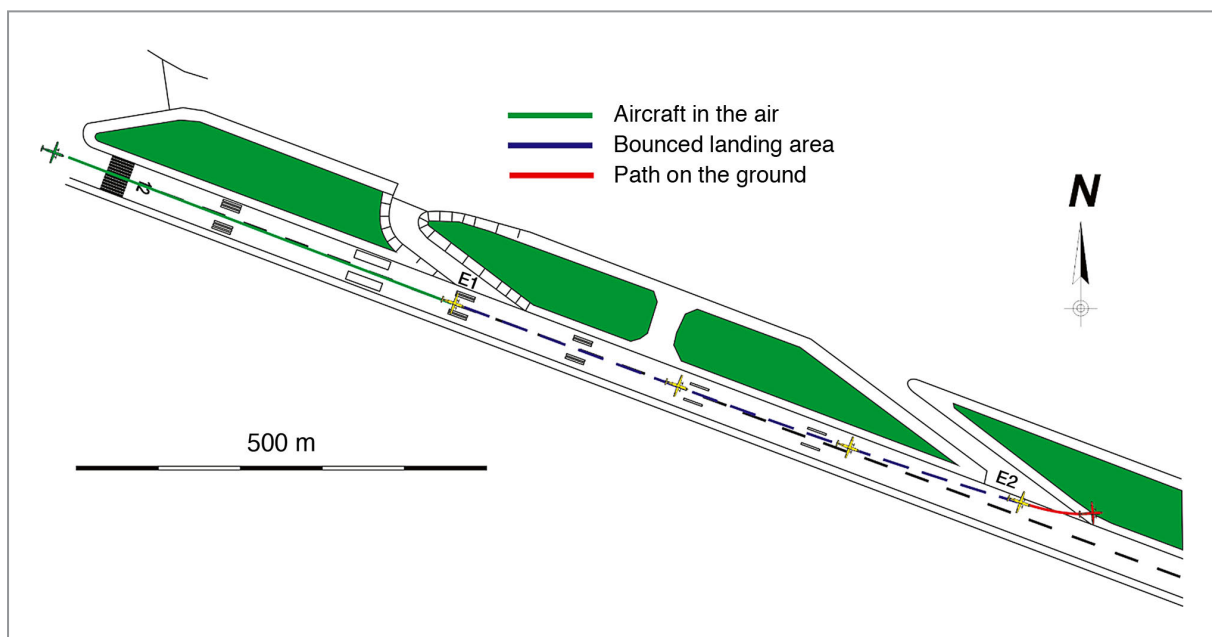
As the crew were close to touching down at the point on the runway near the E1 taxiway, their vertical speed was excessive, causing the aircraft to bounce several times and to divert to the left by the time they reached the E2 taxiway. Eventually the nose wheel departed the runway and rolled onto the grassy area to the left of runway 12 (see figure).

Figure 1. Diagram of the runway and aircraft's flight path (every element is to scale)

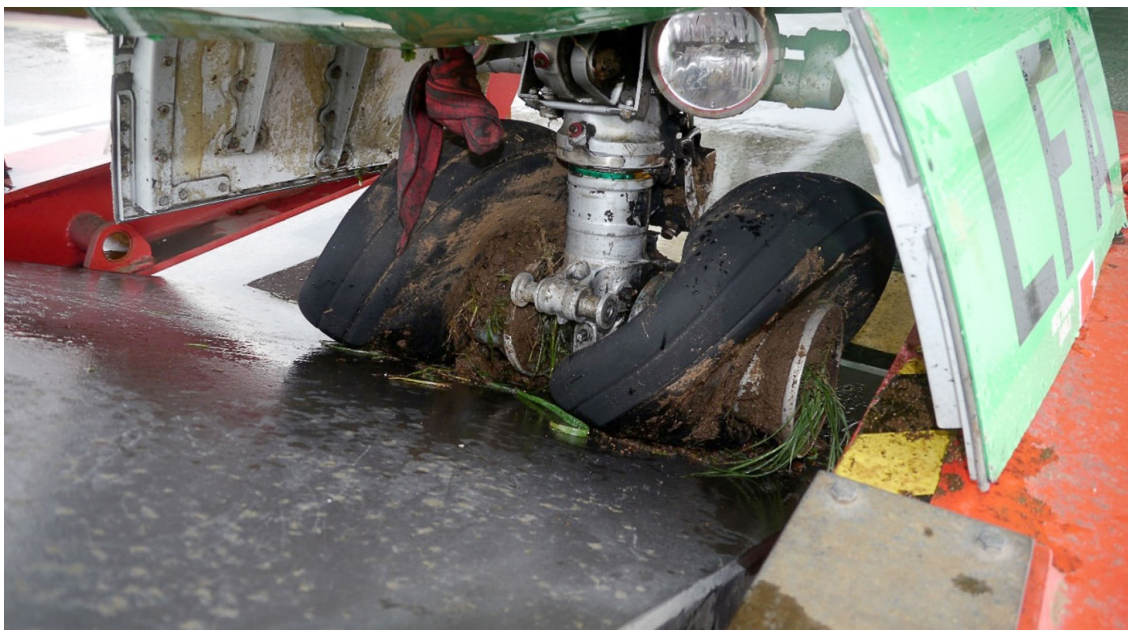
The aircraft's nose wheel was destroyed and there was damage to the main landing gear, specifically to the leg and strut on the left side.

Figure 2. Close-up of the nose wheel

These data are consistent with the breaking of the nose wheel leg and the subsequent loss of directional control, as well as with the damage to the left main gear. Once the aircraft's directional control was lost, its own inertia caused it to depart the runway.

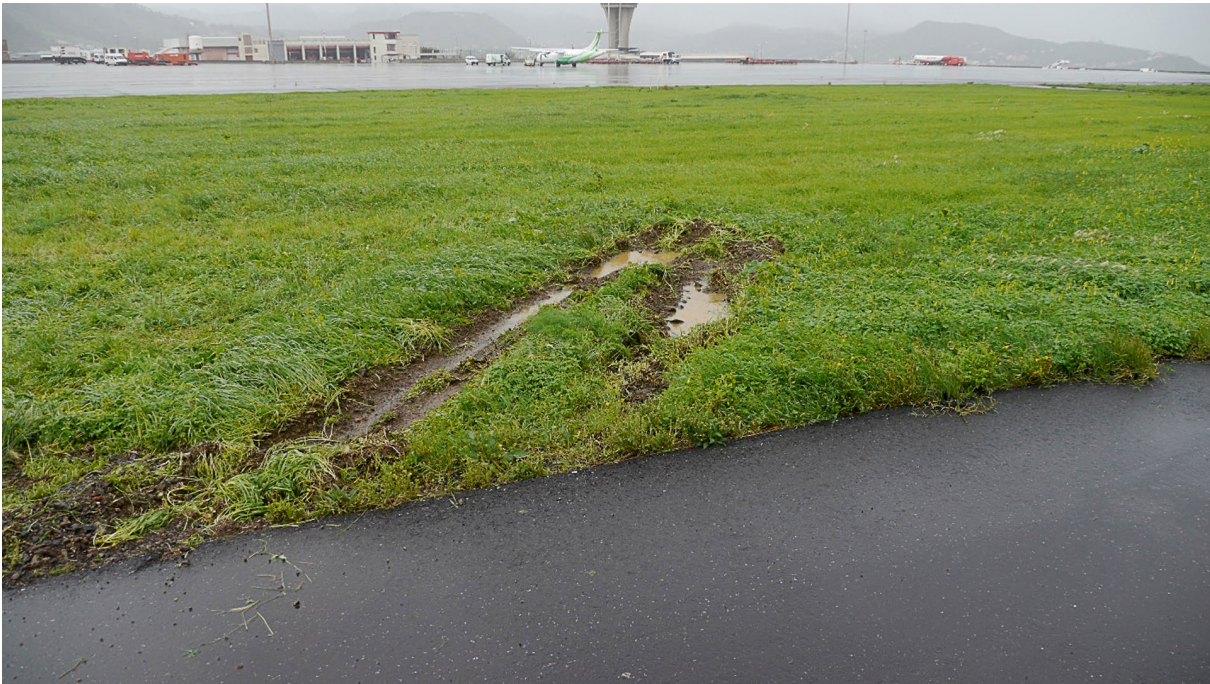
The aircraft sustained damage to its nose leg and to the left main landing gear only. During its landing run, the aircraft moved down the runway, with only the nose wheel exiting the runway and becoming stuck in a grassy area near taxiway E2.

Figure 3. Tracks left by the nose wheel on the ground

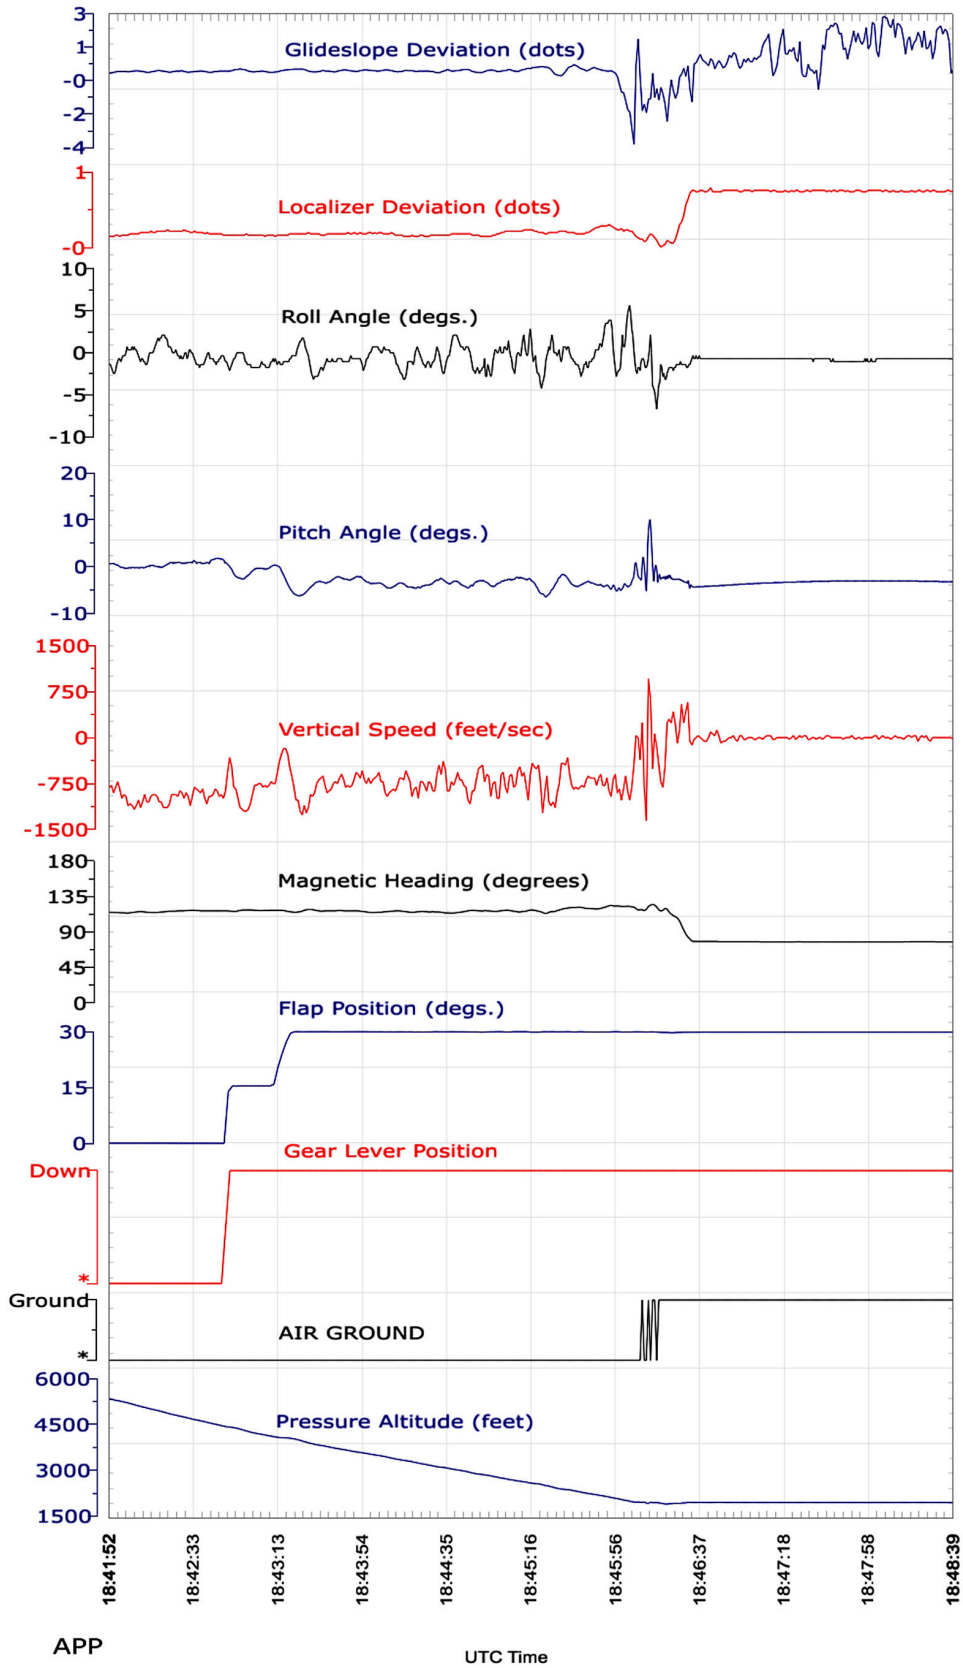
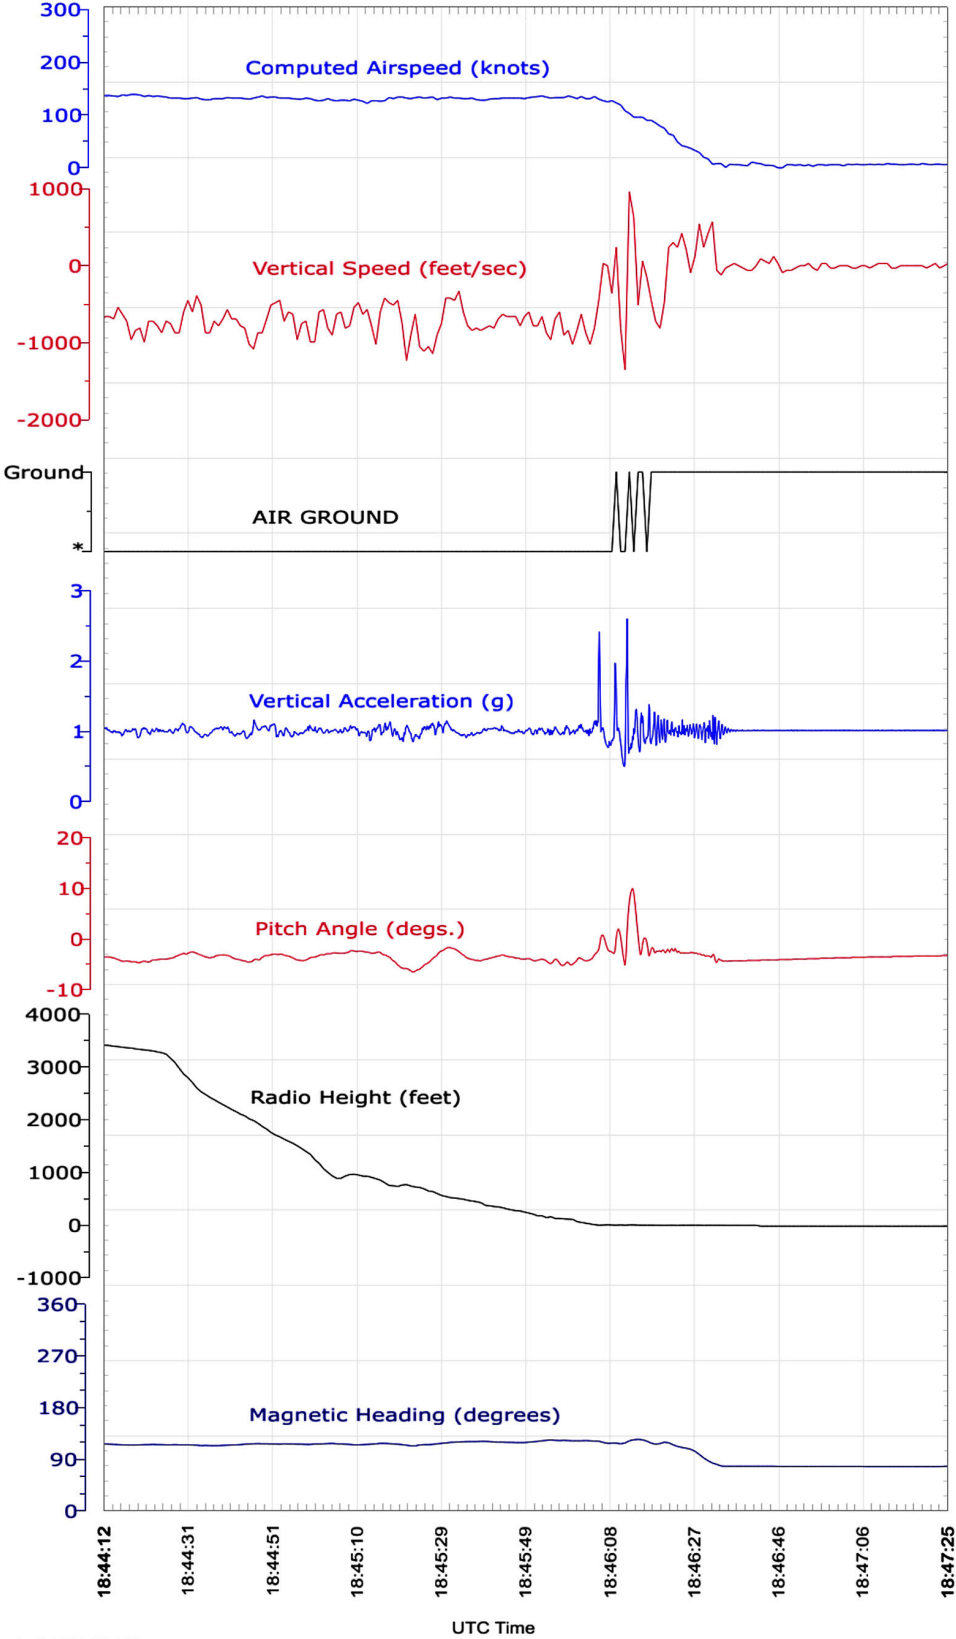
IN 044/2013 EC-LFA ATR72 NAYSA

UTC Time	Remarks
18:45:19	At a radio altitude of 852 ft, the pitch angle went from +3° to -4° in six seconds.
18:45:59	Pitch angle -5°. Radio altimeter 114 ft.
18:46:04	Sink rate 1,200 ft/min. Pitch angle -5°. Radio altimeter 23 ft.
18:46:06	Possible contact with nose wheel. Vertical acceleration 2.41 g. Pitch angle -2°. Radio altimeter -2 ft. Sink rate 450 ft/min. Calibrated airspeed 130 kt.
18:46:10	Initial contact with main gear.
18:46:12	Maximum vertical acceleration 2.60 g.
18:46:13	Second contact with main gear.
18:46:14	Maximum pitch angle 10°.
18:46:15	Third contact with main gear.
18:46:18	Final contact.
