Technical report S-28/2011

Investigation of the sinking of fishing vessel VILLA DE AGUETE off the coast of Mauritania, on the 1st of July 2009

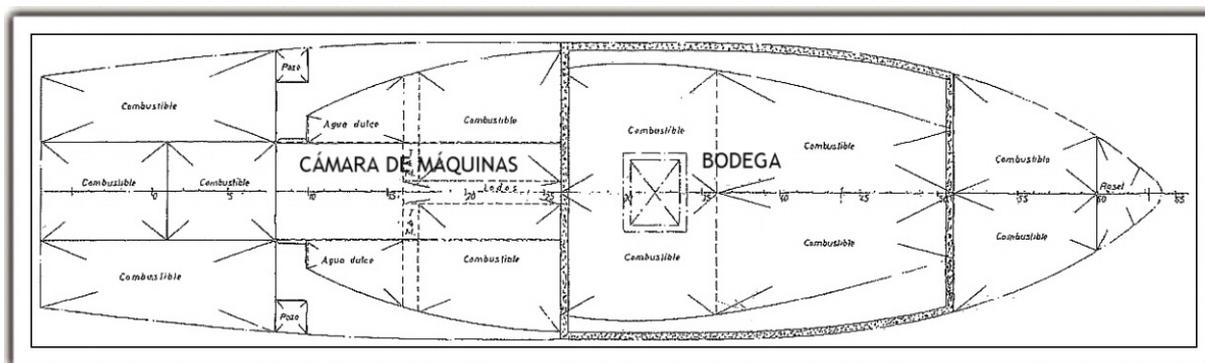
Figure 3. Spaces below the main deck

After analysing the possible flooding of the spaces that are located below the main deck and below sea level, which can be seen in the drawing of figure 3, the following has been concluded:

- The flooding of the fuel tanks and the fresh water tanks, since all of these are practically full, would have not been sufficient to cause the vessel to heel like it did.

- If the cargo hold had flooded and the cod end had shifted to the port side, the vessel would have heeled like she did. The loss of stability caused by the generated free surface would have contributed to the heeling, which would have been compensated in some measure as the centre of gravity got lower due to the effect of the water on board. However, in this case the sinking of the stern would have decreased and that of the bow would have increased, which is the opposite of what actually occurred. Therefore, the flooding of the cargo hold is not considered to be the cause of the accident.

- As stated by the crew, the flooding that occurred in the engine room was not above the deck plates. The area at the bottom part of the engine room narrowed and the water volume in that space was not sufficient for the decrease in stability caused by the effects of the free surface, compensated in a certain measure by the increase in stability created as the centre of gravity got lower, to cause the accident.

Therefore, the flooding of some of the spaces located below the main deck was not the cause of the heeling and the sinking of the vessel.

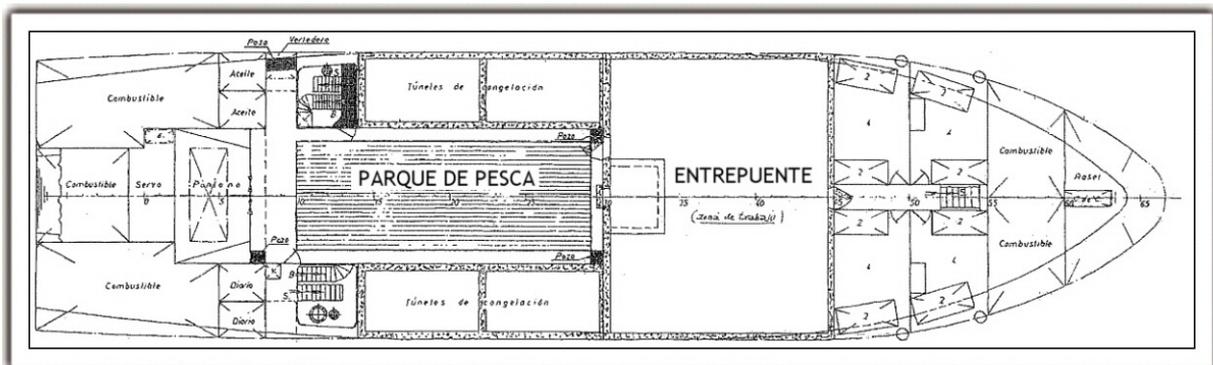
Figure 4. Spaces between the main deck and the upper deck

After analysing the possible flooding of the spaces located between the main deck and the upper deck, which can be seen in the drawing of figure 4, the following has been concluded:

- The flooding of the fuel tanks and the fresh water tanks, since all of these were practically full, would have not been sufficient to cause the vessel to heel like it did.

- As stated by the crew, the accommodation area did not flood.
- The flooding of the steering gear machinery room would not have caused the heeling.
- If the middle deck had flooded and the cod end had shifted to the port side, the vessel would have heeled like she did. The loss in stability caused by the generated free surface would have contributed to the heeling. However, in this case the sinking of the stern would have decreased and that of the bow would have increased, which is the opposite of what actually occurred. Therefore, the flooding of the middle deck is not considered to be the cause of the accident.

- The flooding of the port side refrigeration tunnels would have caused the vessel to heel. However, for the heeling to reach the aforesaid values would have required both tunnels to flood simultaneously, which is not probable.

- The most probable cause of the heeling was the flooding of the fishing area through the waste hopper, which is located on the port side and labelled as dump in the drawing of figure 4.

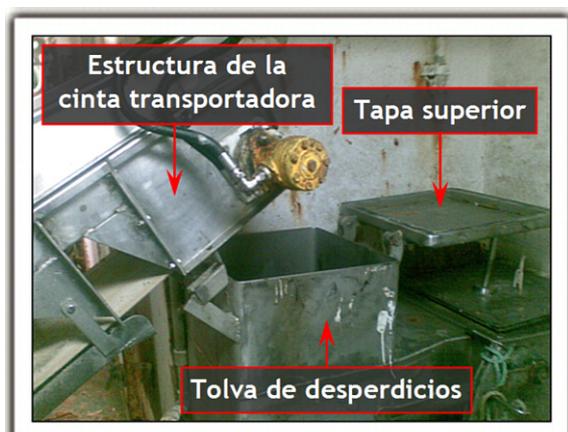
Figure 5. Waste hopper similar to the one on vessel VILLA DE AGUETE

The waste hopper on this vessel was similar to the one shown in figure 5. This type of waste hopper has an outer door on the side of the ship, which is hydraulically closed and a watertight inner lock cover located at the top.

As shown in figure 5, the conveyor belt must be removed in order to close the waste hopper's top cover. It is common practice for crewmembers to not close the cover after processing the fish because it is inconvenient and impractical to remove and install the conveyor belt. If the top cover was left open or wasn't closed properly at the time of the accident, the flooding could only have occurred through the waste hopper if the following two events had occurred:

- That the sea level in the waste hopper area was above the waste hopper’s top cover.
- That the waste hopper’s outer door was left open or not closed properly.

It is probable that the outer door was left open or was not closed properly because the vessel did not incorporate a system to indicate whether or not this door was closed or open and it is common for these types of doors to not close properly when they are shut on any object.

1. To analyze the advantage of prohibiting fishing vessels from using waste hoppers or other types of openings that are located below the first flooding point as per the stability book calculations and the freeboard calculation.
2. To not renew the freeboard certificate of vessels that do not have the freeboard markings in accordance with current regulations.

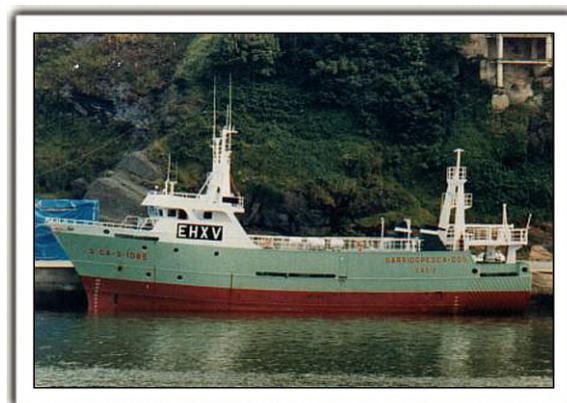
Figure 6. Vessel GARRIDOPESCA DOS, later named VILLA DE AGUETE

None of the photographs that are available of the vessel show the required freeboard markings. The photograph of figure 6, which is part of the vessel’s navigation license and was taken in 1988 when her name was still GARRIDOPESCA DOS, we can see that the vessel did not have the required freeboard markings, which should be visible just like the draught markings.

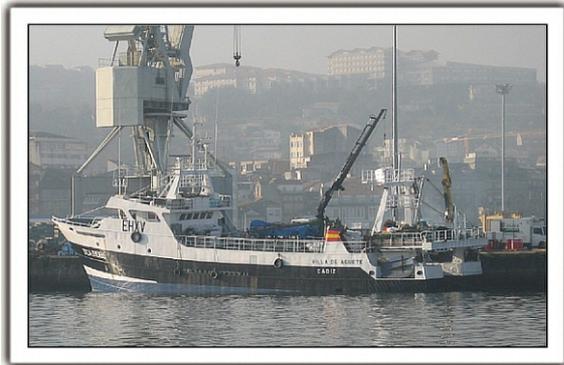
Figure 7. Vessel VILLA DE AGUETE on the 12th of January 2007

In the photographs of figures 7 and 8, we can see that the vessel exceeded the maximum allowed draughts as we will analyze below.

The photograph of figure 7 was taken on the 12th of January 2007 at 11:31 hours. That same day, the vessel was scheduled to depart for the fishing grounds at 16:00 in accordance with the information provided by the Port Authority. The condition of the vessel at that moment corresponded approximately to a port departure condition with 100% consumption on board. Figure 9 shows a drawing of the vessel with the actual flotation of the vessel when the picture of figure 7 was taken; in this picture, we can see that the vessel's flotation was above the main deck and that the waste hopper's outer door was below the water line.

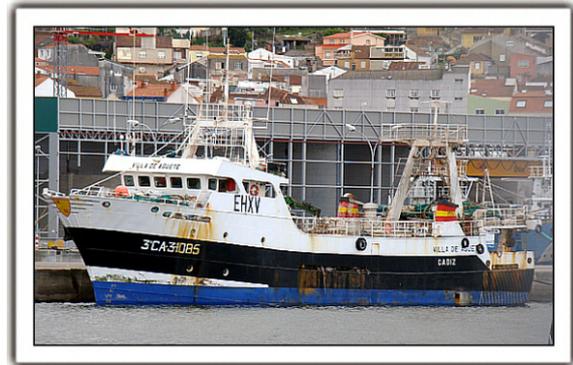
Figure 8. Vessel VILLA DE AGUETE on the 16th of April 2009

The photograph of figure 8 was taken on the 16th of April 2009. The vessel had arrived at the port of Marin on the 14th of April. In this condition, the vessel did not carry any cargo and had very little fuel on board. The drawing of figure 10 shows the actual flotation of the vessel in this condition.

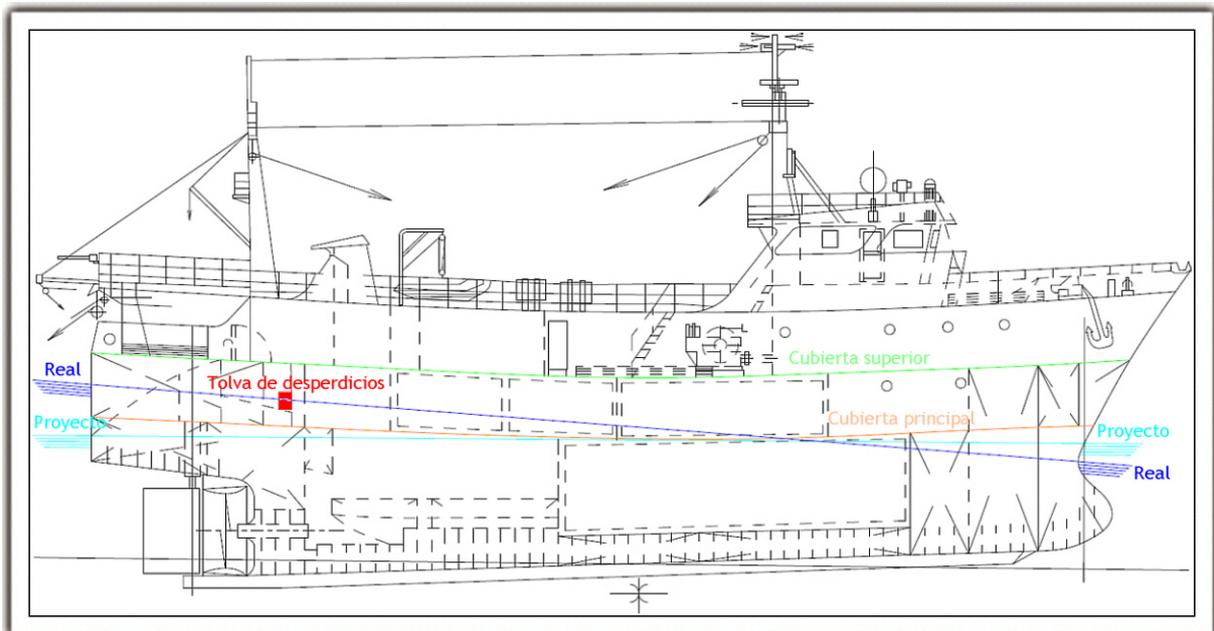
Figure 9. Position of the draughts of vessel VILLA DE AGUETE on the 12th of January 2007

From the analysis of the previous figures we can conclude that the vessel was usually overloaded, with more weight at the stern than authorized; and under the port departure condition with 100% of fuel on board as well as under the vessel without cargo condition and very little fuel on board, the maximum allowed draughts were exceeded as well as those listed in the stability book for these conditions.

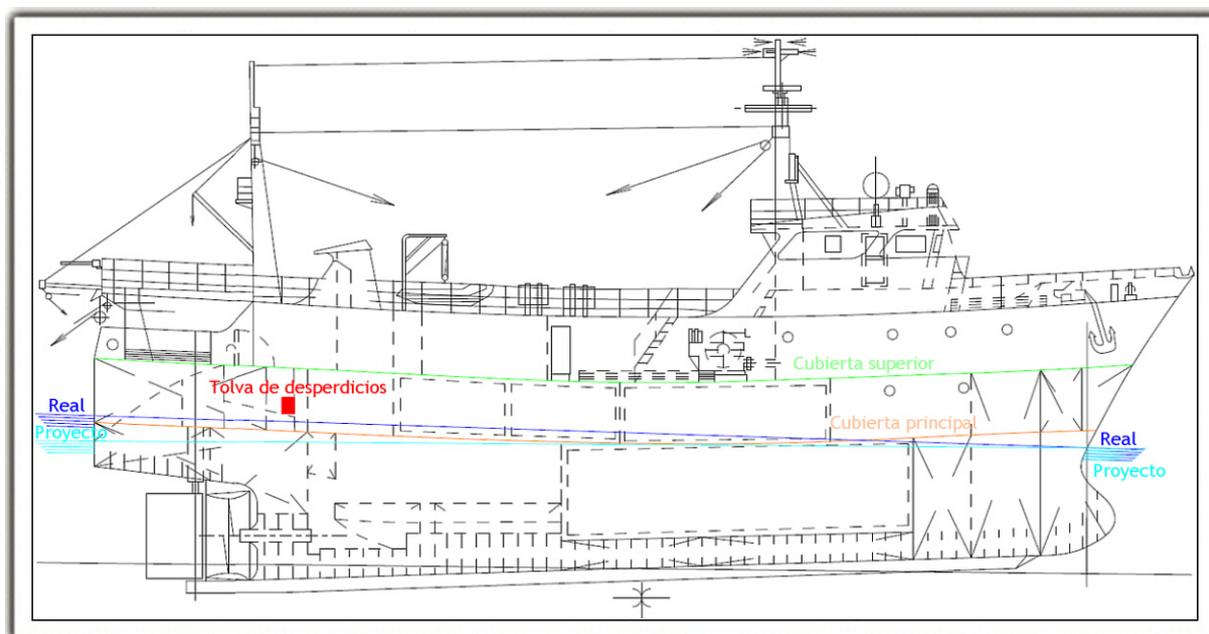
Figure 10. Position of the draughts of vessel VILLA DE AGUETE on the 16th of April 2009

Under the condition of figure 10, the distance from the lower edge of the waste hopper’s outer door to the water is much greater than that of the project.
