**DATA SUMMARY**

Date and time	<b>Saturday, 18 June 2011; 17:15 local time</b>
Site	<b>Tabuyo del Monte (León, Spain)</b>

Registration	<b>SP-SUI</b>
Type and model	<b>PZL W-3AS</b>
Operator	<b>LPU Heliseco sp. z o.o.</b>

**REPORT**

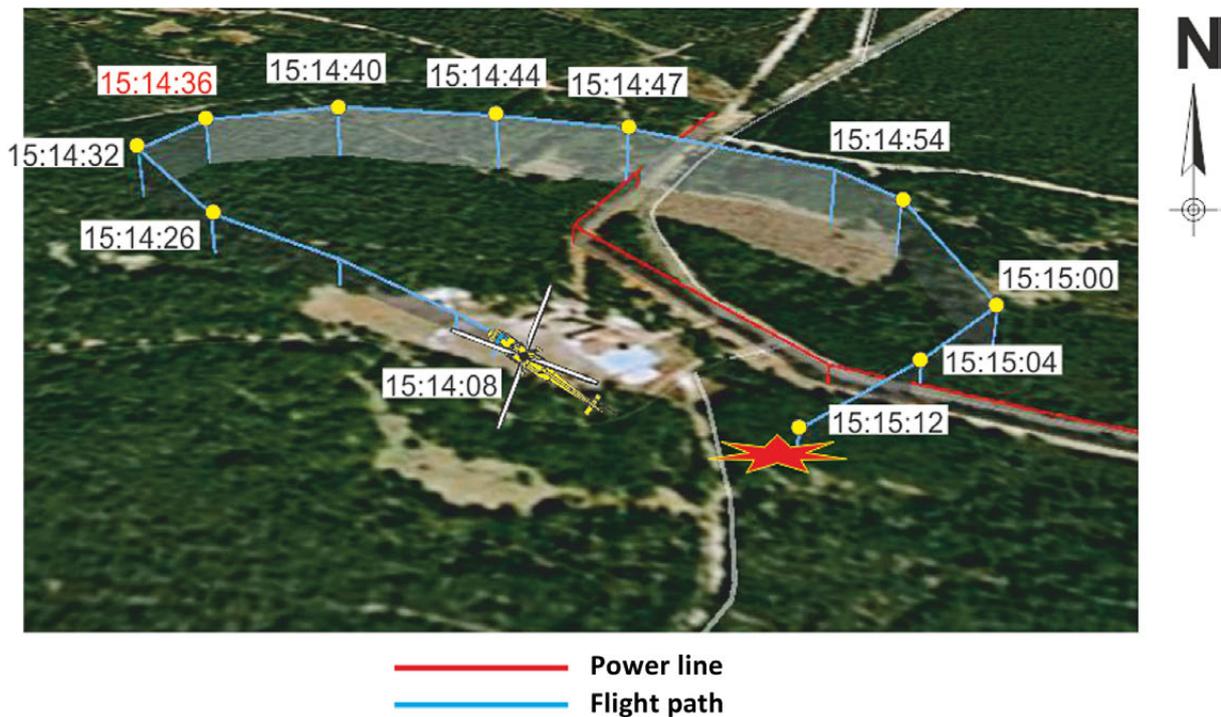
Figure 2. Path taken by the aircraft

Figure 2 shows the path taken by the aircraft as determined from global positioning system (GPS) data. The timestamps are those recorded by the GPS.

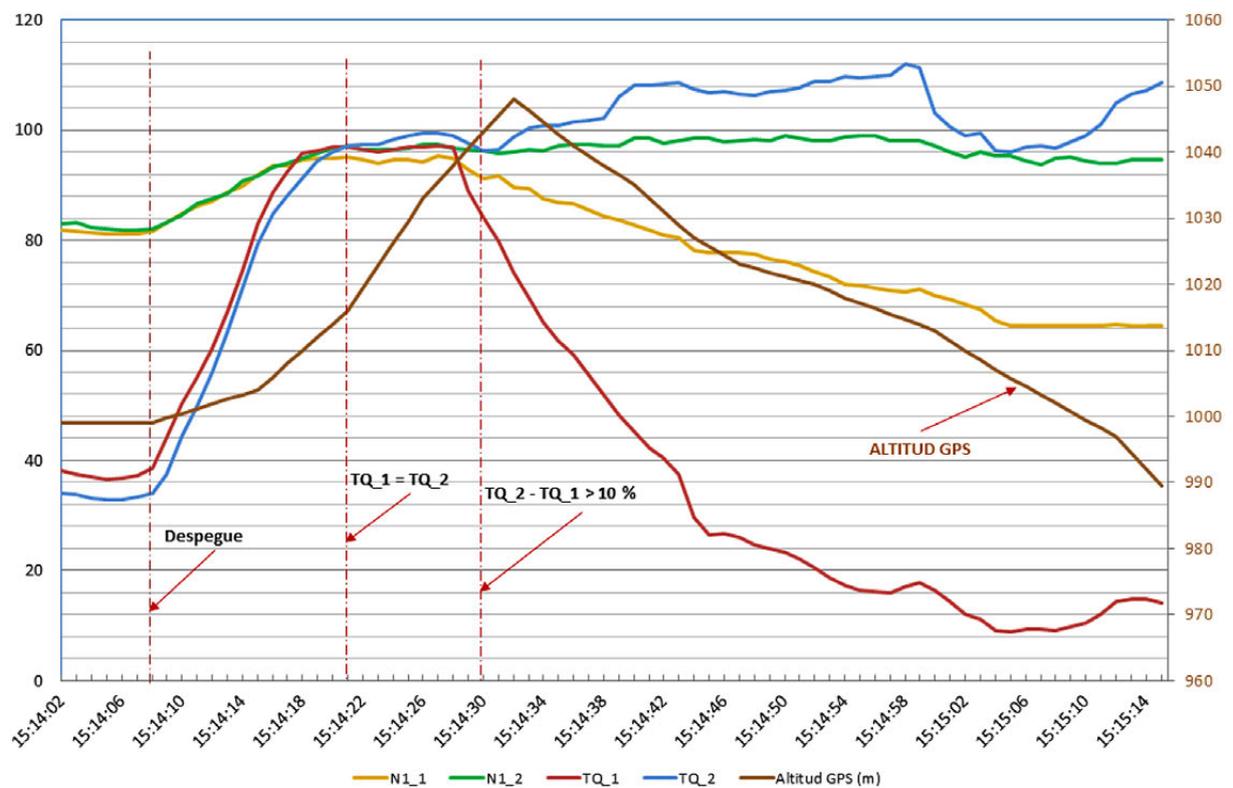
Figure 3. Flight data recorder parameters

The aircraft was outfitted with flight data and cockpit voice recorders. Figure 3 shows the values for torque (TQ\_1 and TQ\_2 in percent) and compressor RPMs (N1\_1 and N1\_2 in percent) for both engines, along with GPS altitude<sup>6</sup>. The values for main rotor RPMs could not be validated.

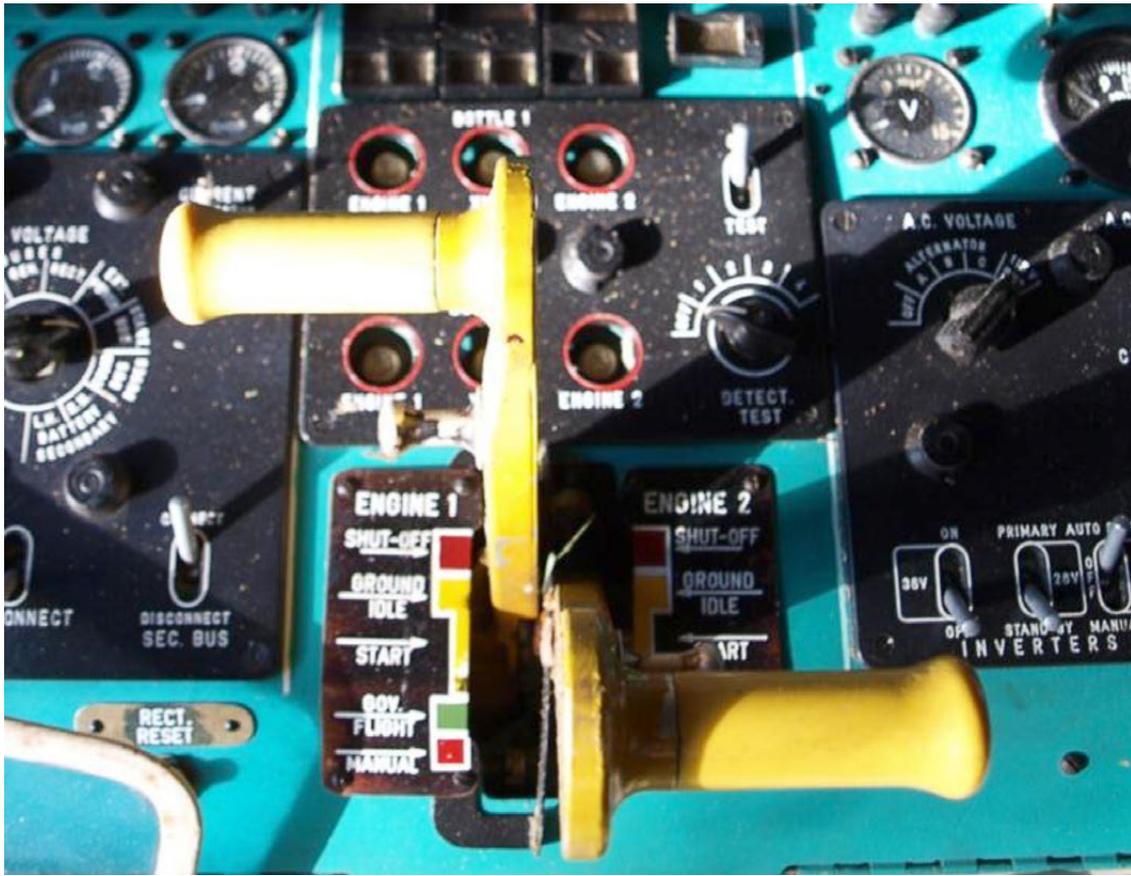
Figure 4. As-found positions of the engine power control levers

- There were small tree branches in the ventilation system ducts for the engine and accessories, as well as firefighting powder residue, which had been sprayed by the responders who reported to aid the aircraft's occupants.
- The hydromechanical turbine RPM limiter (ALRT-2B) and the fuel control pump (ALRP-5) on the #1 (left) engine showed that the engine power control lever was placed in manual control during the flight. This indication could not be checked in the right engine, which could not be accessed during the onsite inspection.
- The right engine power control lever was jammed at about the 60% position. The lever for the left engine was in the SHUT-OFF (fuel cutoff) position. See Figure 4.

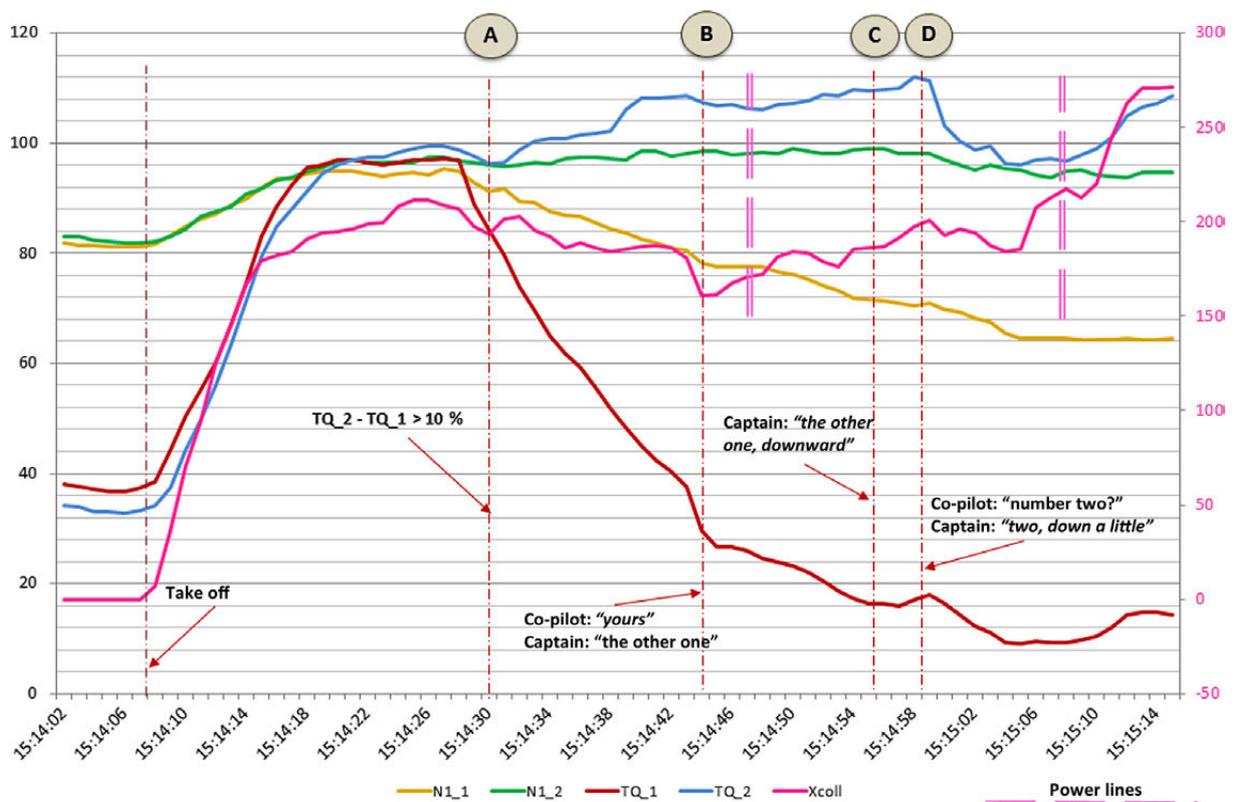
Figure 5. Significant flight events

Figure 5 shows the communications that took place in the cockpit and the flight data recorded.

Once the torque TQ\_1 dropped to point A, the crew recognized the emergency, though no dialogue took place between the crewmembers. The pilot flying stated seeing yellow warning lights on the instrument panel, possibly involving GOV MAX.

The torque on the #2 engine (TQ\_2) increased gradually and automatically to a value of 109%, point B, in keeping with the design characteristics of its control system. The pilot in the «1» position transferred control to the captain. The N1 value continued to fall on the #1 engine.

Eleven seconds elapsed between points B and C, during which the captain made two inaccurate remarks that are not specifically acknowledged by the copilot. The torque value for the #2 engine (TQ\_2) was consistent with the GOV FLIGHT mode of operation and with the slightly increased output commanded by the captain through the collective control during that time as he attempted to ensure obstacle clearance above the terrain.

At point D the CVR recording seems to indicate that the captain was instructing the copilot to work the #2 engine controls, which is what he could have been referring to since just before reaching point C. This assumption stems from the fact that the copilot was operating the thrust lever for the #1 engine, which was found in the MANUAL position during the inspection of this engine's ALRT-2B limiter.

Upon identifying and realizing that the captain's instruction was to reduce the thrust on the #2 engine ("two, down a little") and executing it, TQ\_2 dropped, though the torque immediately rose in response to the captain's operation of the collective control as he attempted to keep clear of the power lines and the wooded area where they would soon be landing.
