DATA SUMMARY

Registration	EC-KIE
Type and model	AIRBUS HELICOPTERS AS-350-B3
Operator	Inaer

REPORT

1. FACTUAL INFORMATION

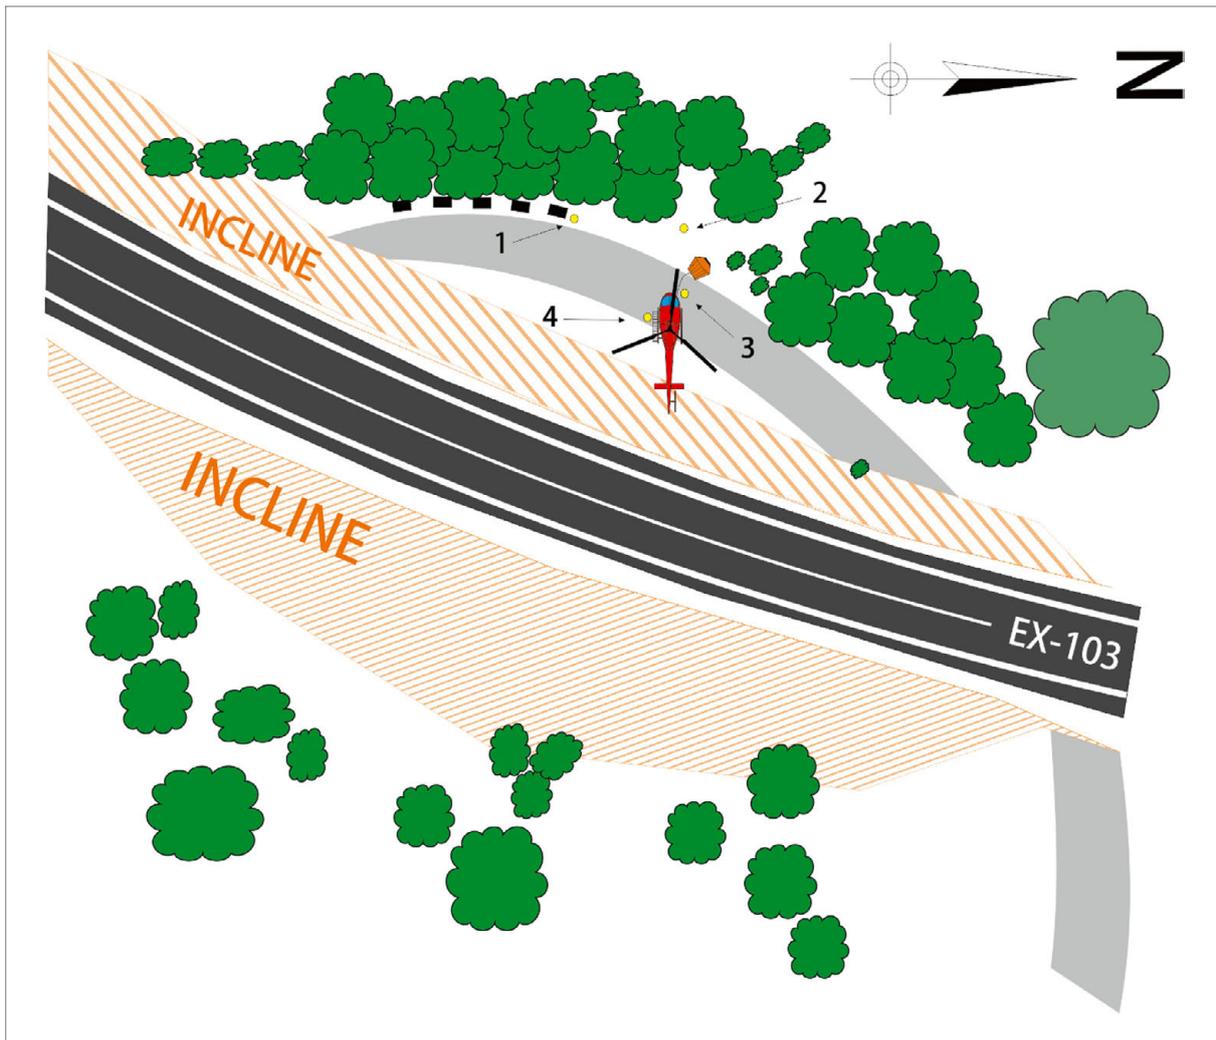
Figure 1. Sketch of the position of the helicopter and of the squad members at the start of the event

As the pilot stated, he saw the firefighter walk to the front of the helicopter and disappear underneath the nose, possibly to check something in the area where the Bambi bucket is latched to the helicopter.

Just then the pilot felt the helicopter start to bounce with increasing intensity. Fearing for the firefighter underneath the helicopter, he decided to take off. He pulled on the collective and the helicopter started to climb, though the abrupt motions continued even more intensely.

The firefighter who was underneath the helicopter hooked himself to the right skid, remaining attached to it until he was able to take advantage of a forward motion of the helicopter to free himself.

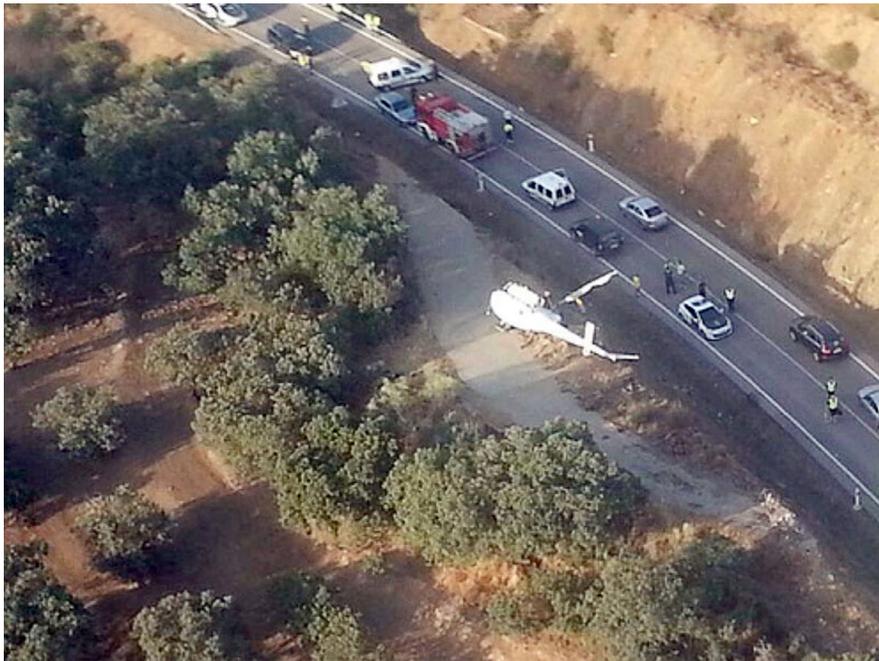
Figure 3. Aerial view of the accident site

As figures 3 and 4 show, this segment of the road is cut off at either end by a left turn in the new road, which is cut into the hillside to the east of the old road, which made a right turn at this location. On the west side of the old road is a wooded area containing mainly oak trees. The elevation of the new road is below that of the old one by about 4 m.

This segment of the old road basically comprises a platform with a distinctly curved and elevated geometry with respect to the new road.

The part where the helicopter landed (central area of the segment) has a maximum width of about 10 m measured from the edge of the wooded area to the start of the incline. The pavement in this area is mixed, with dirt at either end and asphaltic concrete in the middle. The gradient in this area from west to east is rising-falling-rising.

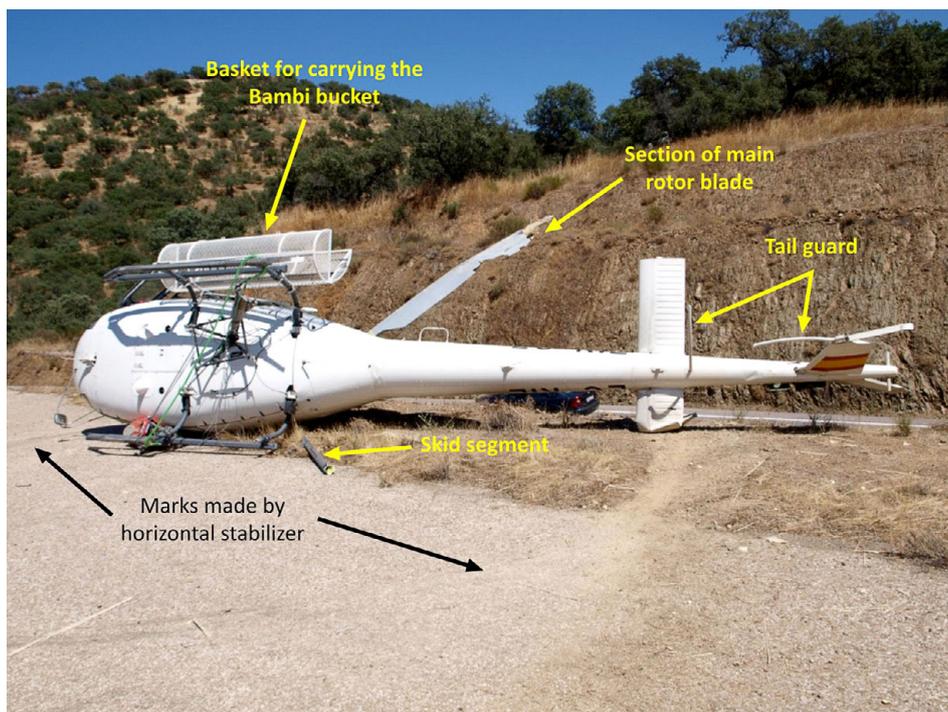
Figure 4. View of the aircraft wreckage

The aircraft was on its right side almost at the edge of the incline, with its longitudinal axis facing North (005°). The helicopter was resting on the right side of the cockpit, the main rotor and the right horizontal stabilizer.

There was a significant deformation on the stabilizer where it was supporting the weight of the helicopter.

The tail rotor had detached from the aircraft and was on the ditch of the new road, which runs along the bottom of the incline. One of the two blades on the anti-torque rotor had detached and was also at the bottom of the incline, but 20 m south of the rotor.

The main rotor still had some blade segments attached to it. Most of the blades had fractured due to the impact and the detached fragments were scattered to the east and west of the main wreckage.

Part of the right skid had detached due to two fractures, one on the skid itself, right behind the forward crossbar, and the other on the rear crossbar. The detached fragment was next to the main wreckage.

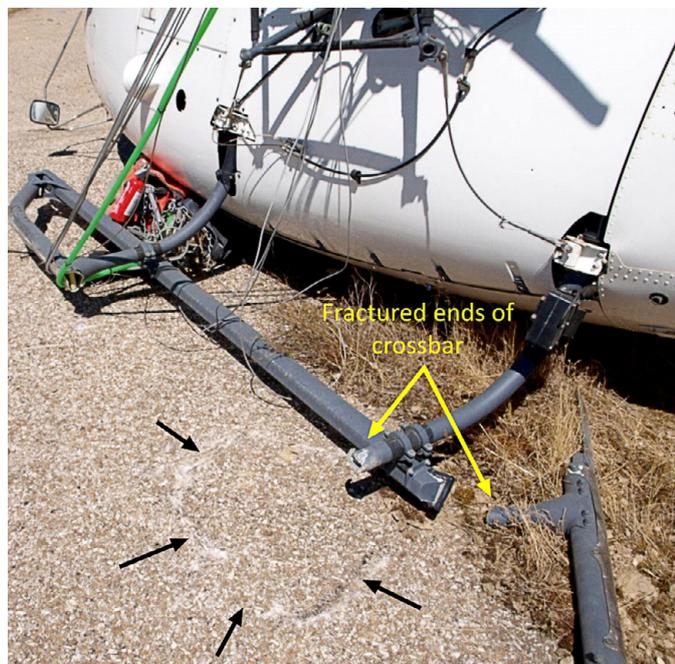
Figure 5. Close-up of the elliptical mark

There was an elliptical mark measuring about 60 × 40 cm near the area where the rear crossbar had fractured, the end of which exhibited significant impact damage.

Behind the mark left by the right skid was another mark, elliptical in shape (see Figure 4), next to which was found the part of the right skid that broke off, as well as the rear crossbar from the landing gear. This mark was left mainly by the part that broke off the rear crossbar.

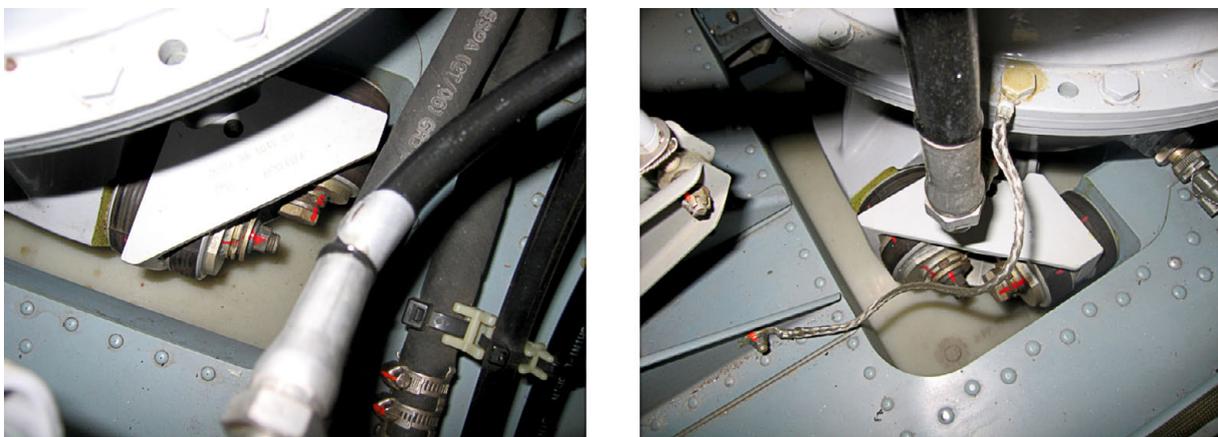
Figure 6. Left rear (left) and right front (right) attachments

- Landing gear. Due to the impact it was partially fractured and bent. As a result, it was not possible to do the specified checks. The different parts comprising the gear, however, with the exception of the broken and detached skid segment, were properly connected and showed no signs of cracking or corrosion. There was also no evidence of damage from before the accident.
- Landing gear attachments. The gear was properly connected to the helicopter structure and to the dampers and showed no signs of warping, cracking or corrosion.
- Blades at the rear of the skids. Their function is to reduce the risk of resonance on the ground while landing, though they have no effect once the aircraft is resting on the ground. The inspection consists of measuring the distance from the end of the strip and the extension of the top part of the skid, which must not exceed 85 mm.

Although these checks were not valid in this case due to the deformations caused during the accident, they were carried out for information purposes, yielding the following results:

- Left skid: 89 mm
- Right skid: 73 mm

The condition of the landing gear was acceptable. Only the spring at the aft end of the left skid was slightly out of specification, though it is thought that it was bent during the accident.

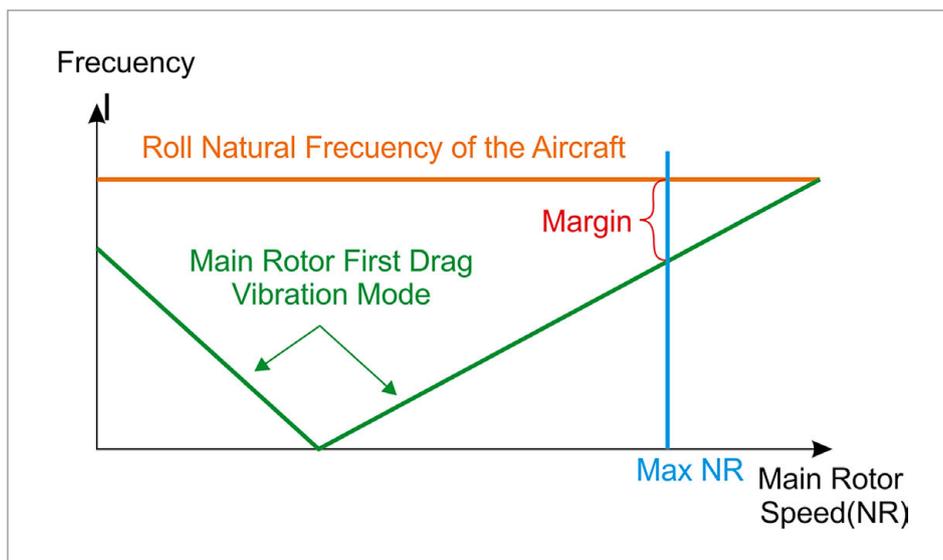
Figure 7. Basic ground resonance graph

The following figure provides a basic diagram of the ground resonance phenomenon, which shows the margin that exists between the curves in normal conditions. When the margin drops to zero, the two curves cross and resonance can appear.

There are several factors that can affect this diagram, and thus alter the position of the curves: a change in the speed of the main rotor (increase), a variation in the main rotor head's stiffness characteristics, a change in the aircraft's natural vibration frequency, etc.

Increasing the speed of the main rotor, which would shift the blue line in the graph to the right, can result from an input made by the pilot to the fuel control (not possible on the model in this accident) or from a problem with the governor, for example.

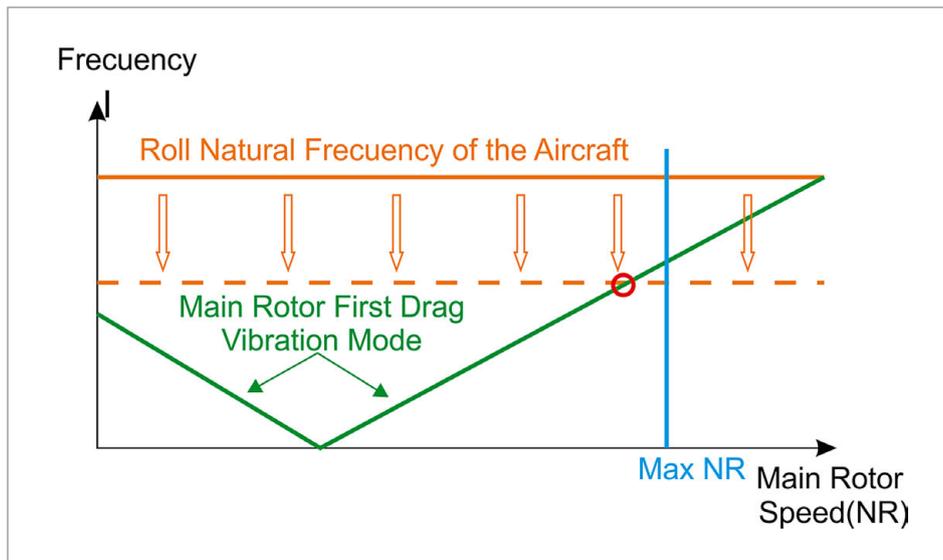
Figure 8. Effect of varying the aircraft's natural vibration frequency on the basic ground resonance graph

The potentiometer on the collective pitch anticipator fails when the measurement of the potentiometer's relative position reaches the minimum (5%) or maximum (95%) thresholds, or when it varies at a rate in excess of 350% per second. The system's design mechanically impedes these thresholds from being reached unless the sensor fails.

The DECU uses the potentiometer's position to determine the thrust that is going to be demanded at any given moment before said demand occurs. This readies the engine to supply the thrust that is demanded, which allows it to keep the rotor's rotation speed within its acceptable range.
