Technical report S-16/2012

Investigation of the collision between vessel BESIKTAS PERA and vessel SUPER FAST BALEARES, at the port of Valencia on the 1st of September 2011

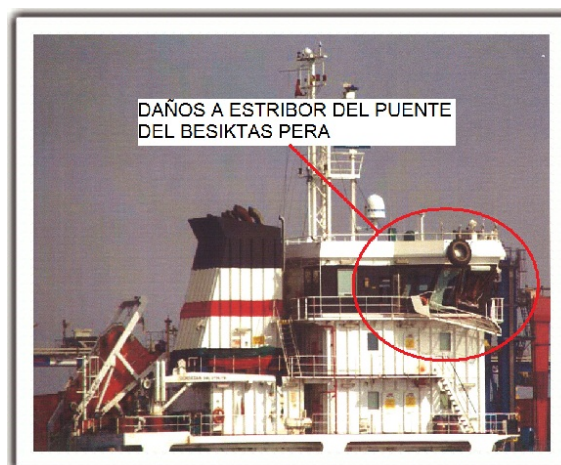
As a consequence of the impact vessel SUPER FAST BALEARES suffered damage to her starboard tack lining above the manoeuvre deck, while vessel BESIKTAS PERA suffered damage to the wheelhouse windows and the wheelhouse deck's starboard side aileron handrails. No contamination or personal injuries occurred.

Figure 2. Damage to BESIKTAS PERA

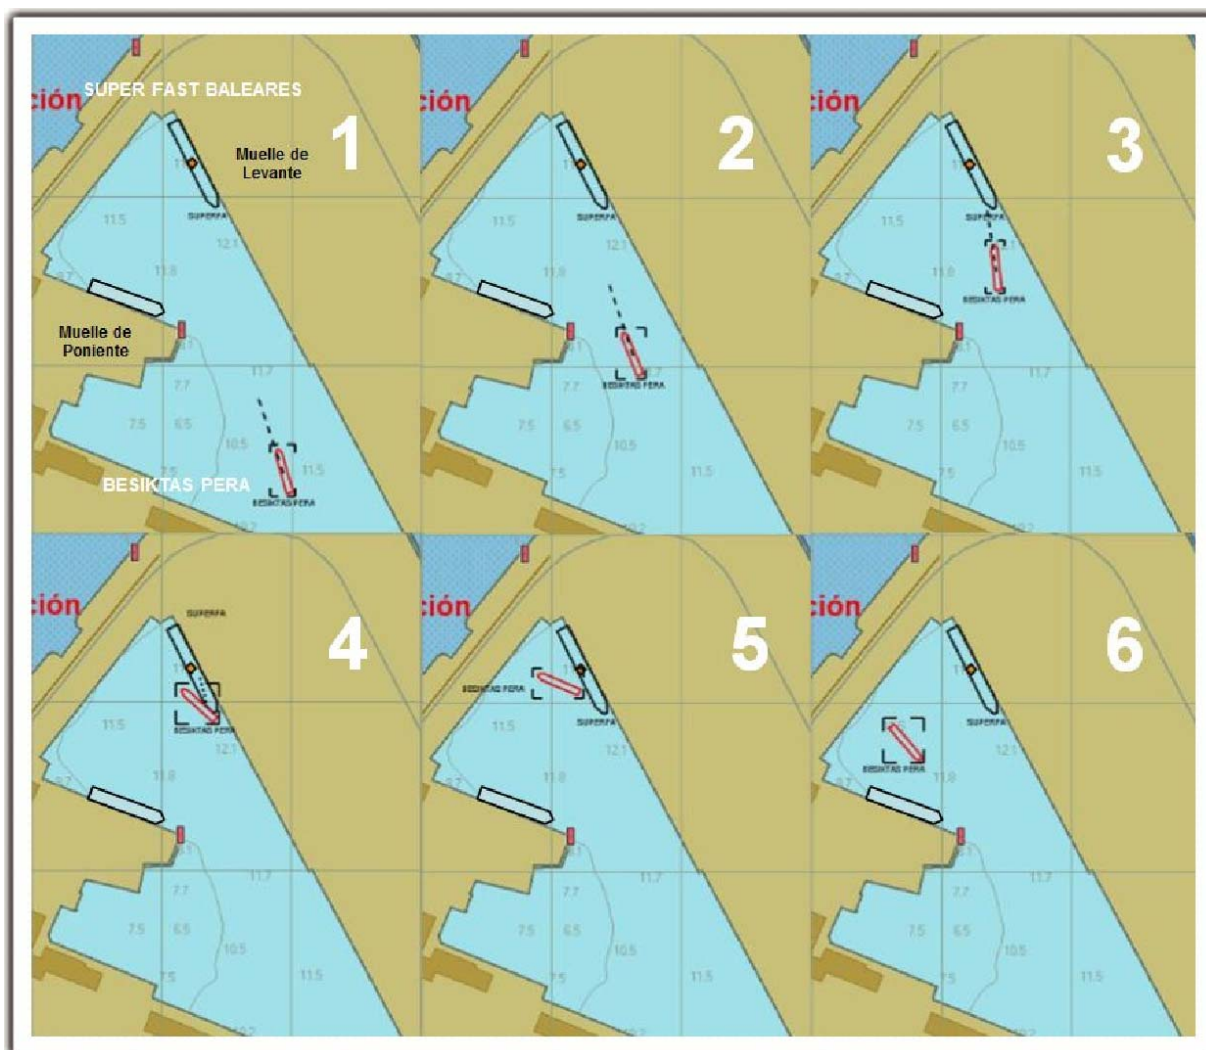
Using the dynamic graphs of the geographic positions transmitted by BESIKTAS PERA's automatic identification system (AIS), which were recorded by Valencia's Rescue Coordination Centre, the course followed by the vessel, which is shown in Figure 5, has been reconstructed.

Figure 5. Reconstruction of the course followed by the vessel

In view of the above, this commission has concluded that the accident was probably caused by planning errors on the part of the Master on board the vessel while carrying out the manoeuvre inside the port yard. An underlying factor was the erroneous estimation of the manoeuvring capacity of the vessel on the Master's part.

1. To tailor the vessel familiarization period for Masters to assume command according to the services that the vessel is going to be providing.
