Report ULM A-007/2016

Accident involving an amateur-built
YUMA ULM aircraft, registration EC-XGB,
in the vicinity of the ULM airfield
in Camarenilla (Toledo, Spain)
on 5 March 2016

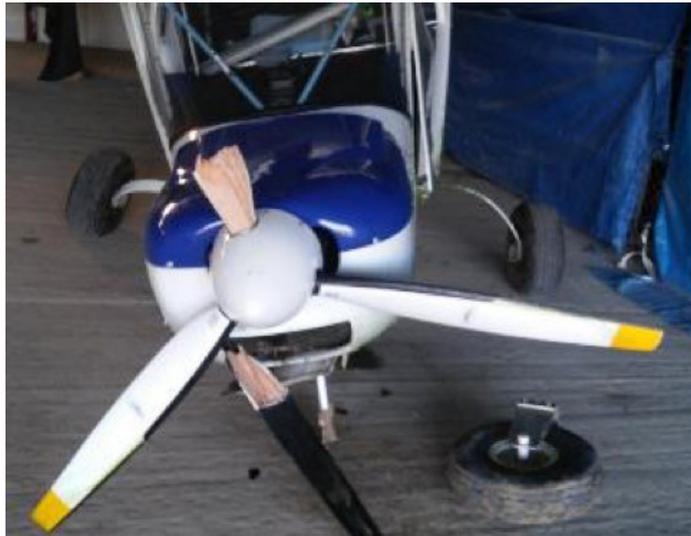
Figure 1. Front end of the aircraft

During the landing, the nose leg broke and the right main landing gear leg bent backwards.

The broken front leg allowed the front end of the fuselage to strike the ground. This impact caused one of the three propeller blades to break and damaged the underside of the fuselage, which affected the oil radiator and the exhaust system.

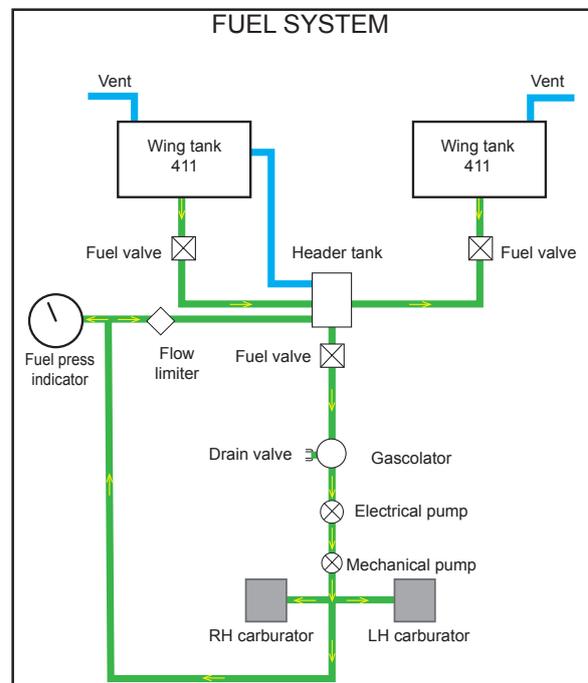
Figure 2. Diagram of the fuel system

Leaving the auxiliary tank is a line that crosses the firewall and goes to the gascolator. The line has a cutoff valve at the outlet of the auxiliary tank. Inside the gascolator is a filter, which has a drain valve.

At the top of the auxiliary tank is a vent line that connects the tank to the tank in the right wing (in blue in the diagram in Figure 2).

From the gascolator, the fuel is routed through a line to the electric pump. Another line channels it from the electric pump to the mechanical pump.

pressure gauge and the other to the auxiliary tank. The latter of these lines has a flow limiter at the outlet of the branch.

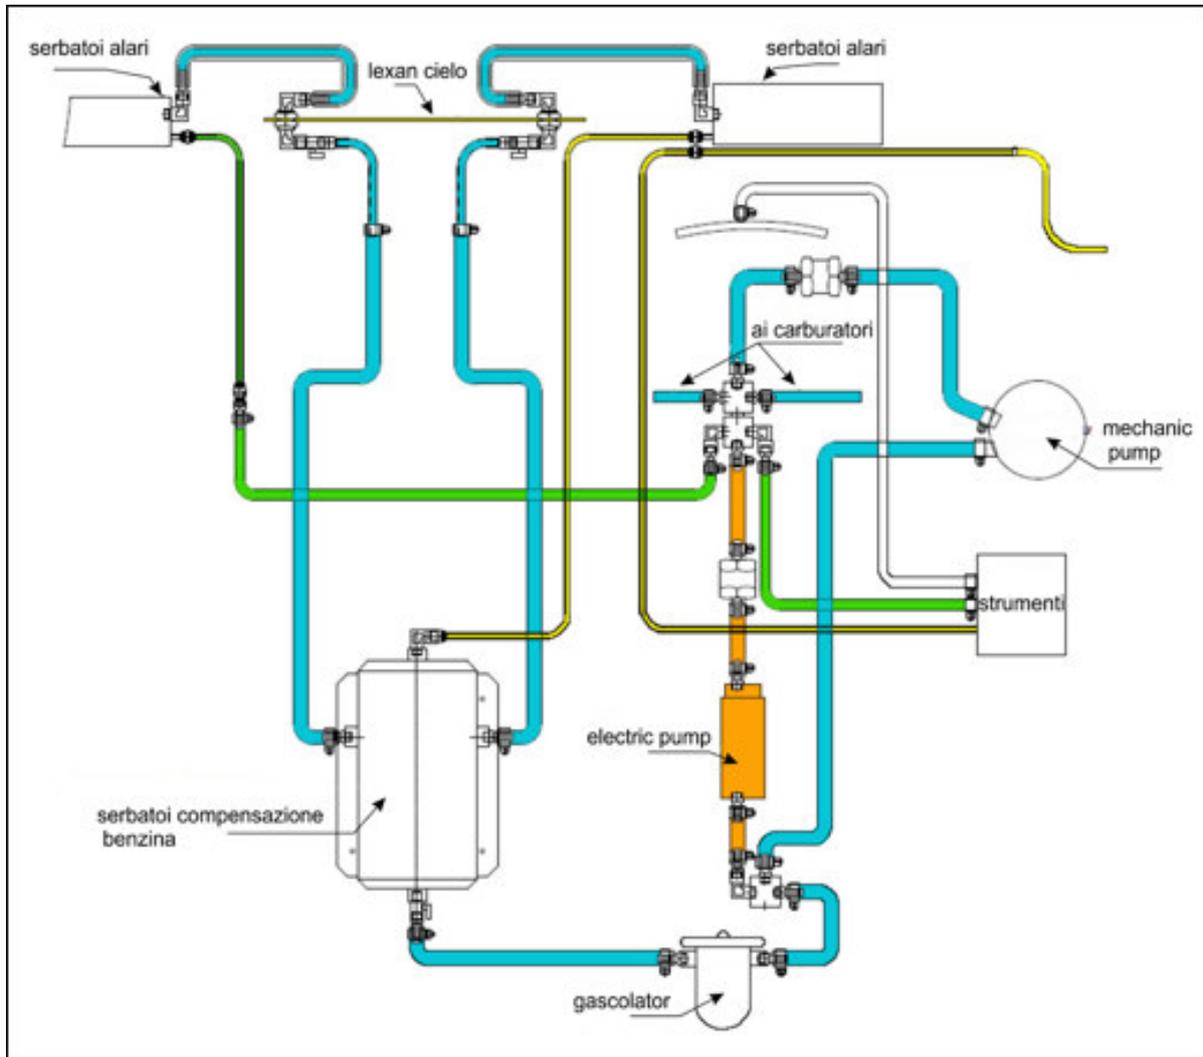
Figure 3. Diagram of the fuel system provided by the kit manufacturer, Alisport

The kit manufacturer provided the diagram for assembling the fuel system used in the fully finished aircraft it sells. This diagram is also included with the kits for buyers to use as a reference when installing the fuel system (see Figure 3).

For this reason, both the aircraft manufacturer, Alisport, and the engine manufacturer, Rotax, recommend fuel systems that despite differing in their design (Alisport recommends a parallel system and Rotax a series system), both ensure the continuity of the fuel supply if the electric pump is clogged.

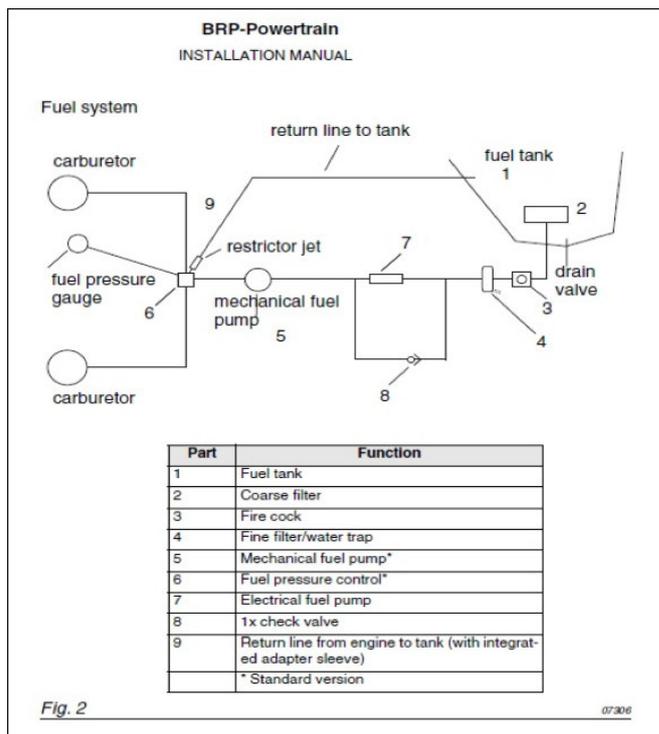
Figure 4. Fuel system diagram in the Rotax 912 engine installation manual

The engine installation manual that is published by the engine manufacturer, Rotax, specifies that the part of the fuel system that goes from, and includes, the tanks and the inlet to the mechanical fuel pump is the responsibility of the aircraft manufacturer, both in terms of its design and its assembly. It adds that the fuel system must be designed in a way that ensures that the engine is supplied with sufficient fuel at adequate pressure under any operating conditions.

In the Rotax layout, this condition is achieved by installing a bypass line with a check valve that circumvents the electric pump.

In light of this, it may be concluded that the builder of the aircraft, which was its previous owner, installed the fuel system without adhering to the recommendations of either the kit manufacturer or the engine manufacturer.

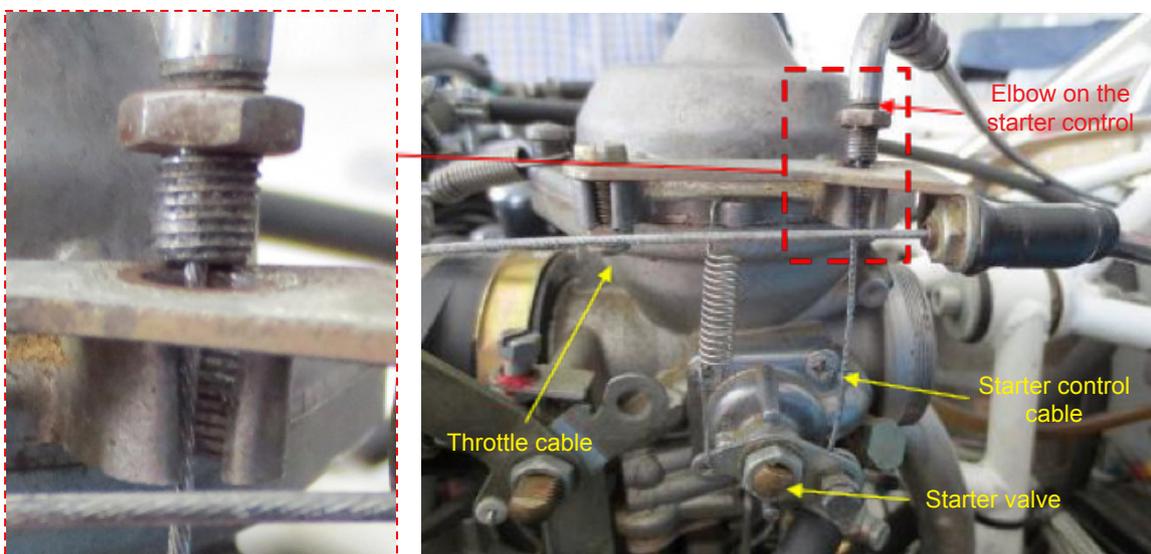
Small particles of dirt were found in the fuel intake on the left carburetor.

Figure 5. Photograph of the left carburetor (right). The elbow on the starter control was removed from its housing for a clearer view. See close-up in the photograph on the left.

The starter valve on the left carburetor did not return to its position when the lever was released in the cockpit. An inspection of this control cable, its sheath and sleeves revealed that the elbow sleeve in the carburetor, despite being in its housing, was loose due to wear on the thread (see Figure 5), allowing it to come loose easily.

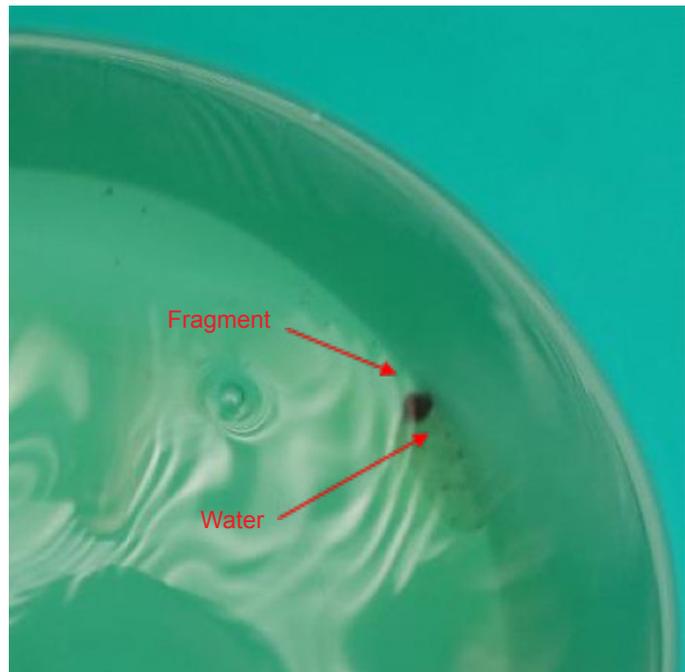
A longer test was repeated with the pump running, during which the fuel was collected in a container. After a few seconds, sludge started issuing from the line, then a small amount of water and shortly afterwards a solid, irregularly shaped fragment some 5 mm thick emerged from the line, after which the fuel flow increased.

Figure 6. Fuel with a solid fragment and water

The solid fragment that was found in the fuel system must have been lodged inside the electric pump, since its size would not have allowed it to flow through the vanes and slots in the pump. This also indicates that the fragment was created inside the pump itself as smaller particles clumped together.

The engine failure was caused by a partial obstruction in the fuel system that restricted the fuel flow to the carburetors.

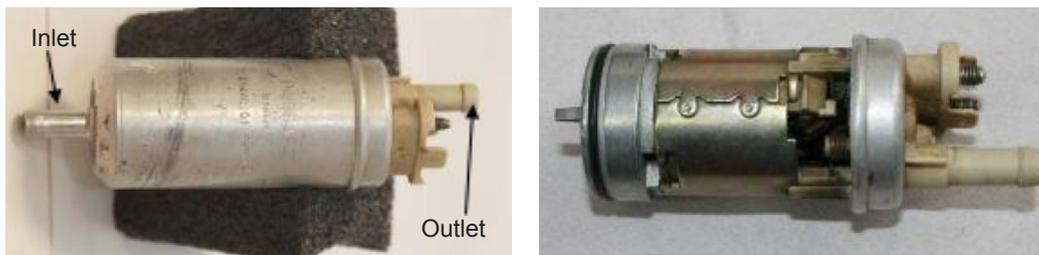
This pump model cannot be disassembled and it is not equipped with a fuel filter.

The pump was opened by cutting off its casing, which revealed this to be a vane pump.

Figure 7. Photograph of the pump in its original state (left) and after part of its casing was cut off and removed (right)

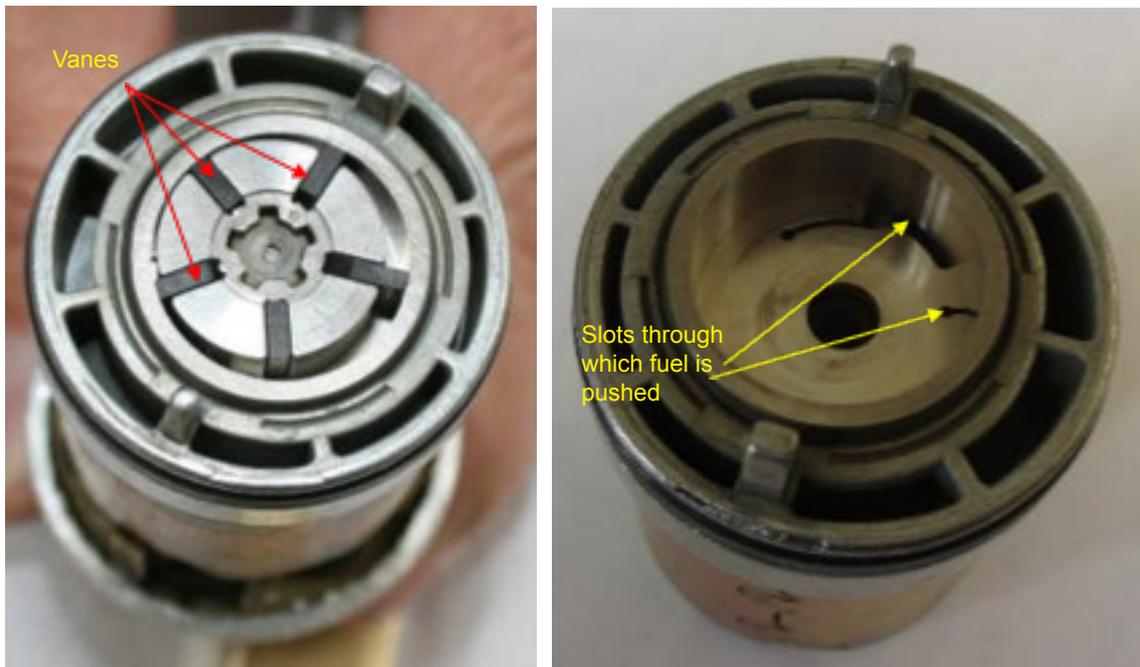
When the motor is energized, the fuel is pushed by the vanes, drawing it into the body of the motor through slots (see Figure 8). The fuel flows both inside the electric motor stator and outside it (through the stator and the outer casing), cooling it. The fuel eventually flows out the pump through a line at the opposite end from the inlet.

Figure 8. Close-up of the vanes (left) and the slots through which the fuel is pushed (right)

There was no dirt or foreign debris inside the pump and all of the flow passages inside the pump were free from obstructions.
