## Report ULM A-022/2016

Accident involving a MISTRAL STANDARD aircraft, registration EC-ZHH, in the vicinity of the Los Alcores aerodrome (Mairena del Alcor, Seville, Spain) on 24 October 2016.

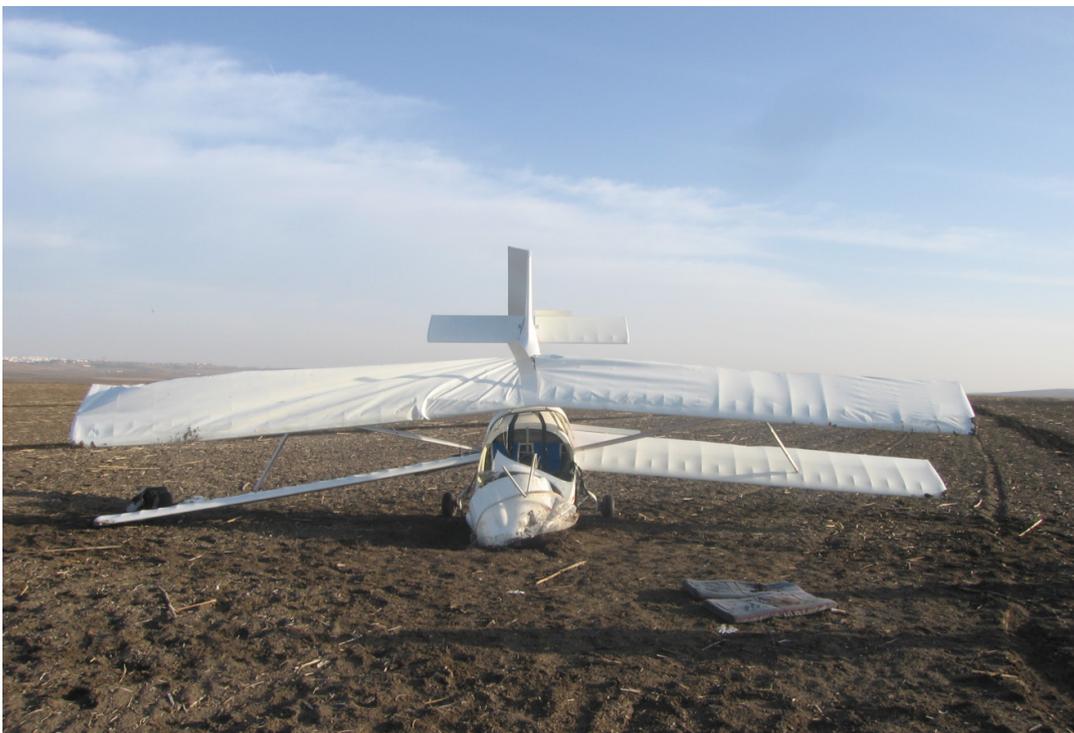
According to the statement from one of the mechanics, on the day of the accident, at about 19:15, the pilot arrived at the hangar, greeted them and said he was going to taxi the aircraft. The pilot then took the aircraft out of the hangar, which is when the mechanic heard the engine at full power. So he went out of the hangar and saw the aircraft on a takeoff run from runway 05. The mechanic stated that the pilot flew three or four patterns at the aerodrome, and that upon starting the last one, he flew low over the runway, climbed with a slight turn to the right and tried to return by dropping the left wing, apparently intending to go back to the runway. The aircraft dove to the ground 200 m away from the runway 23 threshold, digging into the ground, with the nose and the tips of the left wings half buried (see *Photograph 1*).

**Photograph 1.** Aircraft after the accident

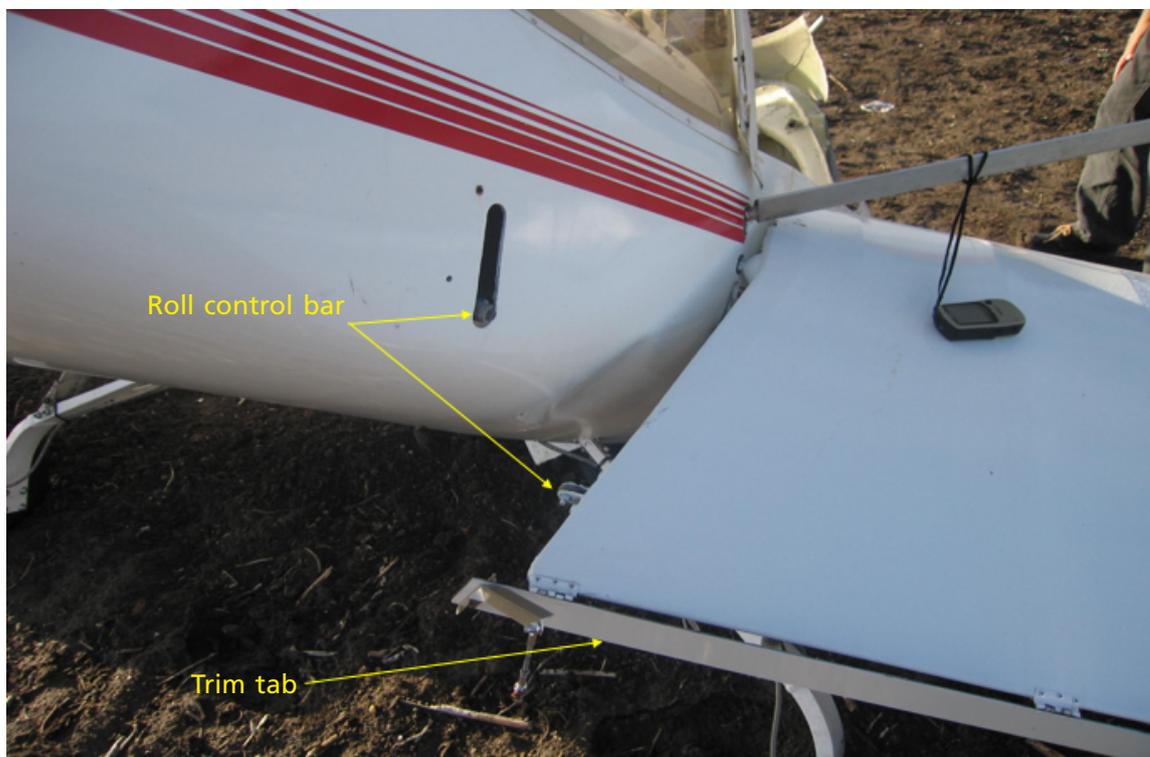
**Photograph 2.** Bottom wing and attachments

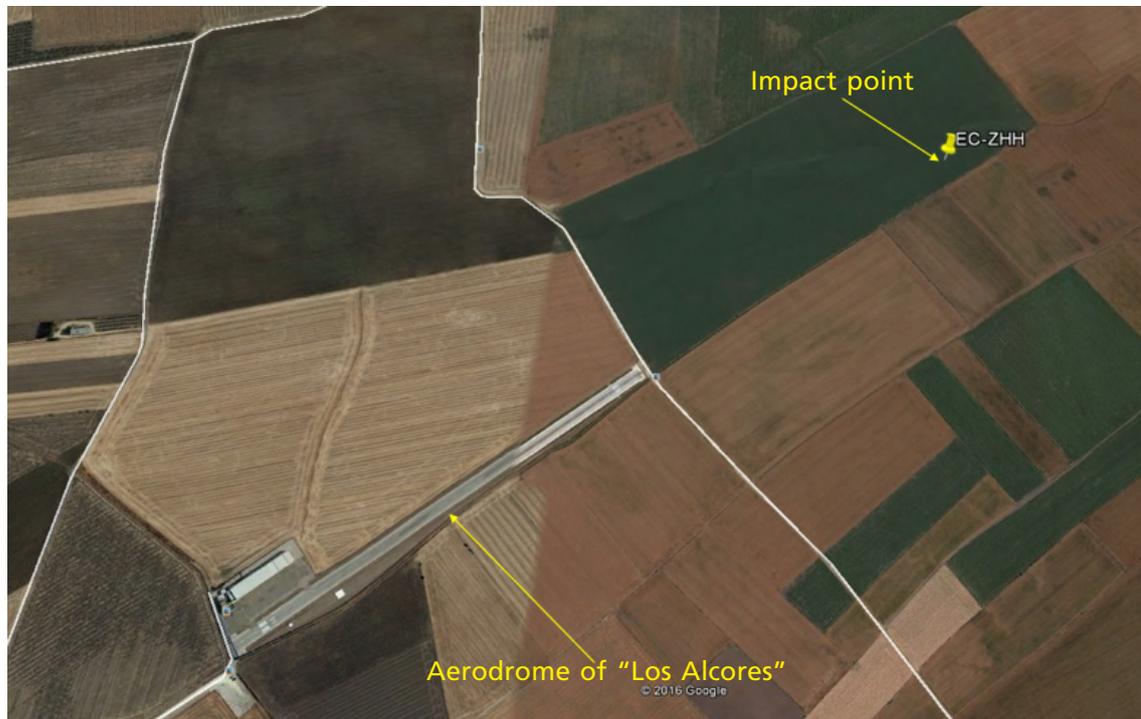
The coordinates of the impact point were 37° 20' 04.68" N - 05° 42' 54.24" W (see *Photograph 3*).

**Photograph 3.** Aerial view of the aerodrome of Los Alcores, showing the aircraft's impact point

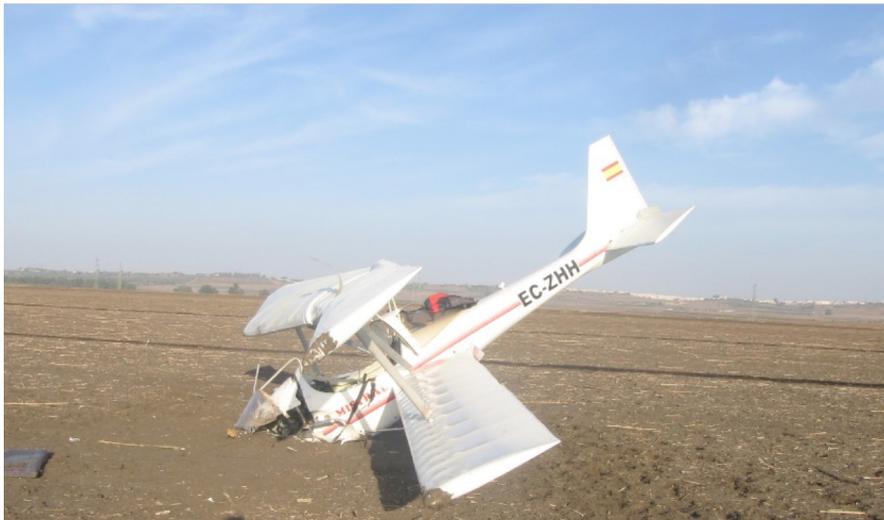
The fuselage seemed to have maintained its shape (see *Photograph 4*). The aircraft had no doors, which were still being repaired. The nose leg had collapsed to the rear. The engine, a Rotax 582, S/N 4559776, was on the ground with the propeller hub half buried. The propeller's three blades were found broken, two at the root and the third at one end. The detached blade fragments were under the engine with the exception of one segment, which was found 10 m forward of the aircraft.

**Photograph 4.** Aircraft after the accident

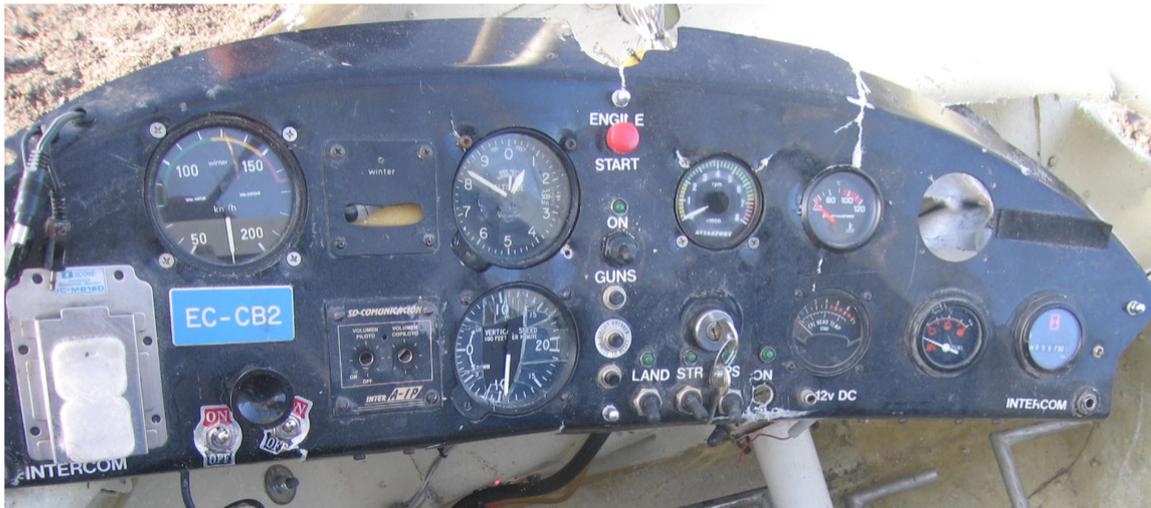
Inside the cockpit, the seats were found in their position with no deformations. The seat harness in the left seat, which the pilot had been wearing, was cut. The instrument panel (see *Photograph 5*) was not the original on the aircraft, having been replaced by a panel taken from another aircraft of the same type and still bearing the latter's registration plate (EC-CB2<sup>5</sup>). Some instruments were still not installed, but the following were:

**Photograph 5.** Instrument panel on the accident aircraft (EC-ZHH)

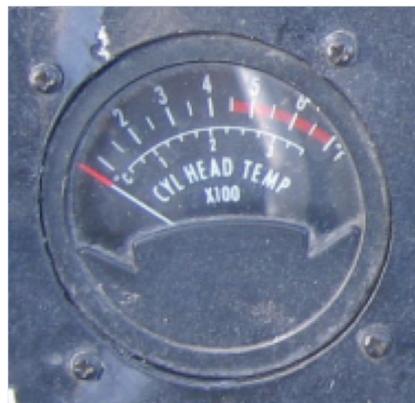
- Engine tachometer.
- Engine cooling liquid temperature.
- Exhaust temperature. It actually measured the exhaust gas temperature<sup>6</sup>, even though the gauge was labeled “cylinder head temperature”.
- Fuel quantity.
- Hobbs meter.

**Photograph 6.** Close-up of the instrument panel with the Exhaust Temperature gauge
