**DATA SUMMARY**

Date and time	<b>Saturday, 20 July 2013; 19:48 h<sup>1</sup></b>
Site	<b>Vicinity of Foz (Lugo, Spain)</b>

Registration	<b>EC-GF8</b>
Type and model	<b>PIPISTREL SINUS 912</b>
Operator	<b>Private</b>

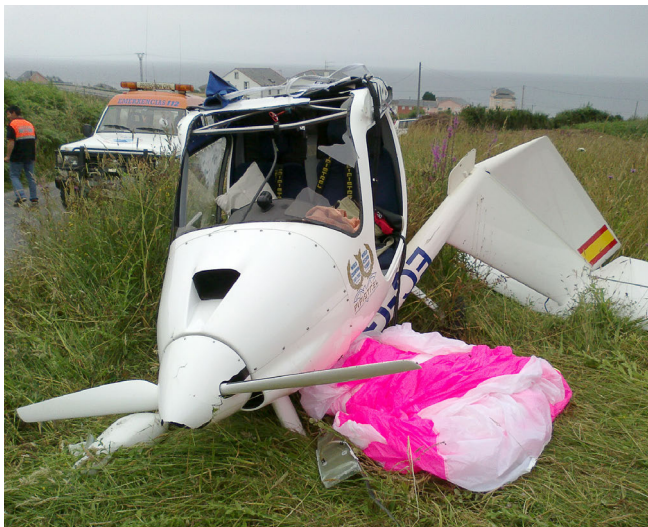
In these circumstances, the pilot decided to deploy the emergency parachute outfitted on the aircraft. When it opened, the aircraft experienced a structural failure that caused both wings and the tail to detach. The cockpit, suspended from the canopy, fell to the ground, with the two occupants inside, who suffered slight bruises.

During the parachute's deployment, the aircraft was subjected to the two forces described in 1.3.2, as the nearly instantaneous reduction in the aircraft's speed subjected the structure to loads in excess of design forces. This caused the frame to fracture, with the two wings and the tail detaching. The cockpit fell to the ground suspended from the parachute, which had performed as intended.
