## Report ULM A-020/2016

Accident involving a Flight Design CT-LS  
aircraft, registration D-MRLM,  
in Requena (Valencia, Spain)  
on 6 October 2016

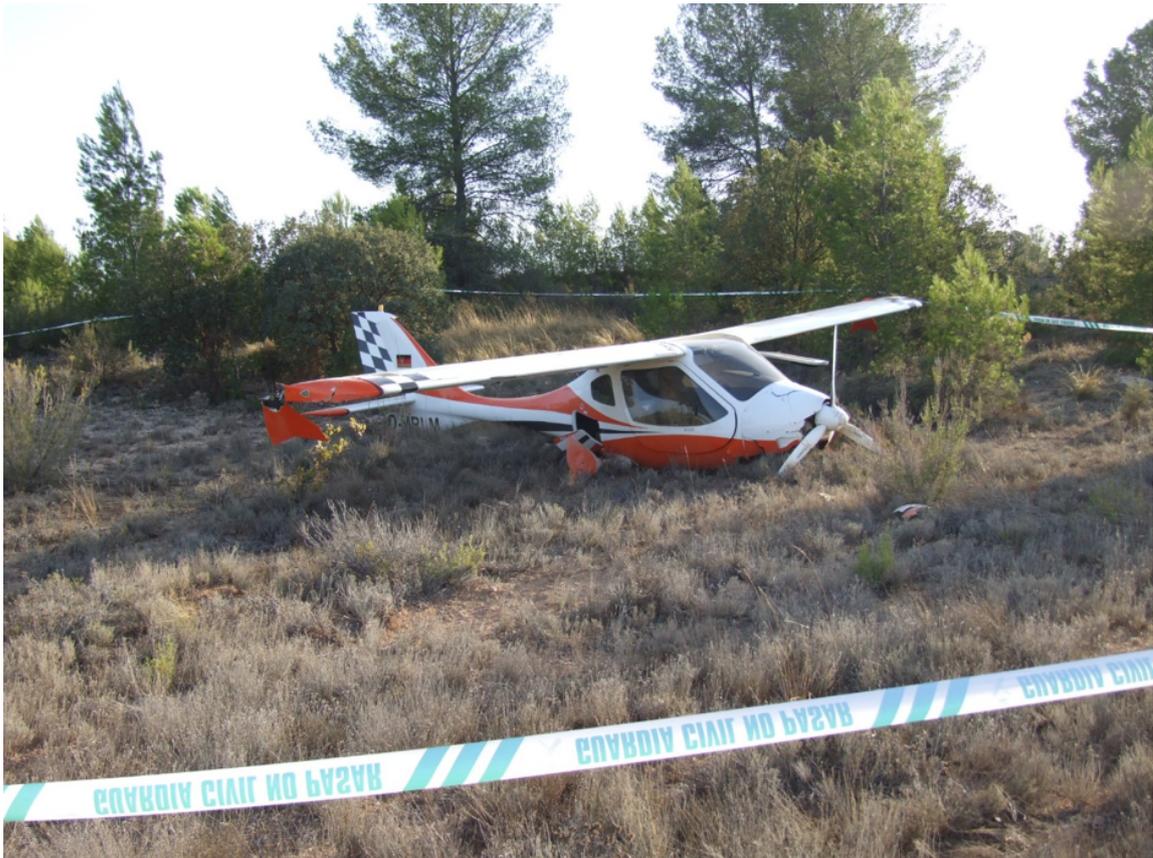
**Figure 2.** Aircraft wreckage.

The aircraft sustained heavy damage throughout practically all of its structure (fuselage, wings, landing gear, propeller, etc.).

The debris field was highly concentrated, with all of the components located within this field. The damage to the aircraft consisted of fractures and deformations to the front and bottom of the fuselage, landing gear, both wingtips and interior of the cockpit. Two of the propeller's three blades were broken.

There were two marks on the ground consistent with the fuselage's impact against the terrain.

There was no fuel in the left wing tank and only 1.5 l in the right wing tank.

There were two impact marks on the ground with no signs of forward motion and paint marks on some stones. This, combined with the highly confined debris field, indicates that the aircraft impacted the ground in a practically horizontal position as the result of stalling at a low altitude. This fact is corroborated by the pilot who, in his statement, stated that at an altitude of 2 m, the aircraft started to stall due to the turn and the loss of speed, as well as due to his pulling back on the control stick, which helped the aircraft lose all its forward speed and fall to the ground.

A check of the fuel revealed that the left wing tank was empty and the right wing tank had a liter and a half, an entirely insufficient quantity to perform the flight.

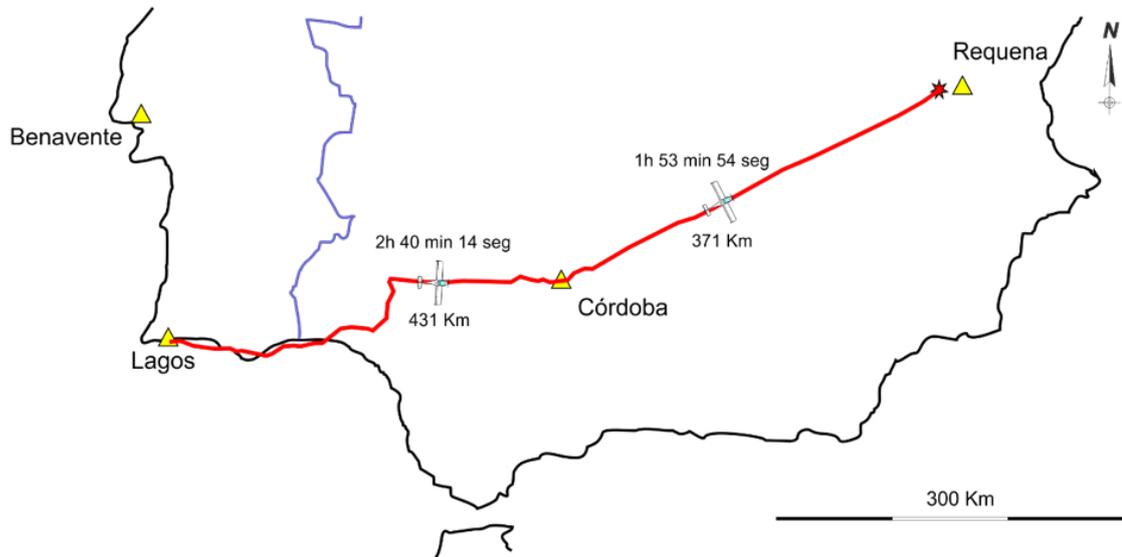
Figure 4. GPS track.

The speeds recorded by the GPS (with respect to the ground) show different values that on occasion exceeded 200 km/h. During the first stage, the values were primarily below 200 km/h, while during the second leg the speeds were mostly above 200 km/h.

The distances traveled were 431 km in the first flight and 371 km in the second, which total 802 km without reaching Requena. This is in contrast to the 760 km considered by the pilot for both segments in his flight plan.

The ground speeds calculated from the data recorded by the GPS indicate that the values during the second segment were slightly higher than during the first. Moreover, the altitude at which the aircraft flew during the second segment was higher due to the higher elevation of the terrain and to the need to maintain a safety margin above the ground.

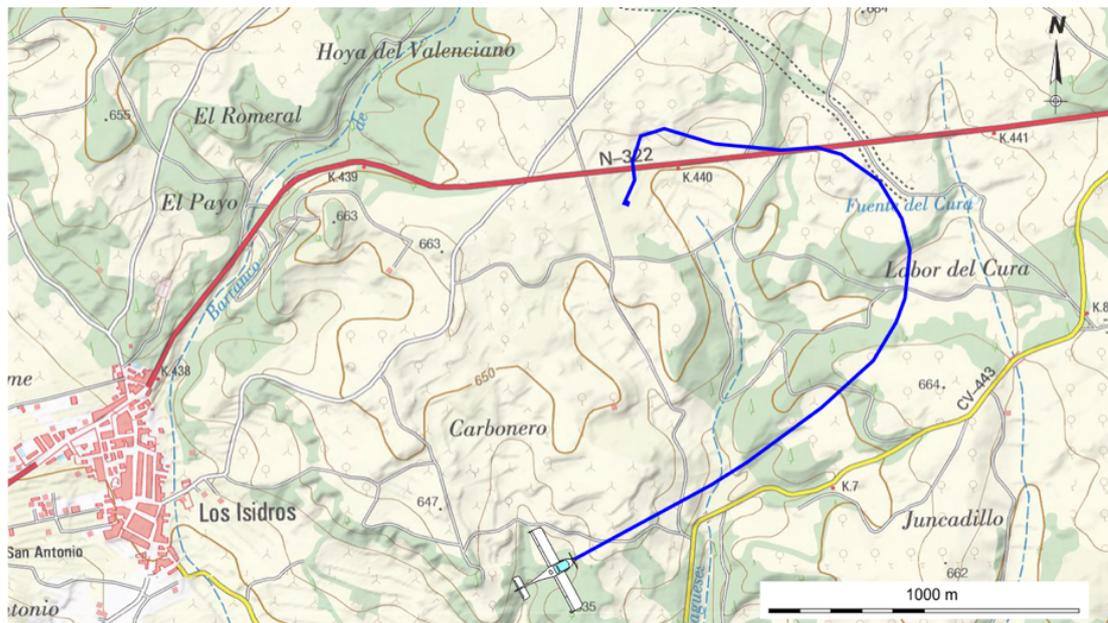
Figure 5. Emergency landing segment.

In the last part of the flight, the aircraft is seen making a 180° turn to line up with a nearby road before finally turning left again to land in a field next to the road.

There were two nearby fields, one on either side of the road, that could have been used to make an emergency landing. Perhaps the fact that the pilot initially considered the road as a landing site - which can always lead to a compromising and/or dangerous situation for the pilot and for any vehicles that may be traveling on it at the time or that appear unexpectedly – and the urgency to act as a result of the low altitude, made it difficult for the pilot to evaluate a more extensive area that might have been available to carry out an emergency landing.
