Report A-026/2014

Accident involving an AGUSTA AW 119,
registration EC-KSD,
operated by the company FAASA,
in the municipality of Alpera
(Albacate, Spain) on 13 September 2014

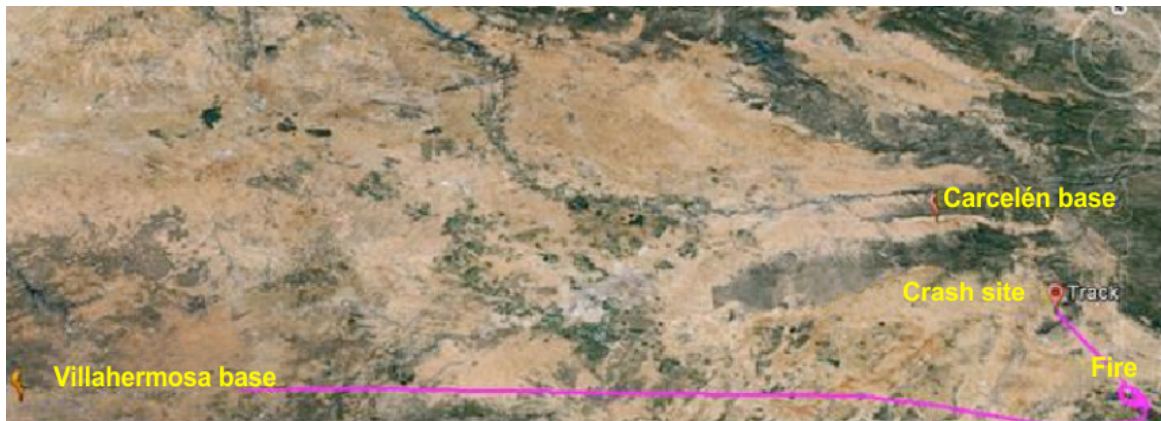
Figure 1. Aircraft's flight path

The helicopter was equipped with a satellite fleet tracking system that sends position, altitude and speed signals. There was also a portable GPS unit onboard with the same features. The units stopped recording at 17:02 and 17:01, respectively.

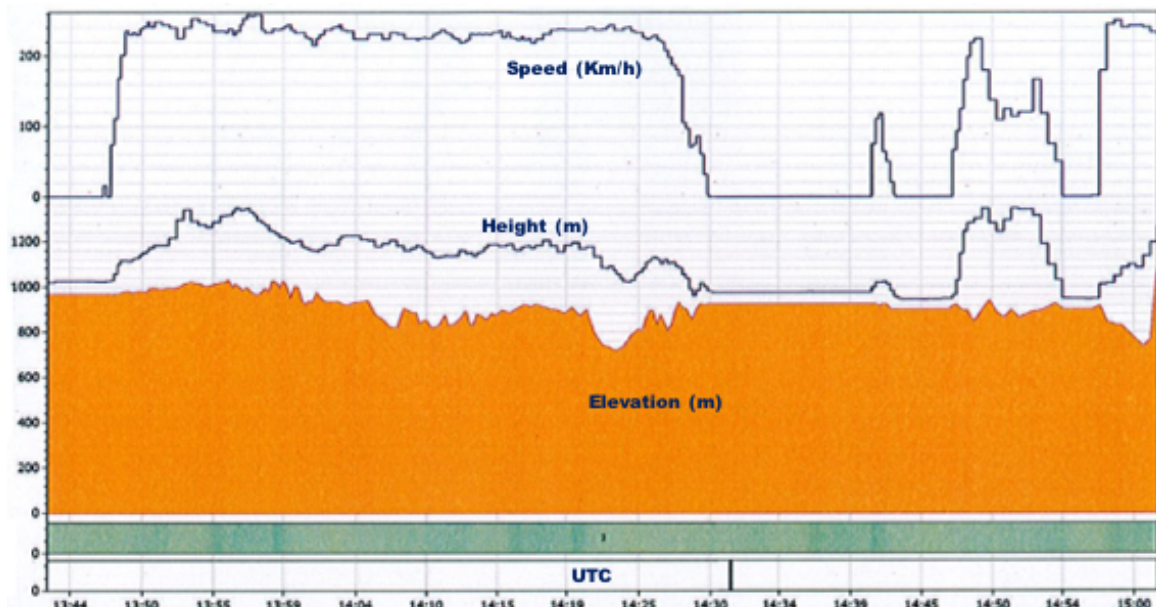
The satellite fleet tracking system stopped recording consistent data at 17:02, and the portable positioning unit at 17:01. The helicopter is thus thought to have crashed moments later while in cruise flight. The graph in Figure 9 shows the helicopter's flight profile, with its altitude (m), the ground elevation (also in m, in orange) and speed (km/h). The data recorded are not exact but rather approximate, since in the two segments with constant altitude and speed, it was stopped on the ground (the times shown in the graph are in UTC).

Figure 9. Flight profile

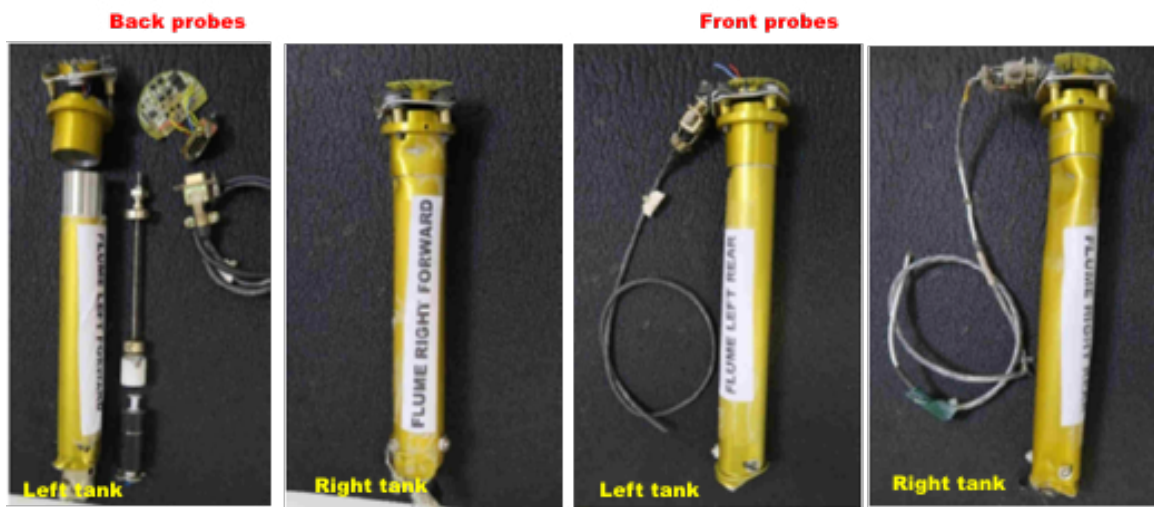
The final inspection was again performed at the BEA's facilities, and was intended to check the connection between the PCB and the float sensor, and between the PCB and the connector (DB9).

Figure 13. Probes of the inferior tanks, object of study

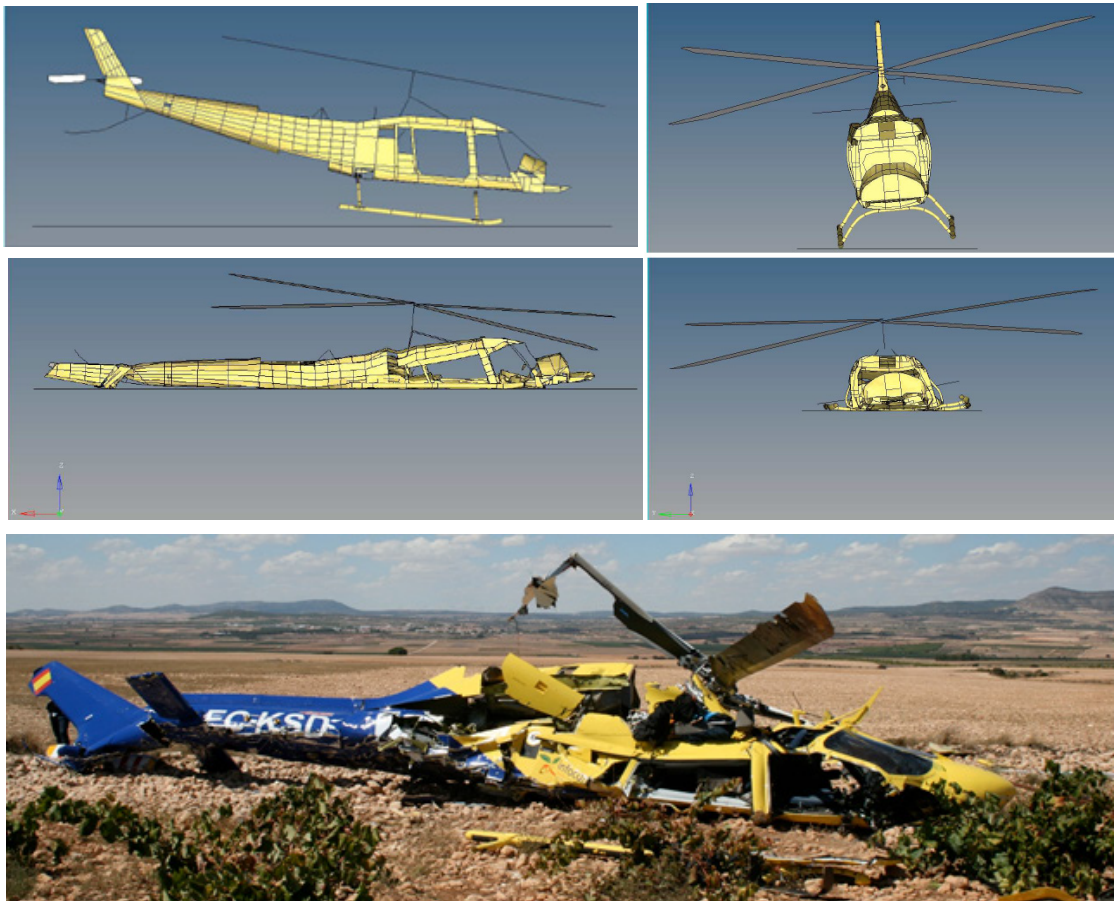
Figure 16. Model of the dynamic simulation conducted by the manufacturer

Although no initial data were available, several models were created that simulated damage that was similar to that actually caused to the helicopter. The goal was to determine the approximate energy at which the impact took place in order to estimate the vertical speed the helicopter had upon reaching the ground, and thus estimate the altitude from which it fell after the autorotation maneuver was terminated.

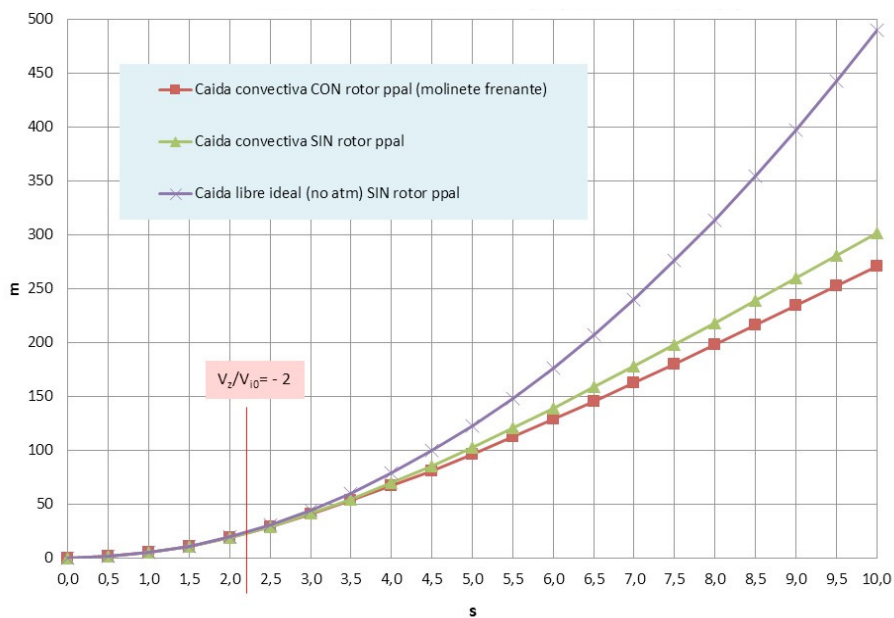
The experiment demonstrates that before its final maneuver, the helicopter had to have a certain vertical speed. As a result, the previous calculations were performed again to start with an initial fall speed different from zero. Based on this, different scenarios were considered, assuming initial speeds from 1 m/s (197 ft/min) to 10 m/s (1,979 ft/min), the results of which are provided in the table.

Figure 17. Free fall distance versus time

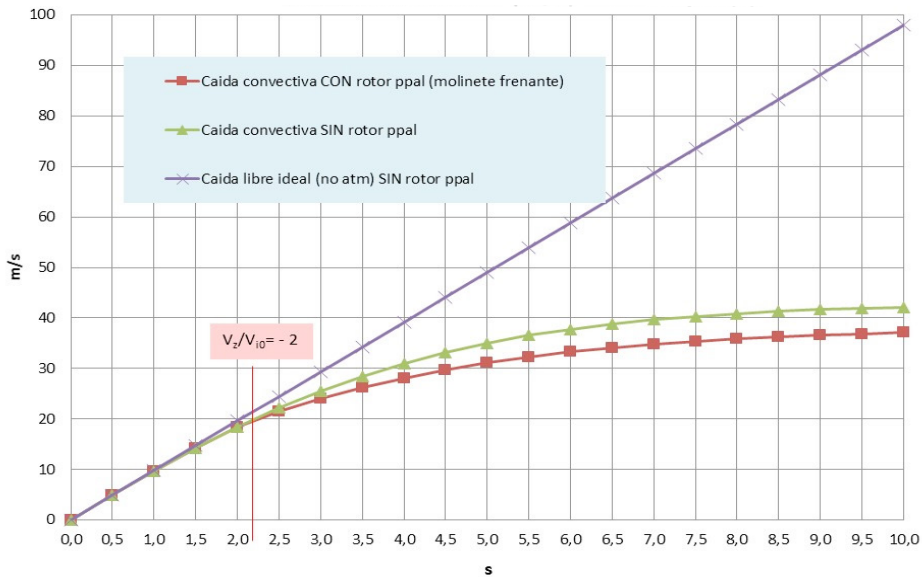
Figure 18. Graphic of the vertical speed versus time
