TECHNICAL REPORT

A-055/2001

Accident to aircraft
FAIRCHILD SA-226-AT,
«Metro II», registration
EC-GDV, in the vicinity of
the Columbretes Islands
in the Mediterranean
Sea, on 10 October 2001

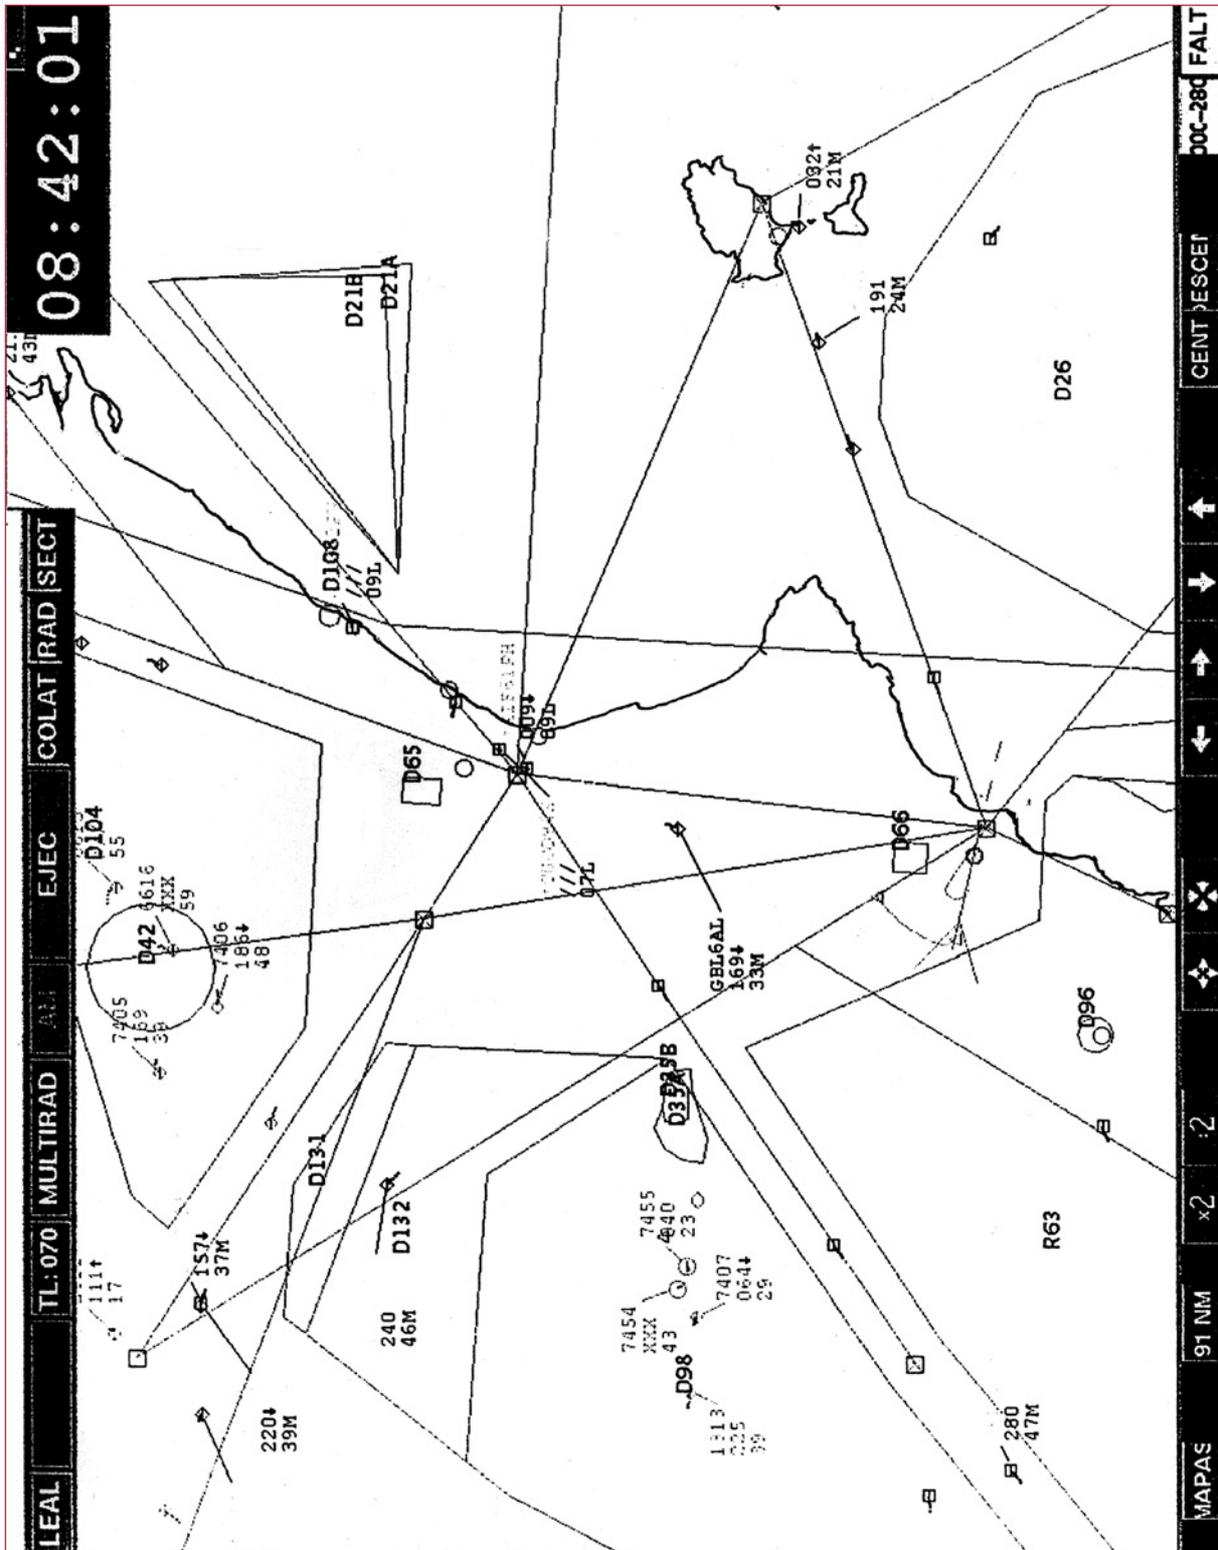
Figure A-2b. Display on radar screen at 08:42:01

- After having completed this turn, the sudden disappearance of the radar screen display between 10:41:59 and 10:42:01 h and the impossibility of recovering radio contact afterwards led to the consideration that the aircraft suffered, at least, total loss of electricity supply possibly caused by a lightning strike.
