DATA SUMMARY

Date and time	24 june 2002; 17:45
Site	Ocaña airfield (Toledo)

Registration	PH-1204
Type and model	SCHLEICHER Ka 6 BR

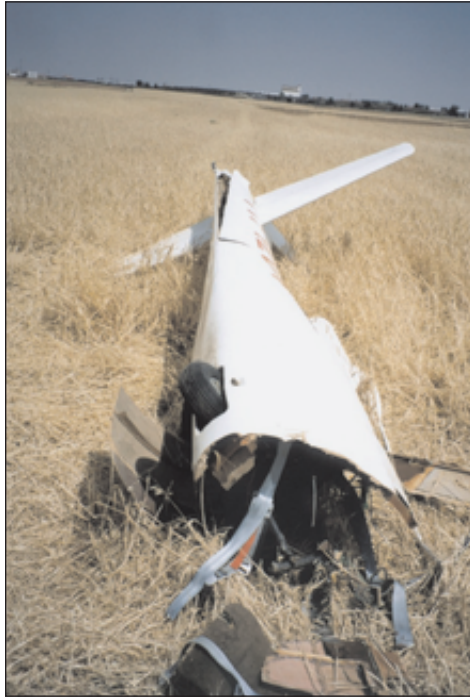
At approximately 17:43, local time, a Robin DR-400-180R aircraft, registration EC-BTN, began to tow a Schleicher Ka 6 BR glider, registration PH-1204, on runway 11 of the Ocaña aerodrome. The take off was carried out in a normal way, the glider lifted off first followed by the towing aircraft shortly afterwards. Seconds later, when both aircraft had travelled about three fourths of the 1200 metre-long runway (see diagram), the tow cable broke.

The towing aircraft continued on its route and the glider began a very shallow turn to the left, almost without banking, as if trying to return to the threshold from where it had departed. When it had turned more than 90° it increased the bank, and instants later the left wing descended abruptly and the aircraft began to descend quickly, until it crashed into the terrain.

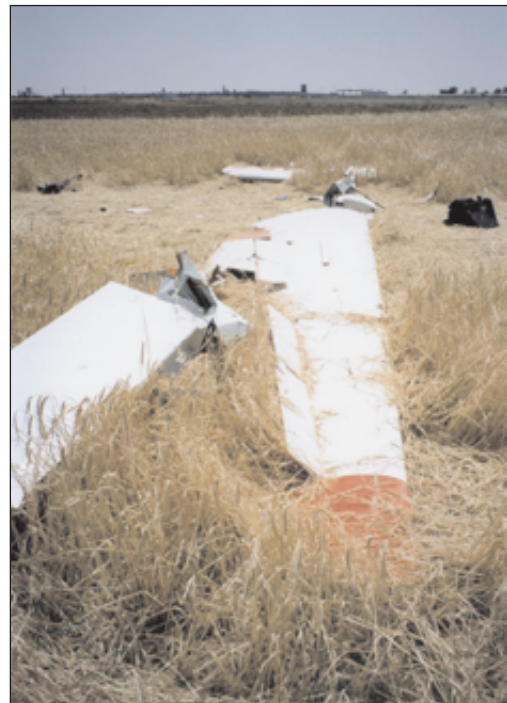
An impact mark was found on the ground, produced by the leading edge of the left wing, and to its left, the impact mark of the aircraft nose was noticed.

The left wing was broken in three parts: the leading edge, located very close to the spot where the wing impacted, a beam fragment and the wing root area, located near the spot where the nose impacted, and the wing tip, located farther to the left.

The nose of the aircraft was completely destroyed up to the wing root. Its fragments were scattered about the area where the impact took place.

The right wing suffered little damage. Its location is indicated on the diagram.

On the other hand, in view of the damages suffered by the aircraft and the marks it left on the ground, it is assumed that the left wing made contact first, as the aircraft was in a banked attitude toward the left. Immediately afterwards the impact with the nose occurred.
