**DATA SUMMARY**

Date and time	<b>Tuesday, 18 November 2002; 16:45 hours</b>
Site	<b>Airport of Sabadell</b>

Registration	<b>F-BRDL</b>
Type and model	<b>SOCATA RALLYE 180</b>

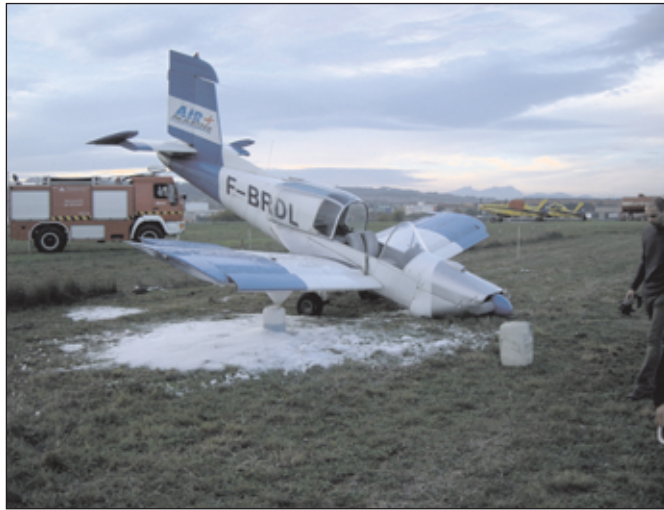
The pilot, accompanied by one passenger, intended to perform a local flight at the airport of Sabadell. He began the take-off run along runway 31 and when the aircraft reached the appropriate speed, it became airborne.

Shortly afterwards there was a sudden loss of engine power. The pilot decided to land again but, as the remaining length of the runway was too short, he decided to make a 180 degree turn, which he was unable to complete, as he mentioned in his statement after the incident, due to the lack of speed and altitude of the aircraft. It finally landed on the runway strip. The impact with the ground was hard, the nose landing gear collapsed and subsequently the propeller hit the ground. The aircraft

crossed the taxiway and finally came to a halt a few metres further on.

The aircraft suffered damage to its nose landing gear, propeller and engine.

The loss of power of the engine was due to fuel starvation caused by the closure of the fuel switch.

The pilot tried to turn 180 degrees to land on the opposite runway (13) to the one he had used to take off (31) and almost stalled the aircraft due to the airspeed decrease and to the increase of the stall speed during the turn. He must have realised this circumstance, as he landed straight away when he had only turned about 90 degrees. However, the collapse of the nose landing gear seems to have been caused by the aircraft falling down from certain height before reaching the ground in a controlled touch down.
