TECHNICAL REPORT

A-002/2003

**Accident of aircraft FOKKER 50,
registration PH-FZE, at Melilla Airport (Spain),
on 17 January 2003**

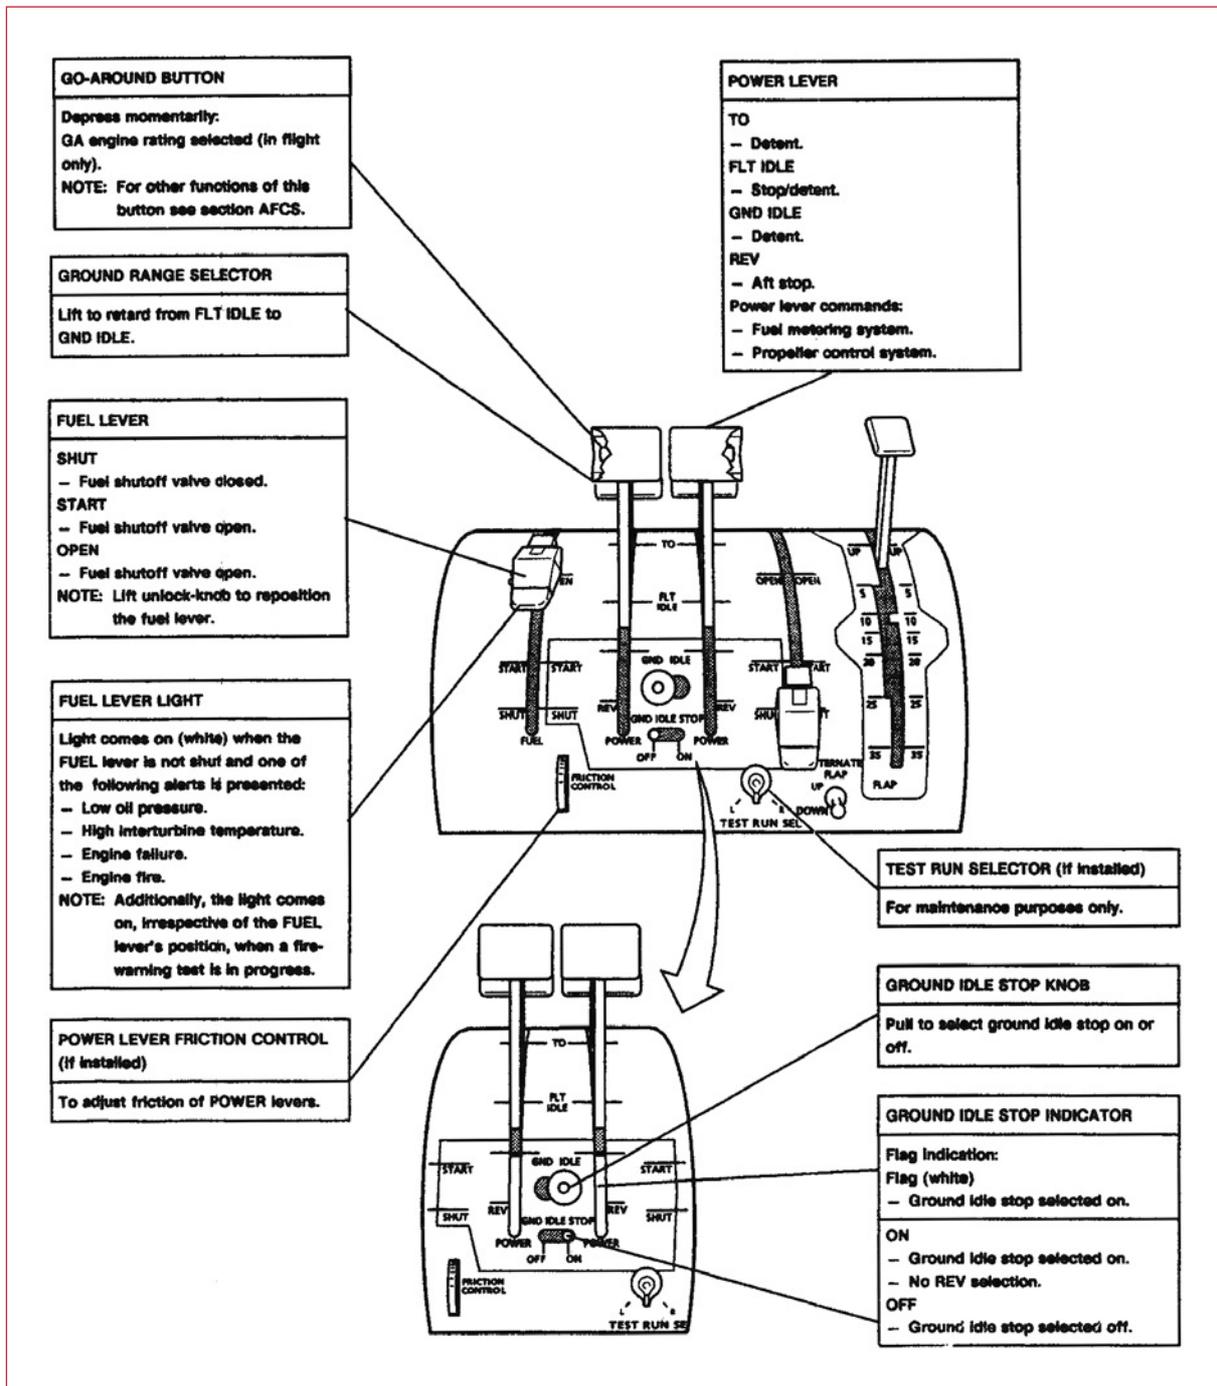
Figure 1.6.3.1. Power lever quadrant (from the Aircraft Operating Manual prepared by Fokker)

To move the power levers below the flight idle detent, the pilot must lift by hand a piggyback lever called the «ground range selector» that is also mounted on the power lever (see Figures 1.6.3.1 and 1.6.3.2).

respectively. Unless certain conditions are met (see next paragraph), the corresponding power lever cannot be moved below the flight idle position, even if the pilot raises the «ground range selector». Except in the event of a failure, this is only possible when the aircraft is on the ground and therefore the solenoid is energized and retracts the automatic flight idle stop.

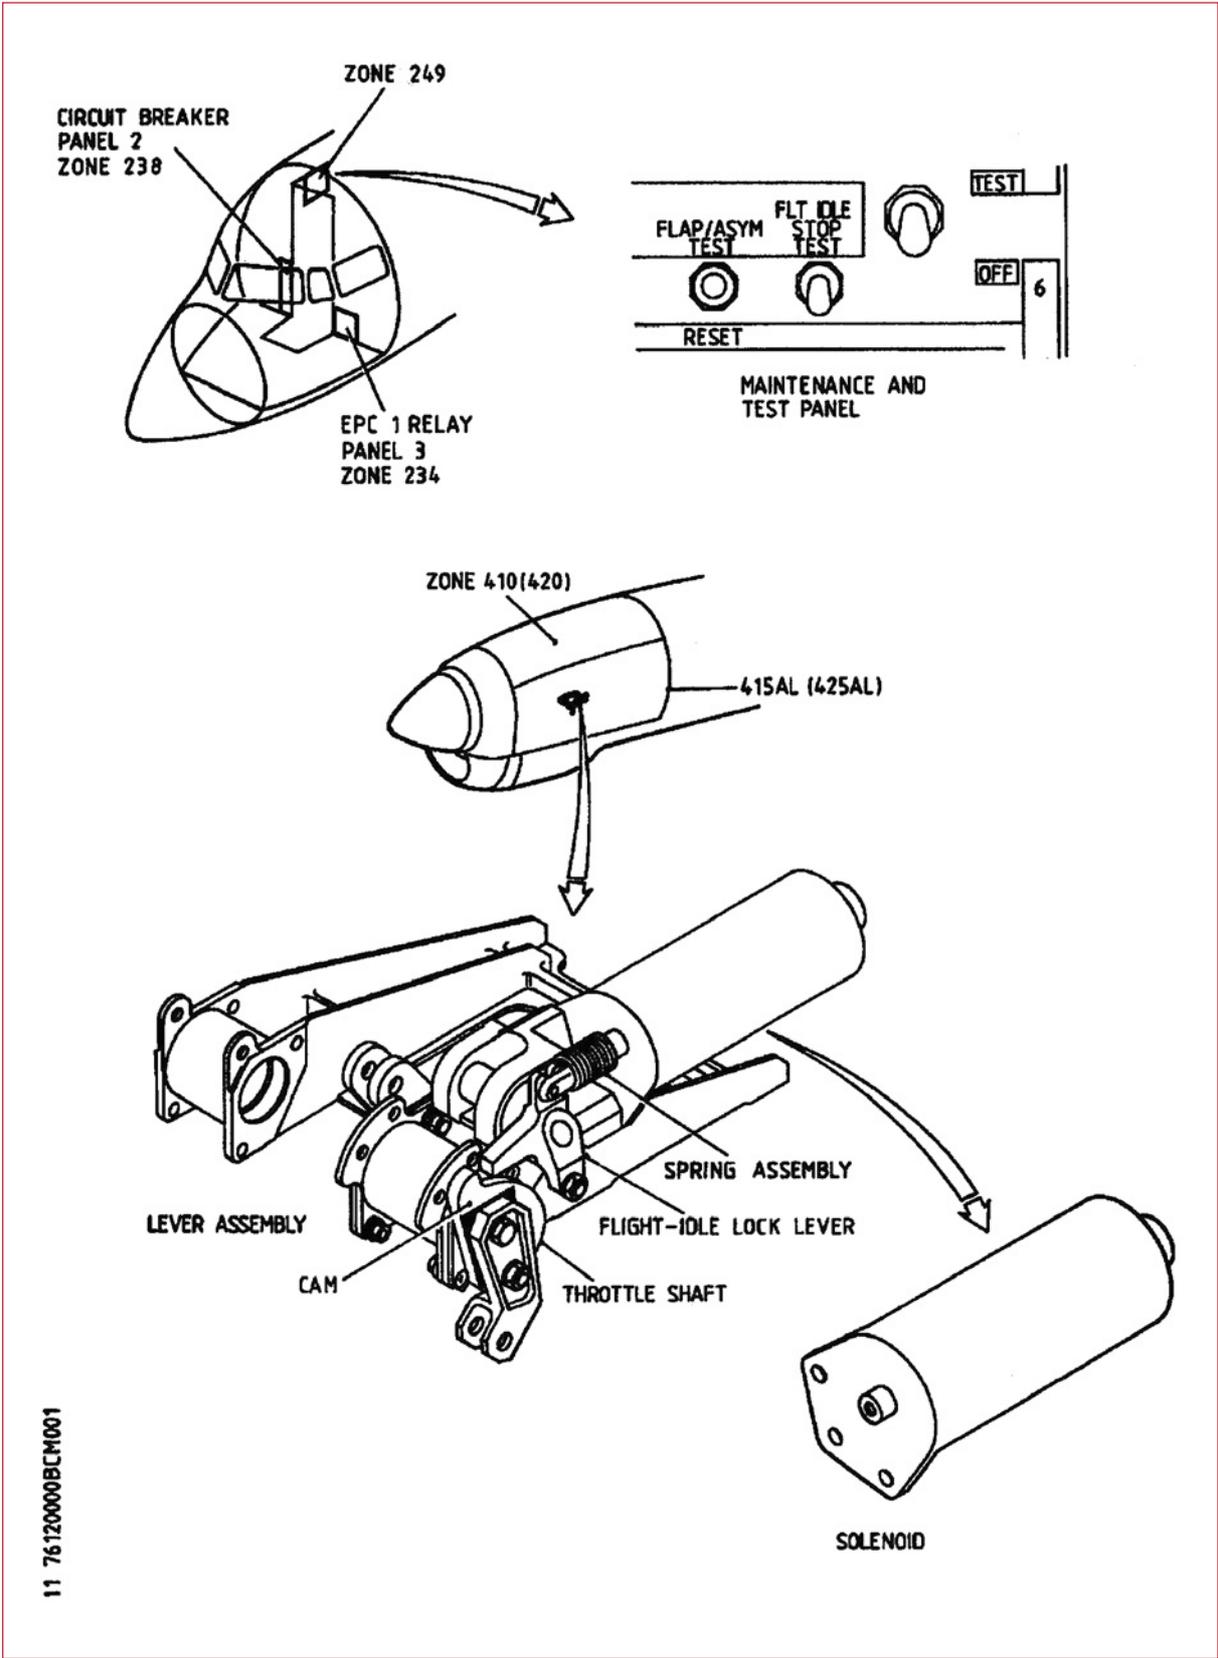
Figure 1.6.3.3. Detail of the automatic flight idle stop assembly (from Fokker Maintenance Manual)

According to the information provided by the Aircraft Maintenance Manual (AMM), the automatic flight idle stop has two solenoids that operate a movable lock lever on the engine throttle controls. The solenoids are attached to a lever assembly on each engine (see Figure 1.6.3.3).

The solenoids are de-energized in flight to engage the lock lever and to prevent movement of the controls to a position below flight idle.

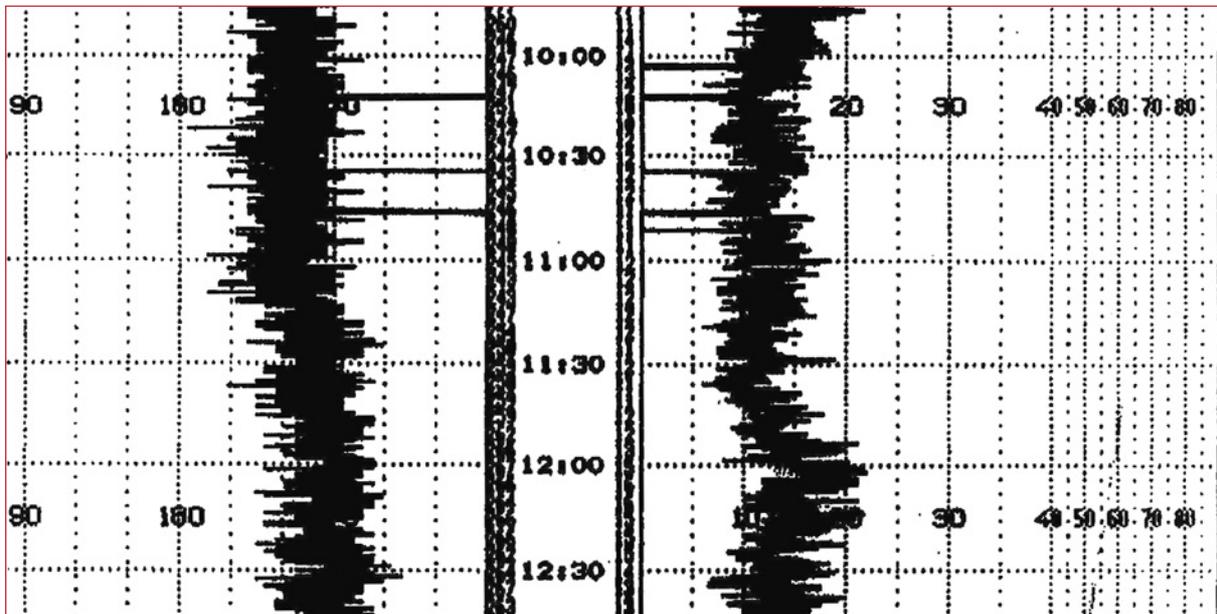
Figure 1.7.1. Instantaneous wind record runway 15 of Melilla Airport on 17-1-2003 between 10:00 h and 12:30 h UTC. On the left the wind direction in degrees is shown. On the right part of the graph, the wind speed in kt is recorded

The runway 15 threshold instantaneous wind record taken by the Meteorological Office of Melilla was reviewed. At 11:00 h, no instantaneous example of wind speed was above 18 kt and the mean value was around 13 kt. The mean value of the recorded wind direction was around 240° (see Figure 1.7.1). This meant almost pure crosswind. Wind direction above 240° meant some component of tailwind. It can be seen that around 11:00 h the wind direction mean value is 240° or less.

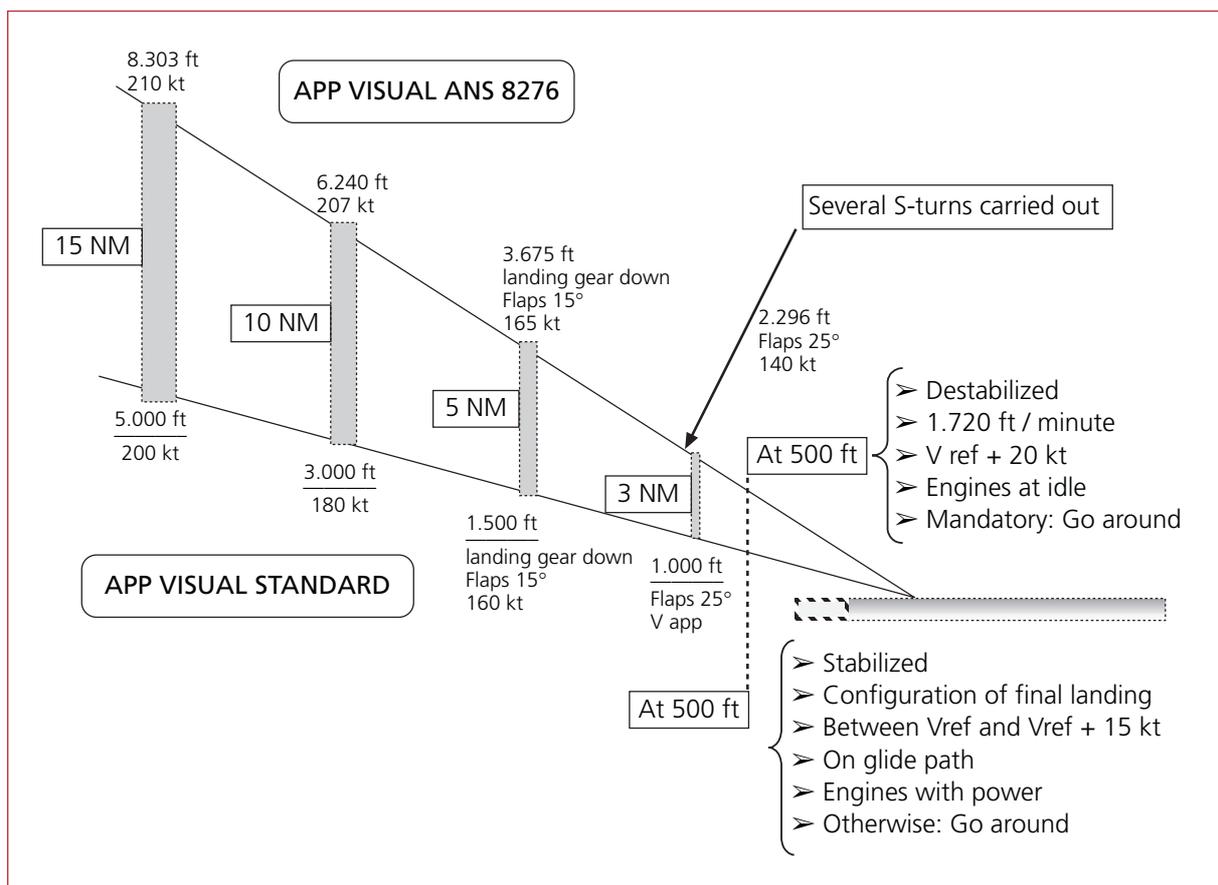
In fact, at 500 ft above the ground, the aircraft was still destabilized, with 1,720 ft/min of descent speed, at Vref plus 20 kt, not at 3° of glide path, and with engines at idle. This compares with the stabilized approach policy of ICAO (below 1,000 ft/min, between Vref and Vref plus 15 kt, engines with power, etc.) to give the conclusion that a go around should have been initiated immediately. The following graph compares a standard approach with the approach conditions faced by aeroplane PH-FZE.

Twenty seconds before touchdown the speed was 147 kt (i.e. 52 kt above the maximum recommended touchdown of 95 kt).

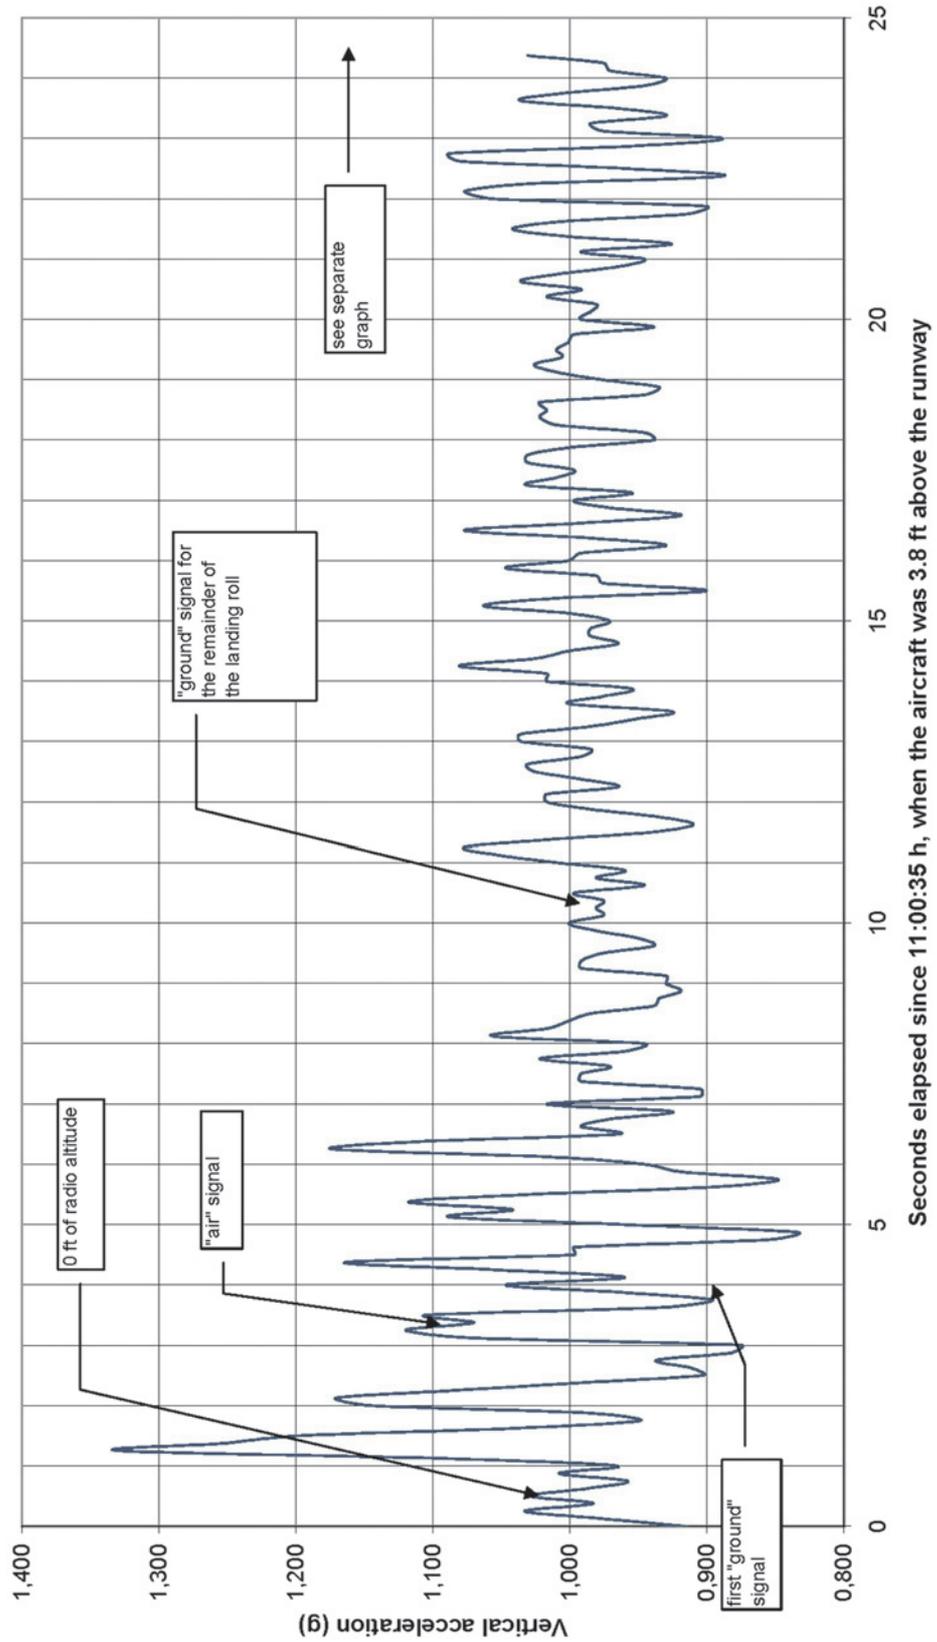
Vertical acceleration during touchdown and landing roll
(the last 5 tenths of a second corresponding to the fall through
the downslope are included in a separate graph)

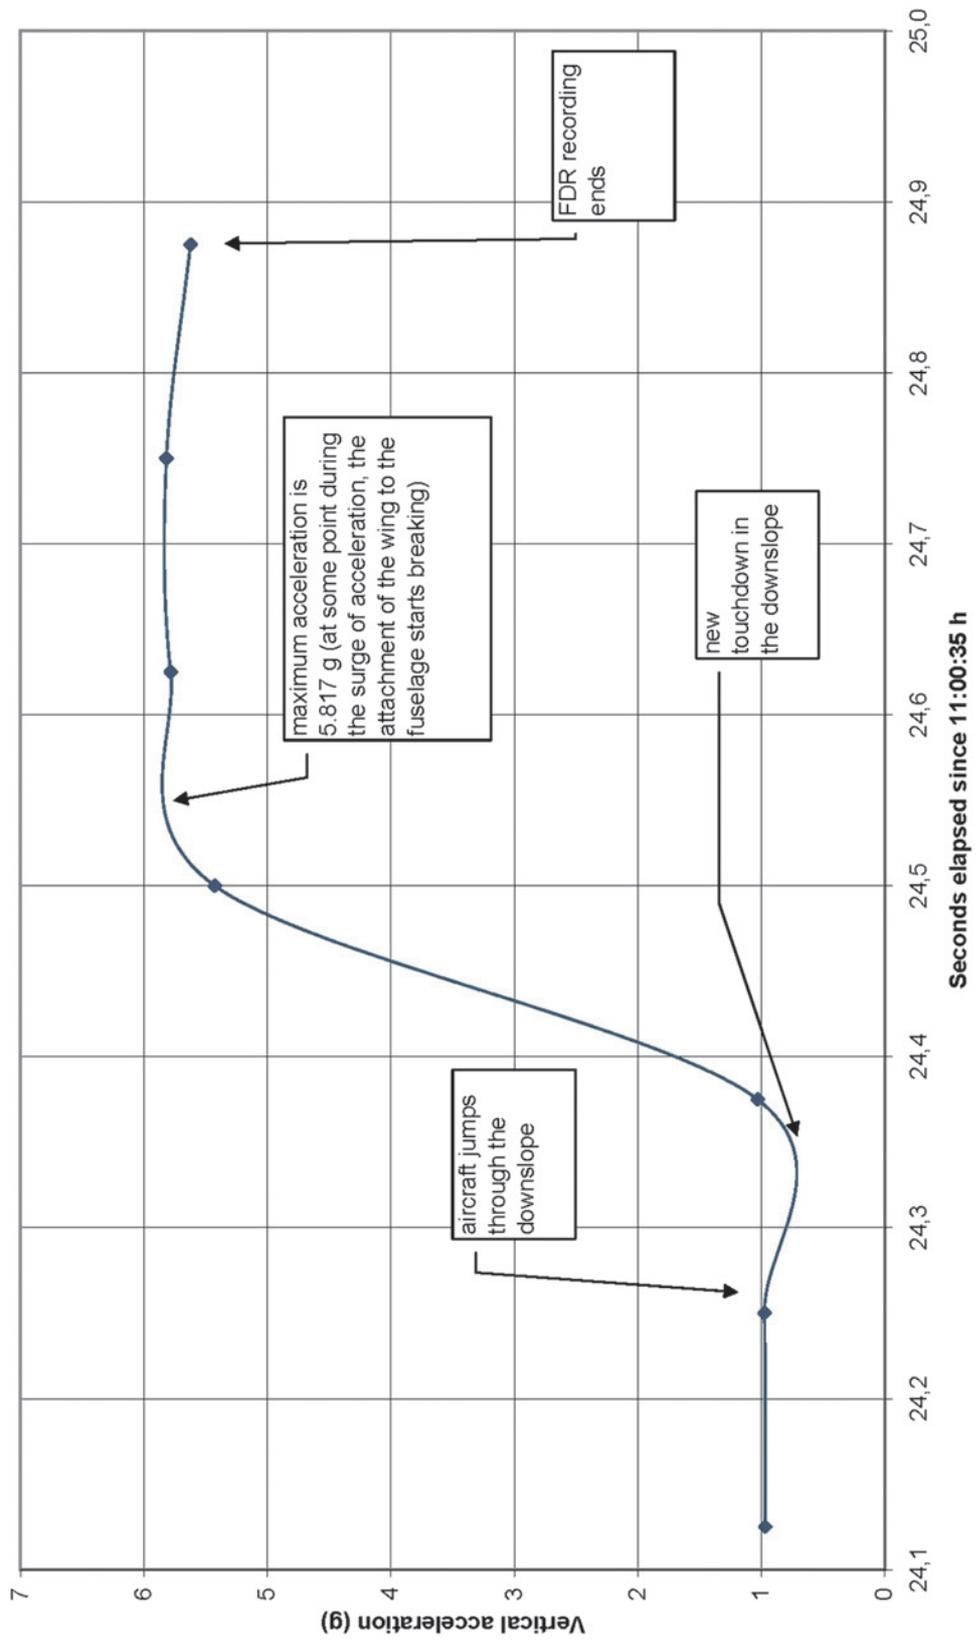
Vertical acceleration in the downslope

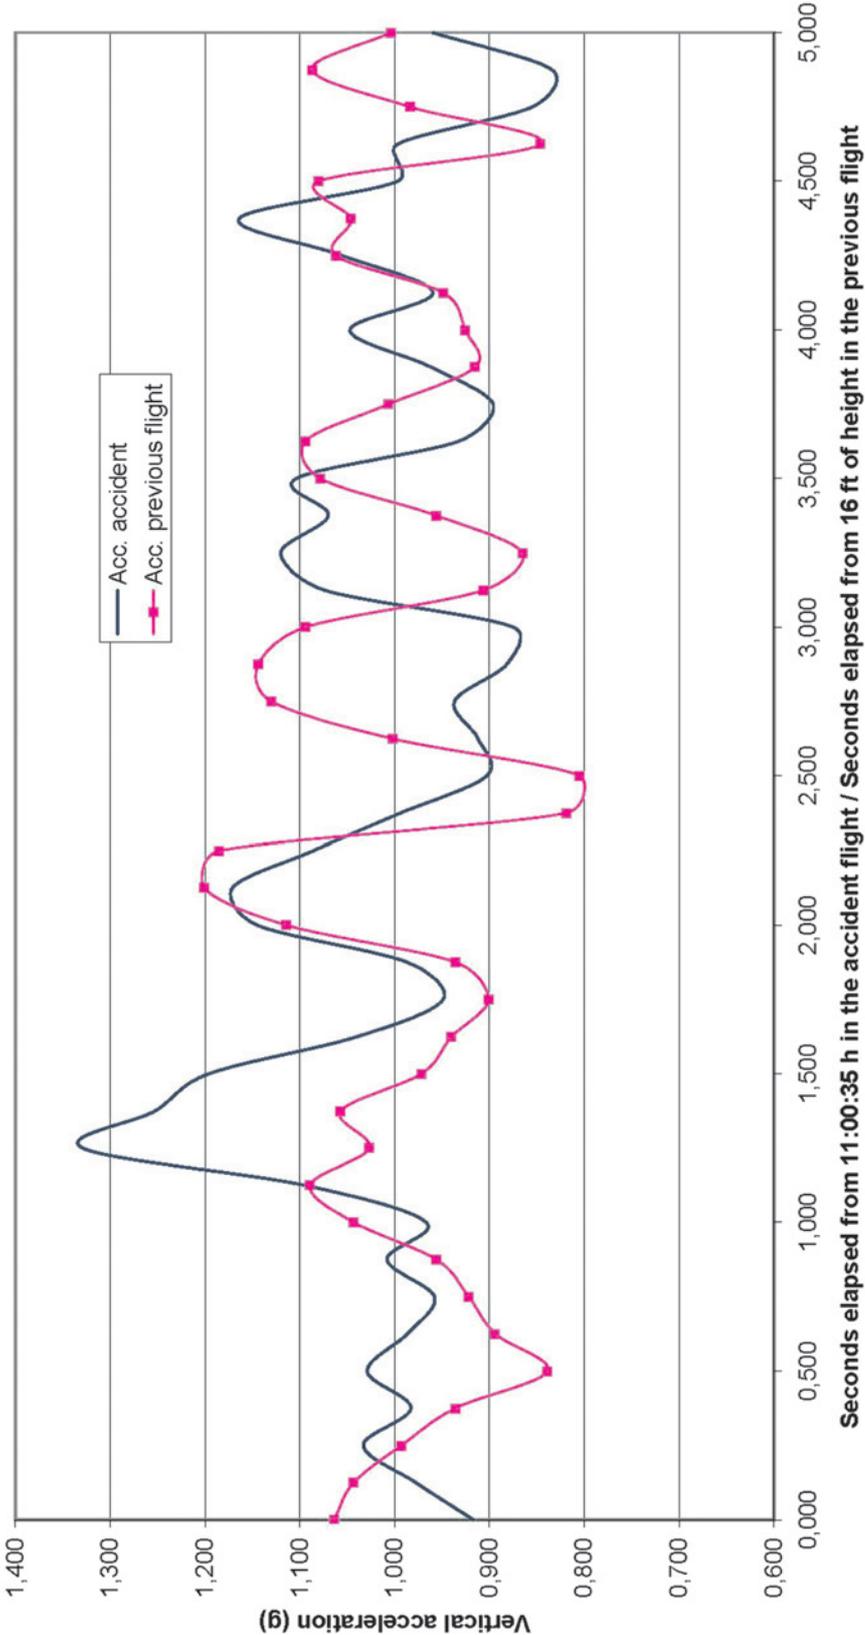
Comparison of vertical acceleration during 5 seconds around the touchdown moments in the accident flight and in the previous flight to runway 15 of Melilla

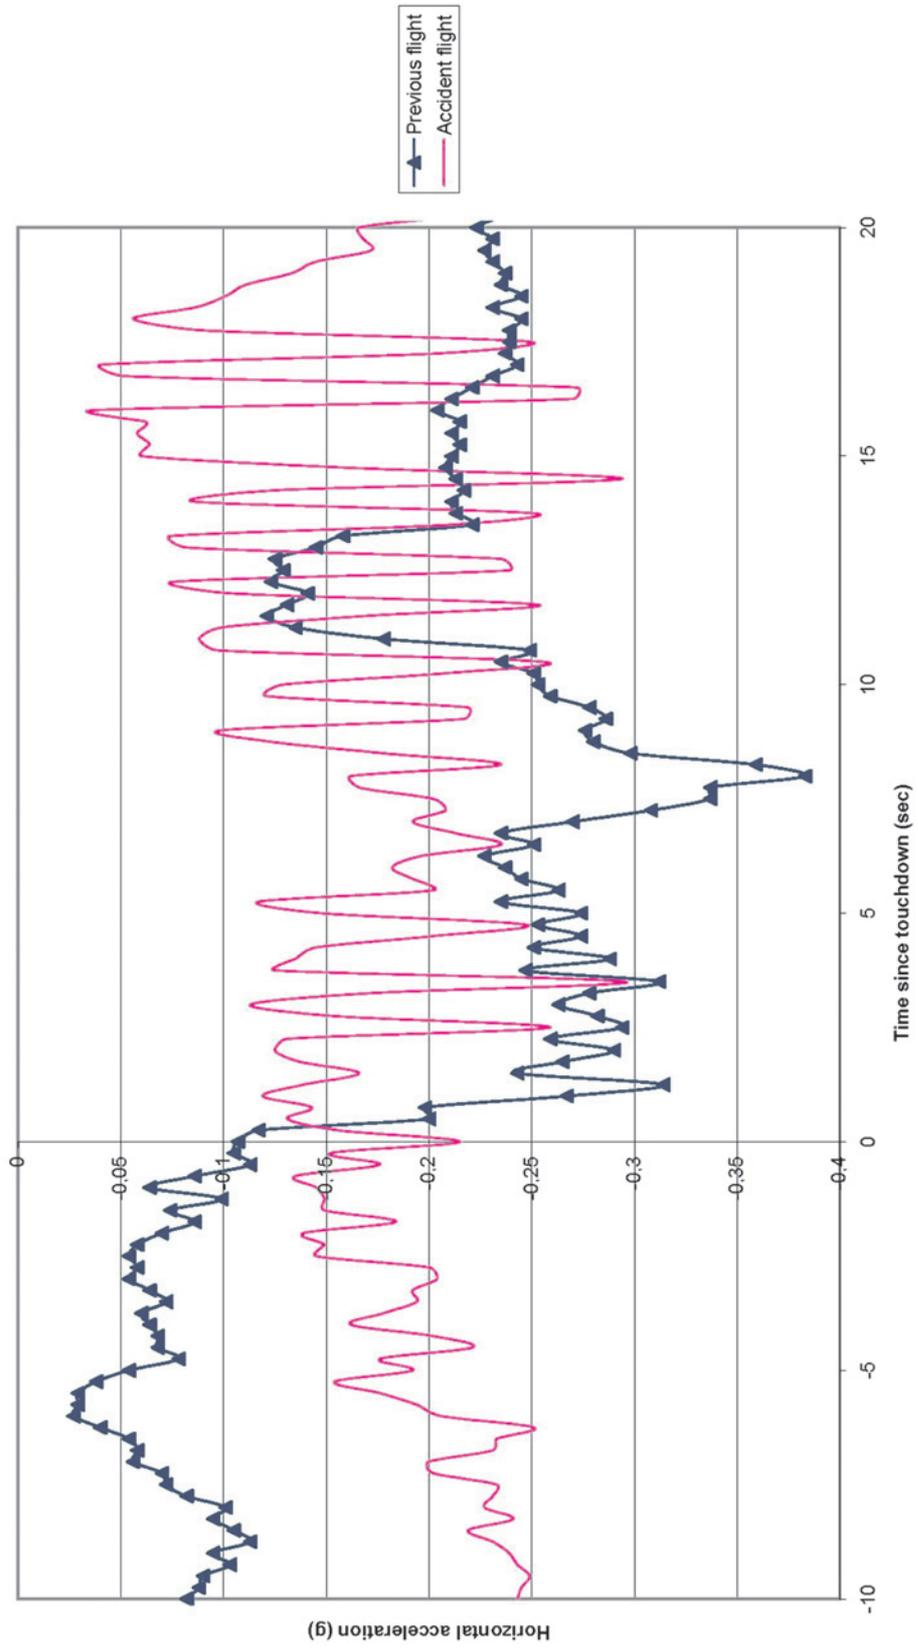
Comparison of deceleration between the accident flight and the previous flight to runway 15 of Melilla
