TECHNICAL REPORT

A-033/2003

Accident to aircraft
SOCATA TB-20
«Trinidad», registration
D-EKBI, at Alto de
Cobata-Sierra Salvada,
Amurrio (Álava-Spain),
on 27 June 2003

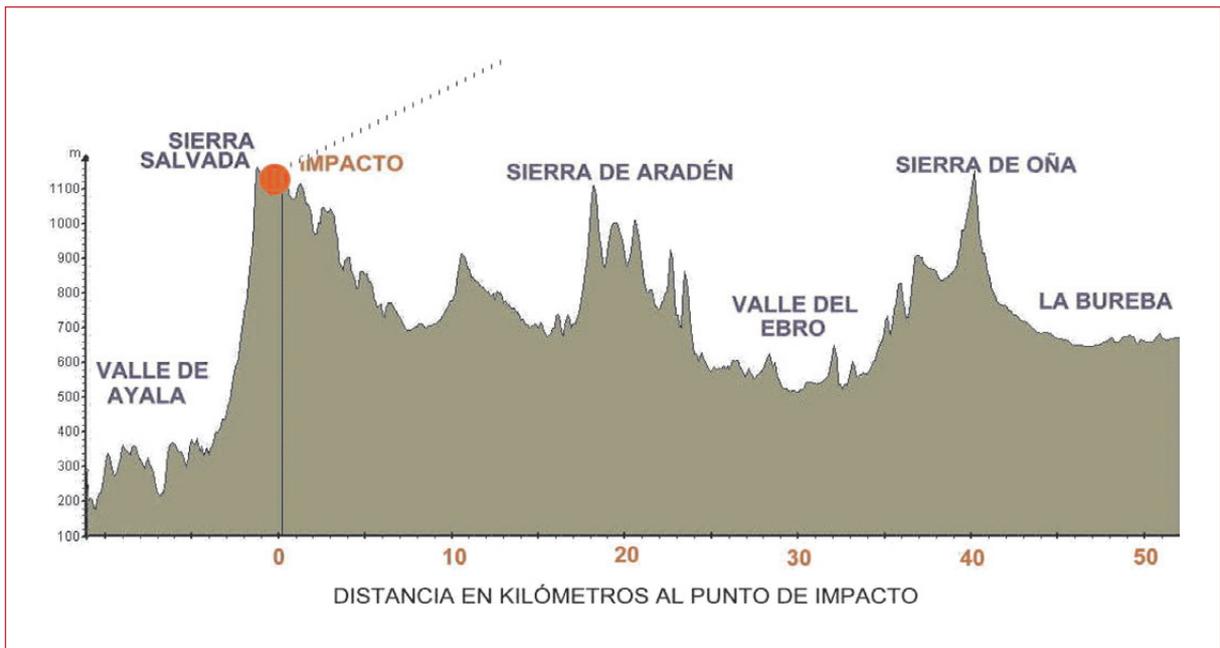
Figure A-2. Profile of the terrain on the route followed by the aircraft

20 NM (37 km) from Bilbao airport. The highest point in the profile is the Aro peak of 1,185 m, at a distance of 2 km on a NW course. Below these points the slope descends to the Ayala valley at lower levels. (See the terrain's profile in Figure A-2 and general orographic and detailed topographical maps in Figures A-1 and A-3 of Appendix A.)

The terrain's gradient at the point of impact in a S-N direction is some 22° upwards and the terrain is very stony with scrub and grazing land.
