**COMISIÓN DE  
INVESTIGACIÓN  
DE ACCIDENTES  
E INCIDENTES DE  
AVIACIÓN CIVIL**

**Report  
IN-045/2004**

In-flight engine failure  
involving a McDonnell  
Douglas MD-83,  
registration EC-FTS,  
operated by Spanair,  
on 21 July 2004  
at Alicante Airport

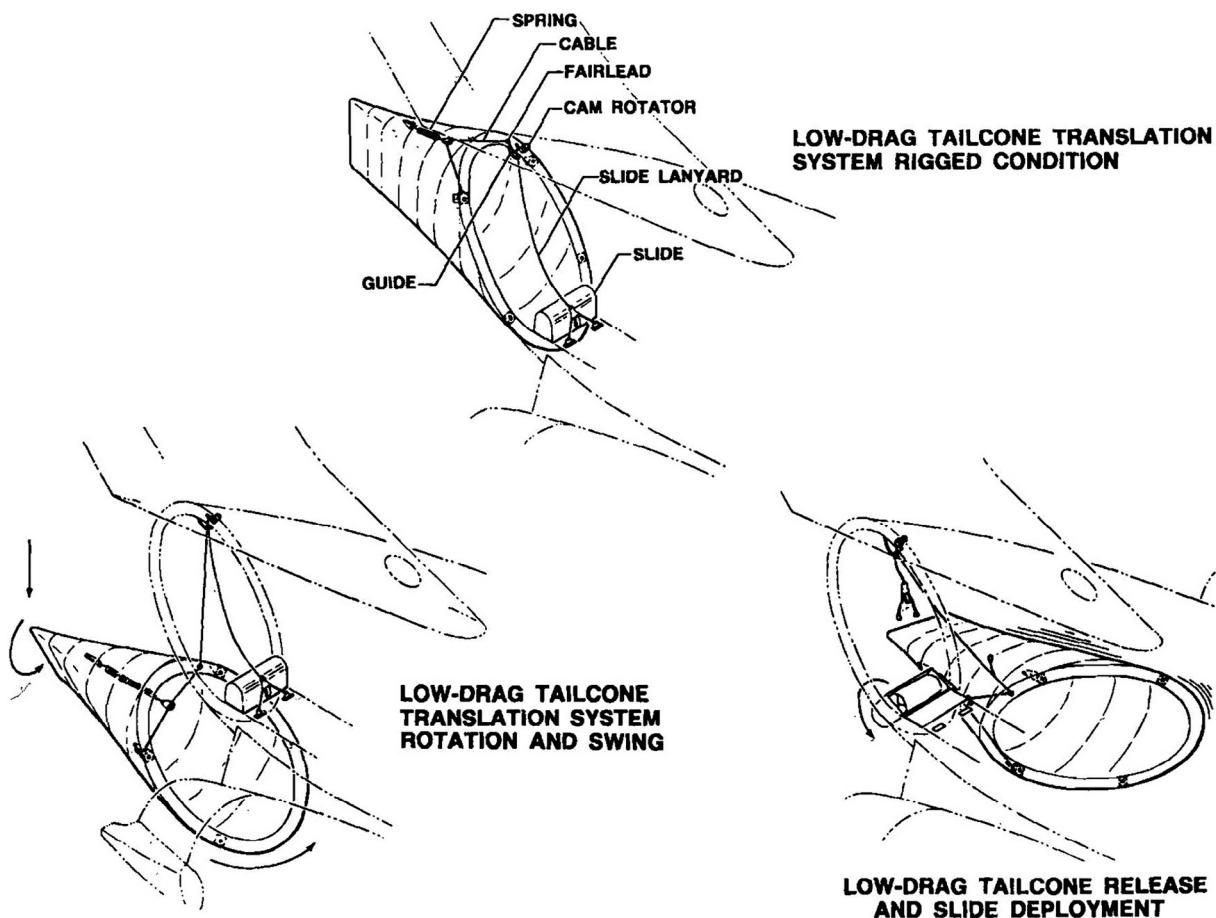
Figure 3. Low drag tailcone translation system

The command to release the tailcone and deploy the slide employs a set of clasps and cables which are attached to a bar on the door and to the clamping bolts on the tailcone and on the slide release system using various rings, velcro strips and automatic buttons. These components must be set correctly if the release command is to be properly transmitted.

During the emergency, doors 1L and 1R were opened in emergency mode, as were the four windows above the wings and the tailcone exit. Although the tailcone did release, the slide did not deploy.

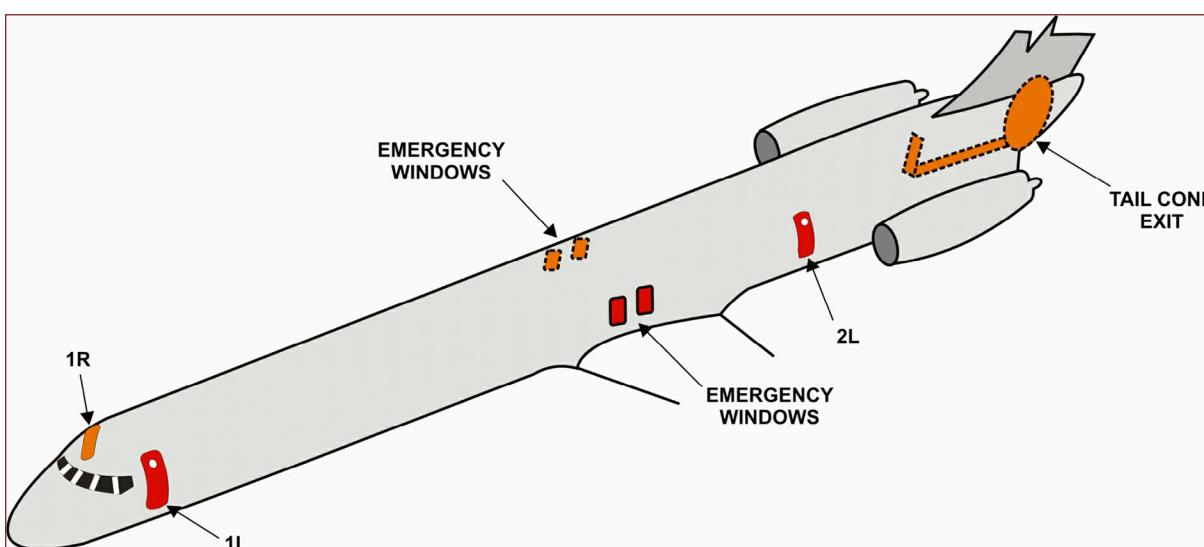
Figure 8. Emergency exits on the MD-83

The evacuation was carried out quickly, mainly via doors 1L and 1R, since the passengers did not want to jump from the windows onto the wings. Neither the tailcone nor exit 2L were used.
