**COMISIÓN DE
INVESTIGACIÓN
DE ACCIDENTES
E INCIDENTES DE
AVIACIÓN CIVIL**

**Report
A-068/2004**

Impact into the Guadalquivir
River of Agusta Bell AB-412
helicopter, with registration
marks EC-GBE, at San Juan
de Aznalfarache (Seville),
on 14 November 2004

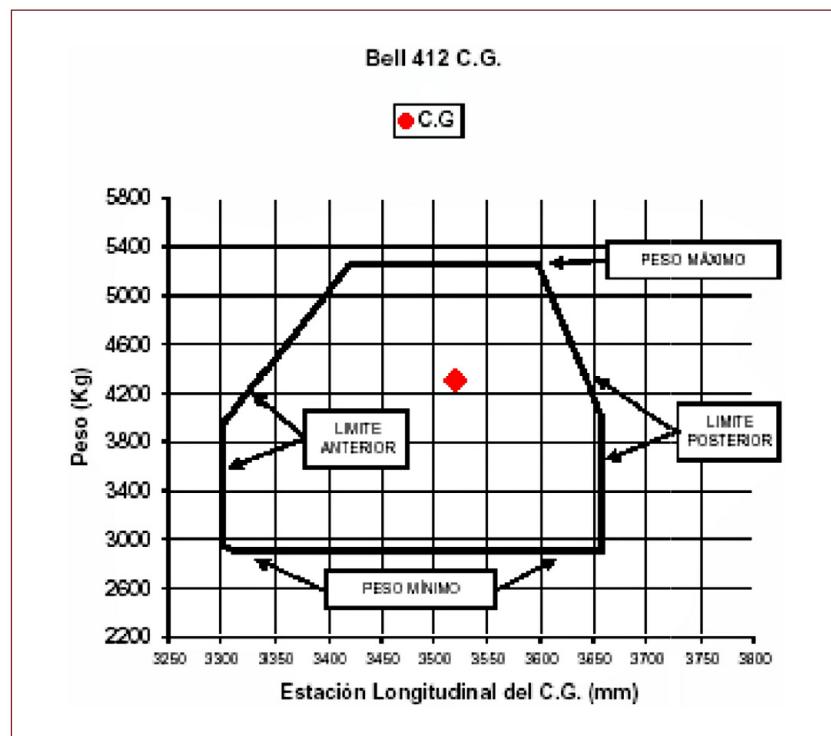
Figure 2. Longitudinal center of gravity

In accordance with the previous diagram (see Figure 2), the aircraft's weight and center of longitudinal gravity at the time of the event were within limits.

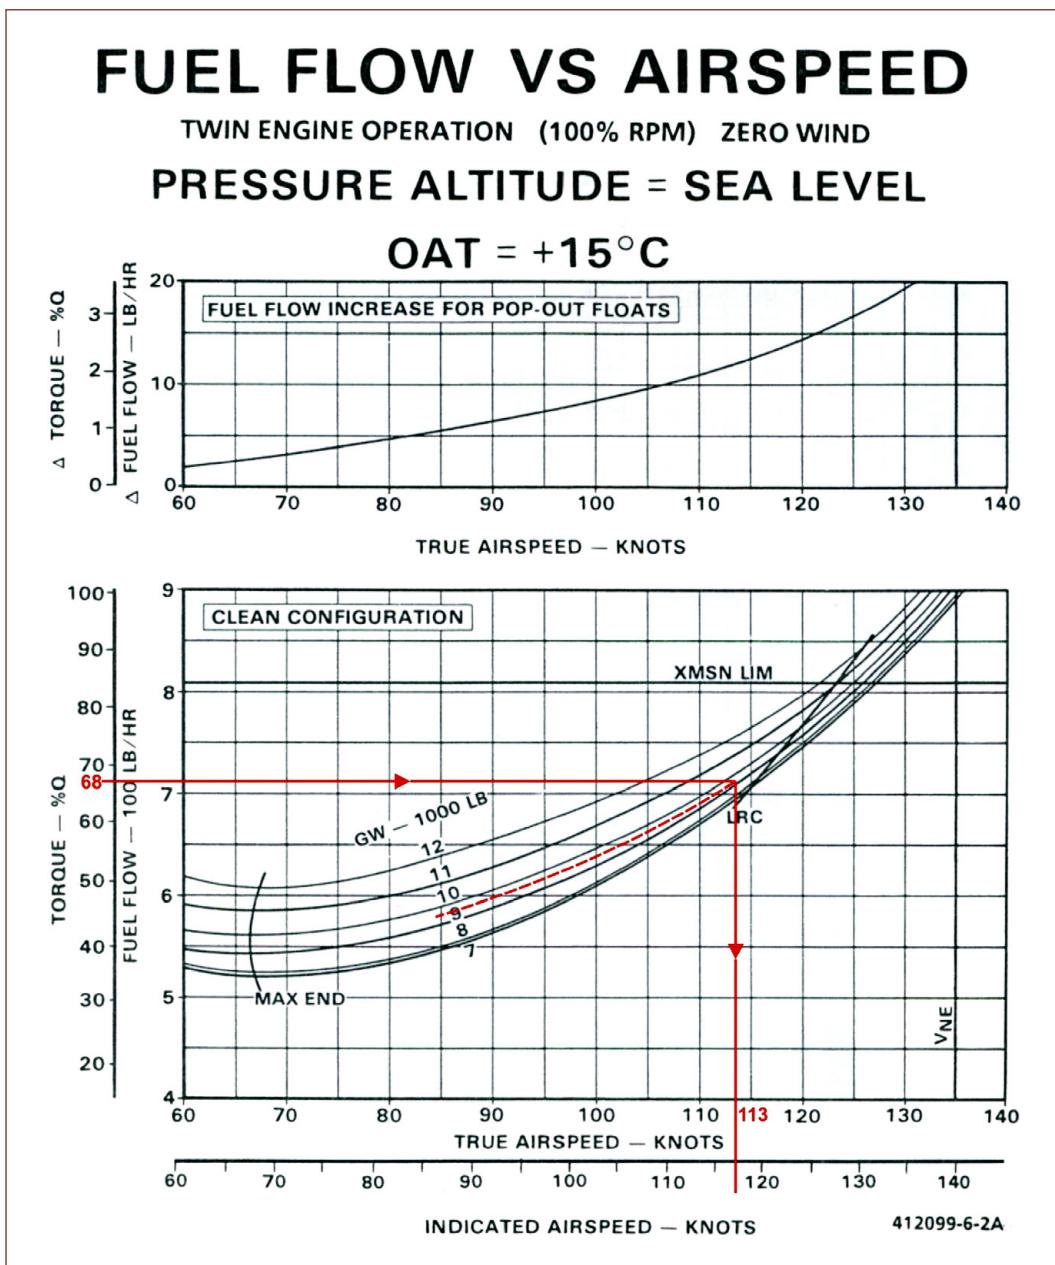
Figure 5. Chart of fuel flow versus airspeed

The above data were input to the graph (see Figure 5), with a resulting airspeed value of 113 kt.

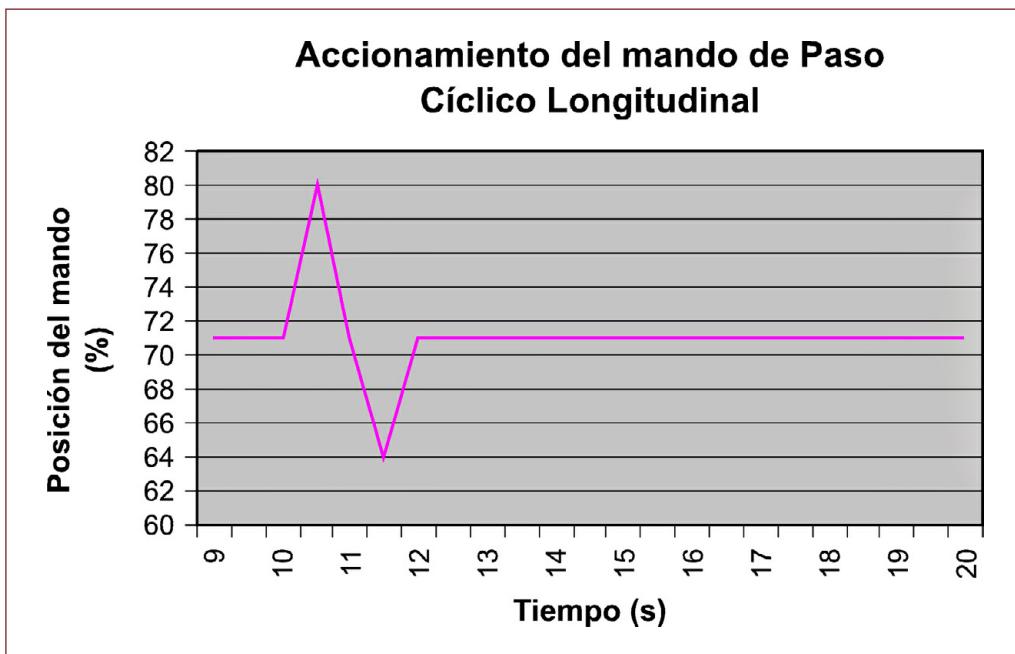
The result concluded that a 9% forward movement of the cyclic control stick and back again in one second, followed in the next second by a 7% movement backward and a return back to its original place could cause the helicopter to descend 100 ft in 10 seconds, in accordance with the profile described (not symmetrical cyclic reversal input).

At the same time it was noticed that starting from level flight, the pitch angle changed to -5° down² in the first two seconds of the descent, followed by a slow recovery to -2° in the subsequent 8 seconds. The descent velocity reached -4 m/s and was reduced to -3 m/s by the time the ground was reached (see Appendix A).
