Report A-035/2005

Accident occurred on 13
July 2005 to aircraft PZL
Swidnik W-3AS Sokol,
registration SP-SUB,
operated by Hispánica
de Aviación in Tineo
(Asturias-Spain)

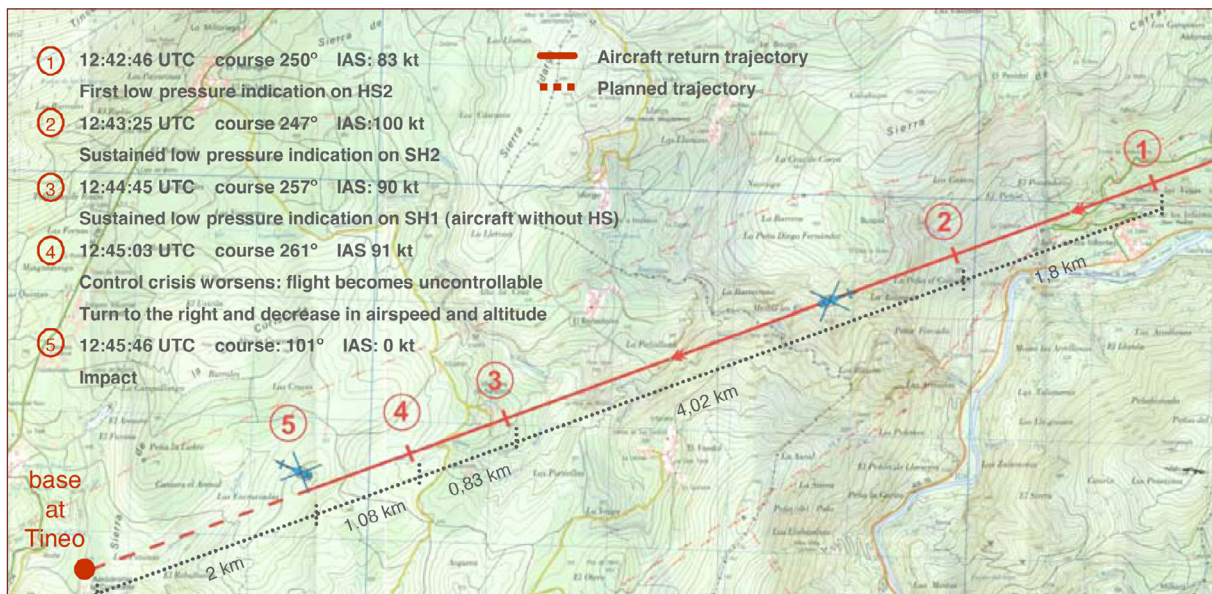
The aircraft finally impacted the ground at 12:45:46 UTC. The ground sensor had indicated initial contact 3 seconds before. The last recorded value for the heading was 101° with a 0 kt IAS. During the last few seconds prior to the accident, the FDR recorded a roll attitude of up to 20° to the right and 25° nose up, though the impact took place with a 22° left roll attitude and a 9° nose down angle.

Figure 2. Trajectory during the last 3 minutes of the flight

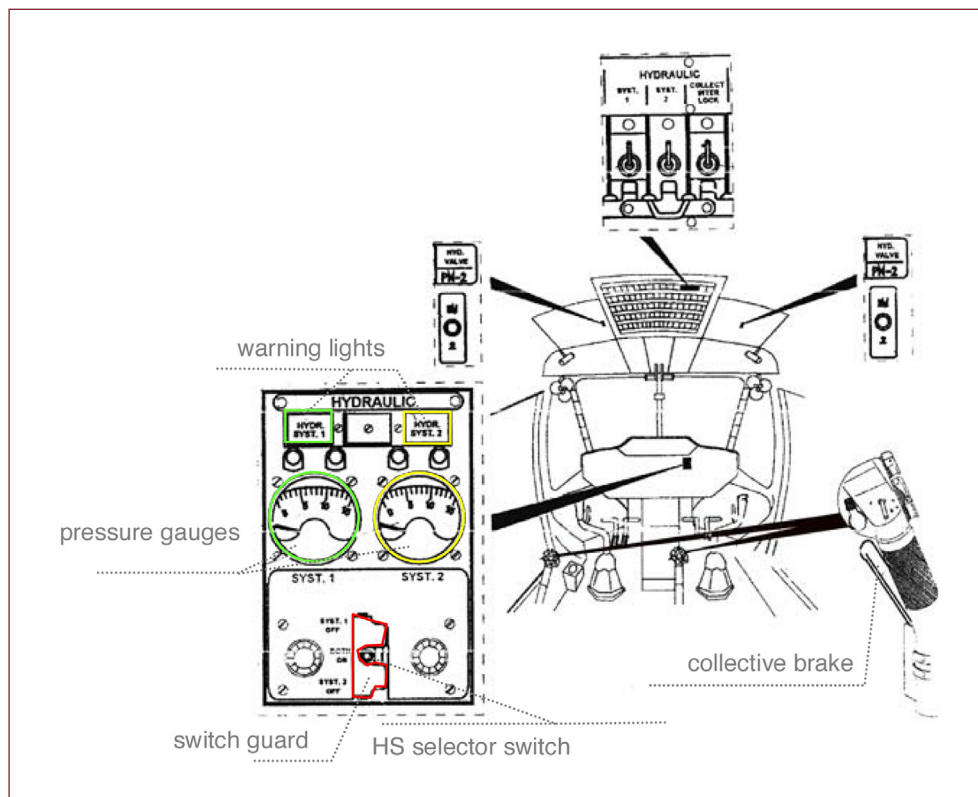
Figure 7. HS controls in the cockpit

Although both systems are normally in operation, there is a selector switch in the cockpit (figure 7) which allows both systems to be in operation (BOTH ON) or for one of them to be disconnected (SYST 1 OFF by flipping the switch up or SYST 2 OFF by flipping the switch down). Under normal conditions, both systems are selected, although there is sufficient hydraulic pressure to operate the actuators, and thus the helicopter controls, with just one system in operation. The same panel where the HS selector switch is located also houses two hydraulic system pressure indicators, which give information on each system's pressure, and two warning lights. The normal operating pressure is between 90-110 kg/cm². A drop in pressure to 70 kg/cm² will be reflected by the pressure gauge as well as by the warning light.

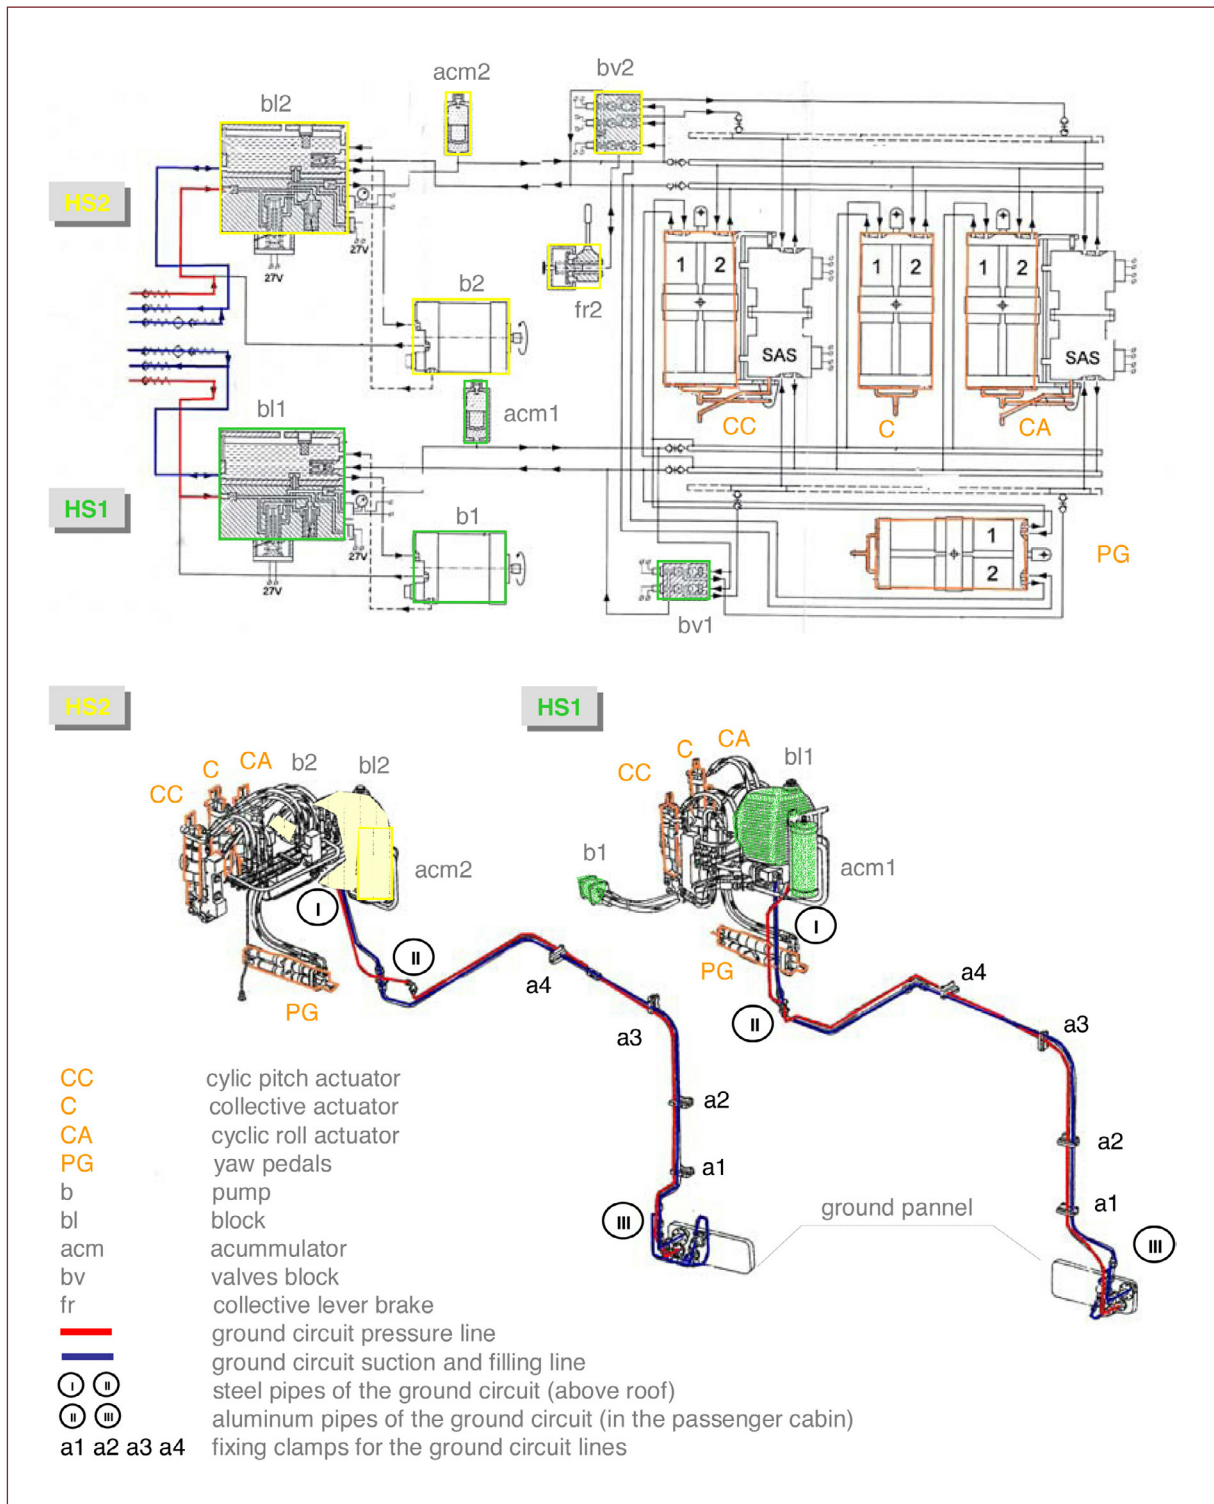
Figure 8. HS layout and distribution in the W-3AS

In addition to the main components described in the previous paragraph, each hydraulic system has a ground servicing circuit made up of two lines (a pressure line and a filling/suction line) which connect the lower part of the block with the ground panel located in the right rear of the main fuselage. Each ground circuit line has three pipes bundled together and arranged as follows: section I-II in figure 8 (made up of one pipe) goes from the block to the roof and section II-III in figure 8 (made up of two pipes) starts in the roof and runs along inside the passenger cabin.

The installation and piping run of the hydraulic system indicate that the only event that would explain a loss of hydraulic fluid in the area of the passenger cabin as described by the pilot in his statement is a break in the ground circuit's first section, which is beneath the overhead just before clamp 4 (figure 9). The intermittent pressure fault in HS2, which over the course of 39 seconds became sustained, as shown by the FDR, is
