**DATA SUMMARY**

Date and time	<b>Sunday, 16 October 2005; 13:15 h UTC<sup>1</sup></b>
Site	<b>Flight level 280 approximately 40 NM away from VOR Zaragoza</b>

Registration	<b>HA-LOM</b>	<b>EC-HAF</b>
Type and model	<b>BOEING 737-800</b>	<b>AIRBUS 320-214</b>
Operator	<b>Malév Hungarian Airlines</b>	<b>Iberia</b>

**REPORT**

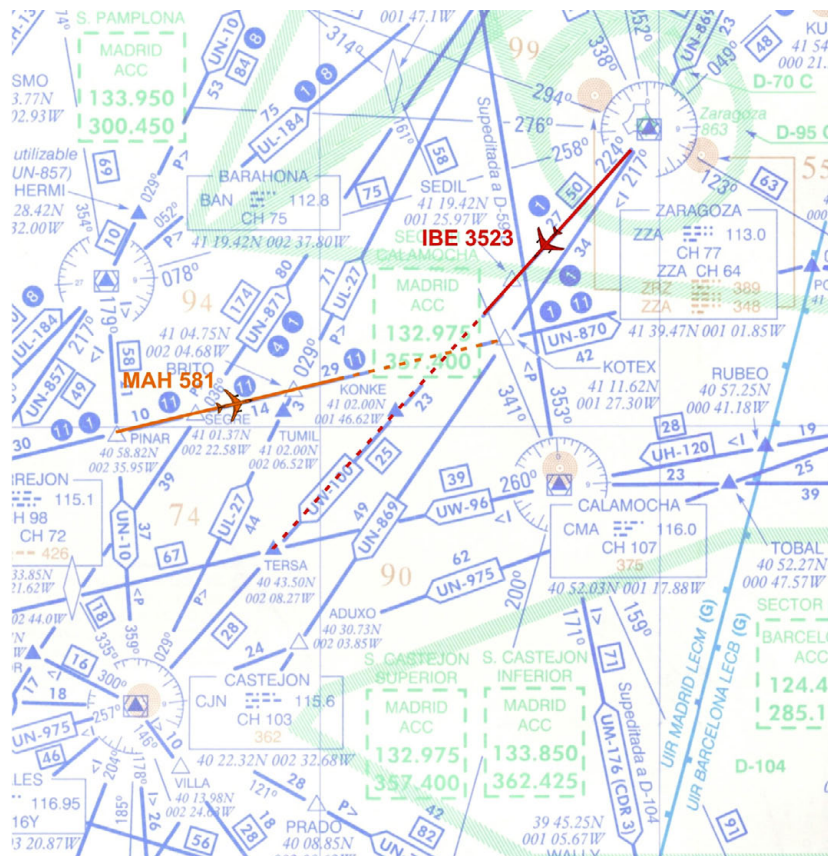
Figure 1. Planned routes for the two aircraft

Aircraft MAH 581 was climbing away from LEMD on airway UN-870 on a heading of 080° (see Figure 1), although at the time of the incident it was in level flight at FL 280. Aircraft IBE 3523 was descending toward LEMD on airway UW-100 on a heading of 240° and on standard terminal arrival route (STAR) TERSA ONE BRAVO.
