DATA SUMMARY

Date and time	Monday, 9 January 2006; 09:00 h UTC
Site	Barcelona-El Prat Airport

Registration	EC-GAT
Type and model	MD-83
Operator	Spanair

Operation	Commercial air transport – Scheduled – Domestic – Passenger
Phase of flight	Landing

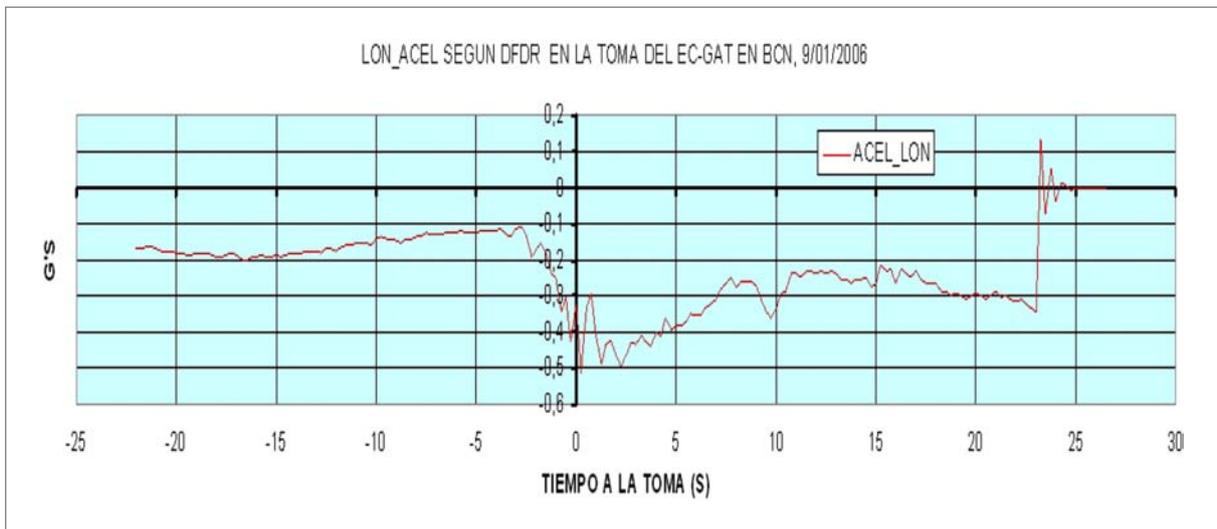
Figure 10. Longitudinal acceleration

The following two graphs show, after a rearranging of the data, the variation in the longitudinal and lateral accelerations, which are taken and logged by the DFDR four times per second.

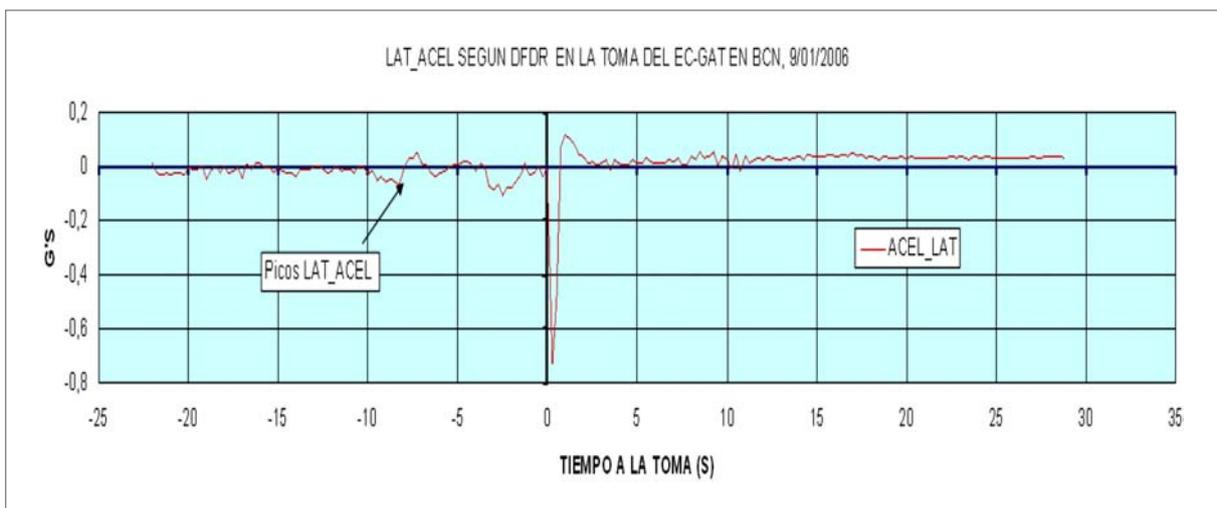
Figure 11. Lateral acceleration

3. The oscillations in lateral acceleration (see Figure 10) during the approach became more pronounced at $t = -8$ s. This can be attributed to forces in the nose gear while the main gear was still not on the ground.

The recording for the lateral acceleration (Figure 10) shows a high value to the left of 0.727 g's instants before touchdown, at $t = 0.25$ s, which corresponds to the turn in the trajectory seen in the photograph of Figure 1.9.1.

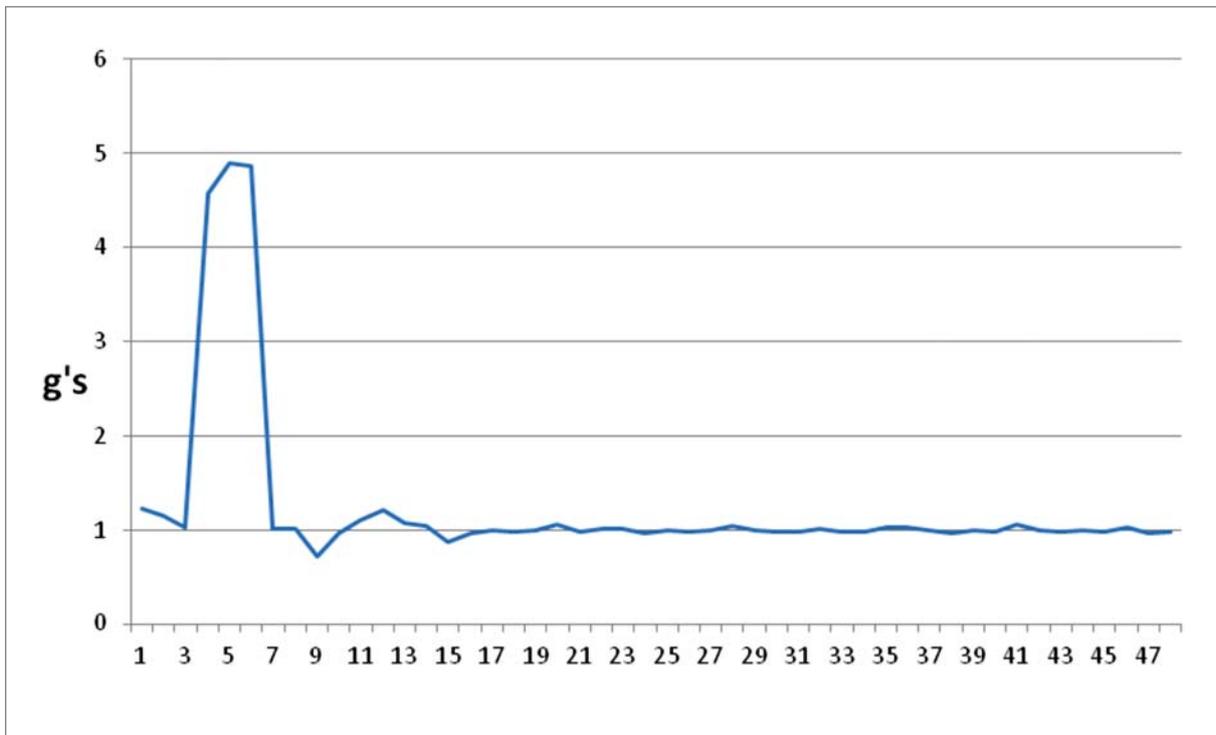
Figure 12. Vertical acceleration

The trend in the parameters for the lateral and vertical accelerations is shown in numerical table form in Appendix A, along with the values for aerodynamic speed, magnetic direction, pitch angle, engine rpm's and fuel flow, among others.
