**DATA SUMMARY**

Date and time	<b>Thursday, 8 September 2006; 22:00 h (UTC)</b>
Site	<b>Madrid-Barajas Airport</b>

Registration	<b>A7-ABV</b>
Type and model	<b>AIRBUS 300-600 (B4-622R) MSN 690</b>
Operator	<b>Qatar Airways</b>

Operation	<b>Scheduled – International – Passenger flight</b>
Phase of flight	<b>Taxi prior to takeoff</b>

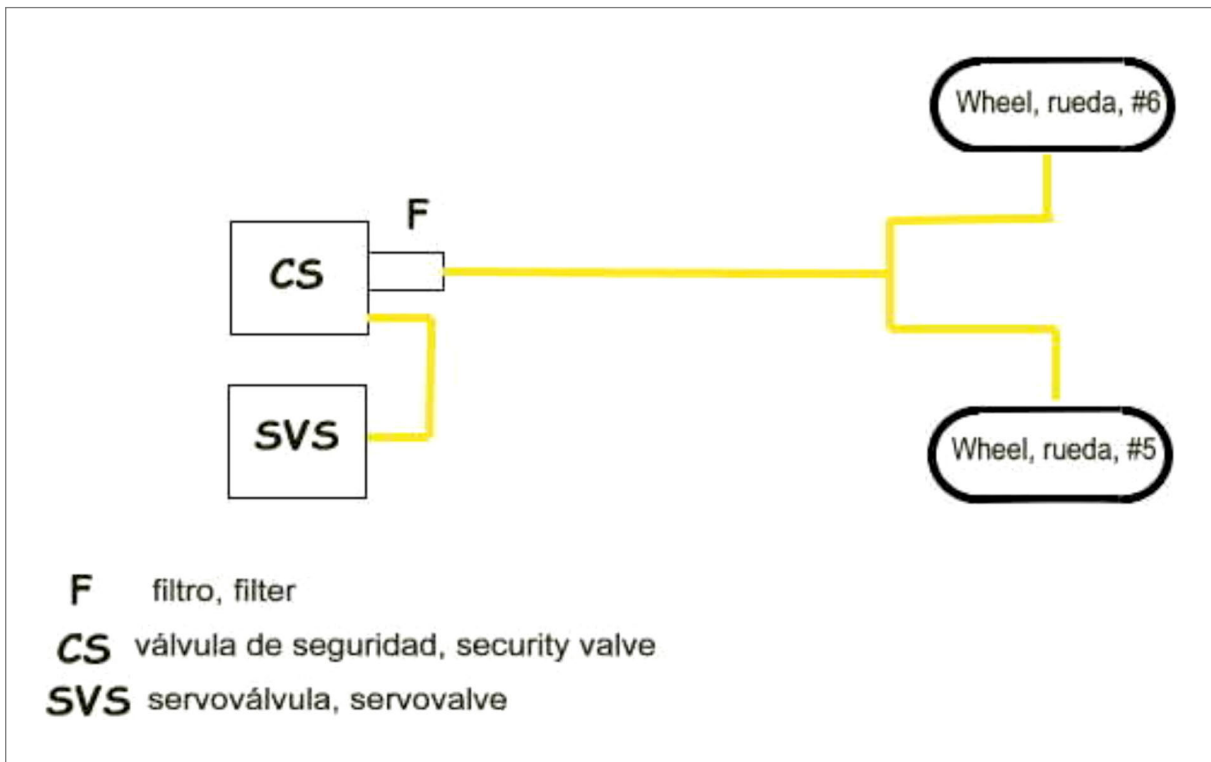
Scheme alternate brake system

The thermocouples for measuring the brake temperatures are housed inside the brake packs, which function as a heat sink.

This airplane was not equipped with wheel cooling fans.

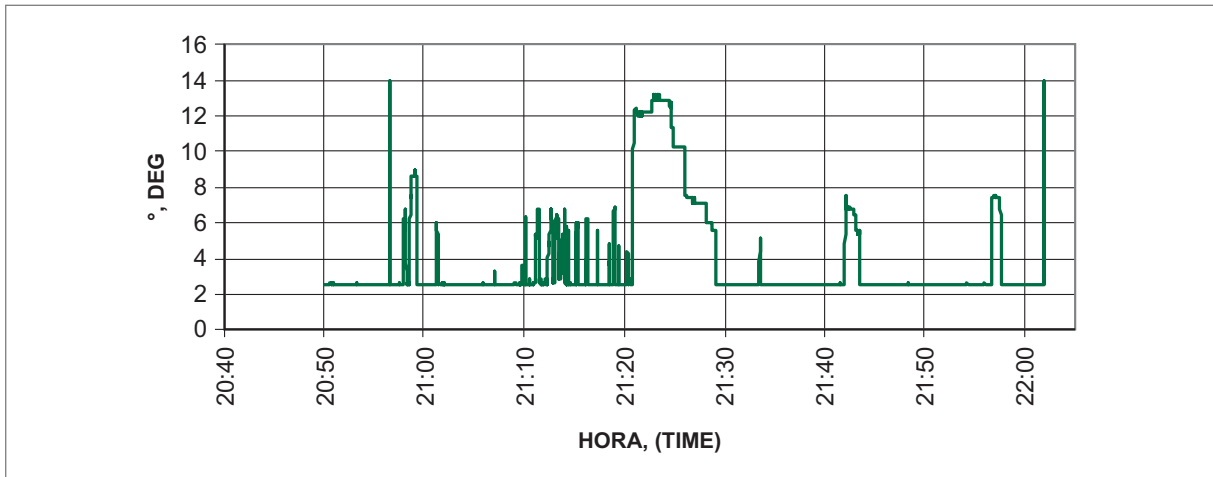
RH brake pedal

Lastly, the two graphs that follow show the engine power levels used to taxi. At no time was thrust in excess of 1.08 EPR used and the two engines were used simultaneously.
