**DATA SUMMARY**

Date and time	<b>Tuesday, 16 January 2007; 15:30 local time<sup>1</sup></b>
Site	<b>Tenerife South Airport</b>

Registration	<b>G-VCED</b>
Type and model	<b>AIRBUS 320</b>
Operator	<b>My Travel Airways</b>

Aircraft	<b>None</b>
Third parties	<b>Collapse of the platform on the boarding vehicle</b>

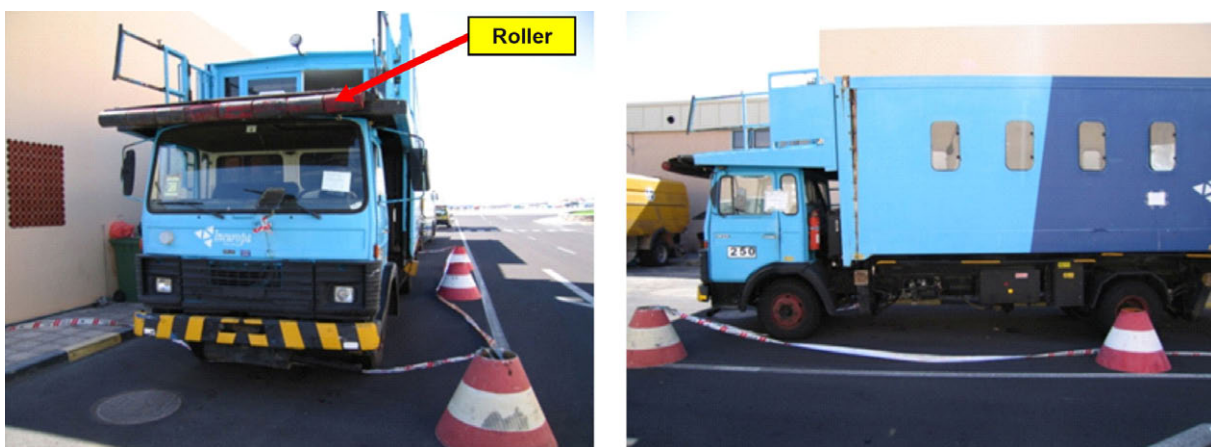
Figure 2. Front and side views of the vehicle

The platform that detached was fixed to the cabin of the passenger truck by a frame that was fastened by twelve rivets along the top horizontal part and another twelve on the sides, eleven of which were aligned vertically, with the twelfth forming a triangle with the two rivets at the top and in front of them. All were so corroded that some had completely worn away, while only the head remained of others. The rivets were nailed to the passenger cabin's wooden beams, which had completely rotted.

The vehicle's overall condition was one of advanced deterioration, as evidenced by the corrosion on the metal components and the rotted wood. Corrosion was clearly visible along a solder line on a bar used as a handrail on the side of the rear platform. The truck's passenger cabin was mounted atop a trestle that had four crossbeams along its length. A significant amount of material was missing from several of the crossbeam-trestle unions due to corrosion, such that some of the supports were exposed to the air, as shown in Figure 5. The vehicle's undercarriage, both in the driver's and passenger cabins, exhibited corrosion and a shortage of material.

the platform was within its load limit under normal circumstances, and that the collapse was due to the advanced deterioration of the anchor and support points.
