1. FACTUAL INFORMATION

On 23 February 2008, a SIKORSKY S-61N helicopter, registration EC-FVO, based at the A Coruña Airport as the "Helimer Galicia", was dispatched at 20:14 to take part in the search for a body that had been sighted floating in the vicinity of the south part of the Playa de San Jorge (San Jorge Beach, Ferrol, A Coruña).

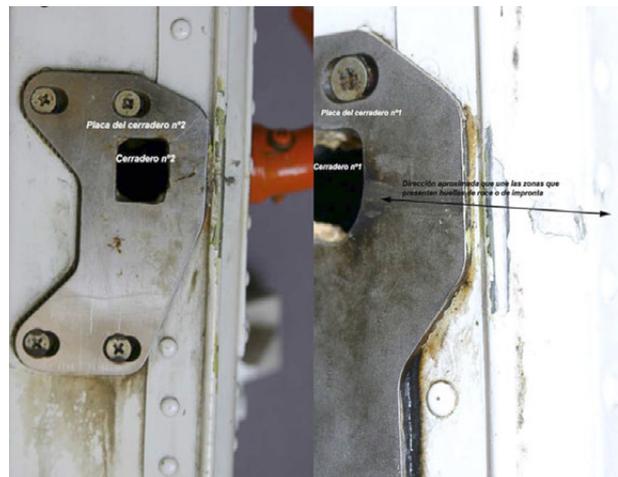
Photograph 10

There is no general deformation of the hinged portion of the helicopter door. In general, most of the damage noted on the structure corresponded to friction marks and imprints on the cylindrical rod located between the outer sheet metal and the outer sheet metal
