**DATA SUMMARY**

Date and time	<b>Wednesday, 5 March 2008; 08:25 local time<sup>1</sup></b>
Site	<b>Yaiza (Island of Lanzarote)</b>

Registration	<b>EC-FJV</b>
Type and model	<b>AEROSPATIALE AS-350B2</b>
Operator	<b>Helicópteros Insulares, S. L.</b>

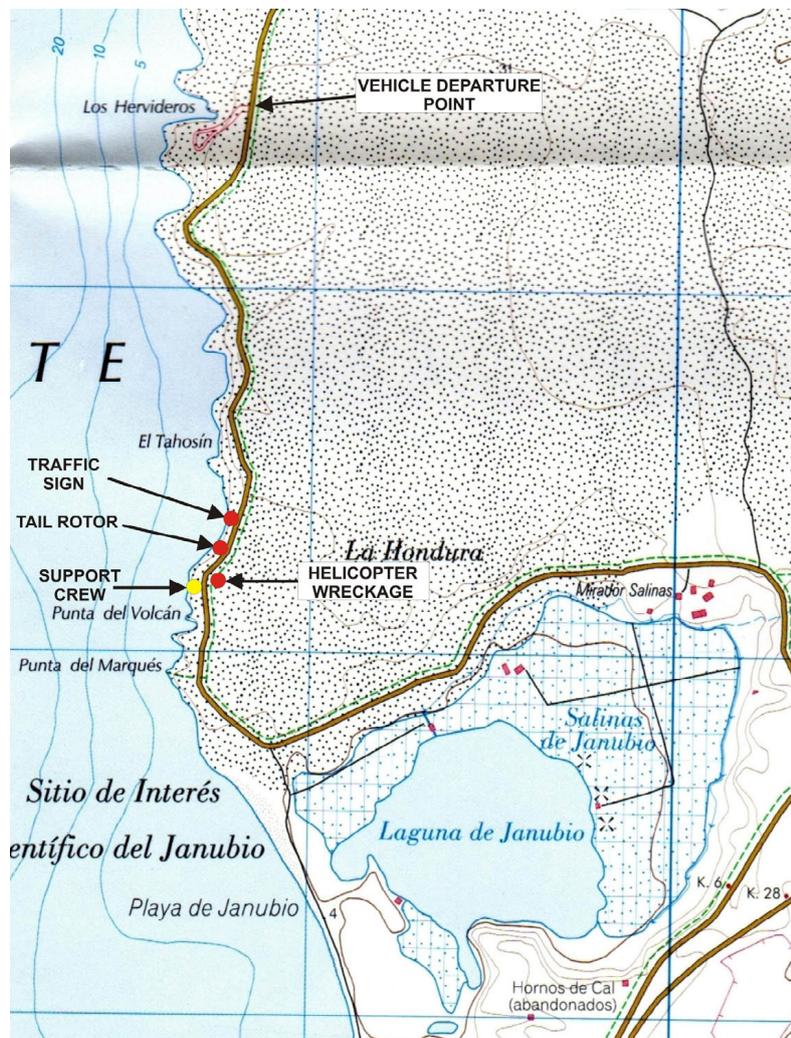
Figure 1. Map of the area

Figure 1 shows where the vehicles departed from, and their destination, which is where the ground support crew was located, the location of the traffic sign against which the tail rotor impacted, as well as the final location of the tail rotor and main aircraft wreckage.
