DATA SUMMARY

Date and time	Monday, 23 June 2008; 13:20 h¹
Site	4.5 km west of the Madrid-Cuatro Vientos Airport

Registration	EC-GCX
Type and model	CESSNA 177 RG "Cardinal"
Operator	Private

REPORT

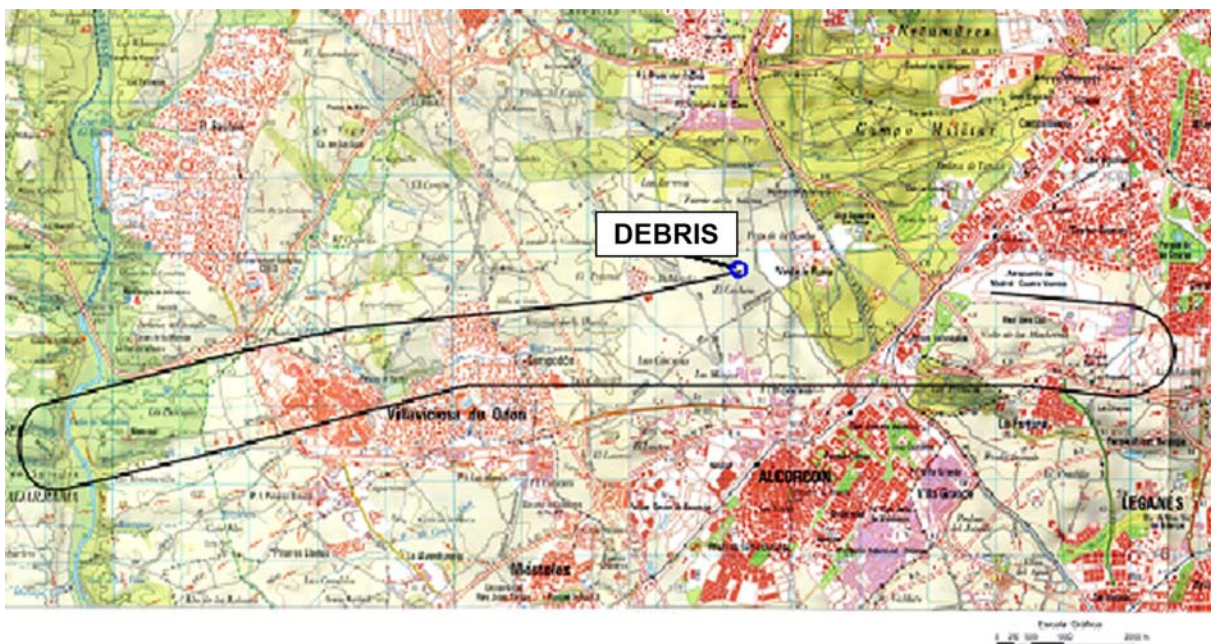
Figure 1. Estimated trajectory

The aircraft took off at 13:10 from runway 10, entered the circuit with the runway to the right, and departed it via point W, which is located above Villaviciosa de Odon. The pilot then headed toward Aldea del Fresno to carry out the scheduled tests. At 13:14, with the airplane 3 NM west of Villaviciosa de Odon and flying at an altitude of 4,000 ft, the pilot notified the control tower at Madrid-Cuatro Vientos that he was experiencing engine problems and requested to return directly to the airport. After being cleared to proceed directly to runway 10 he initiated the trip back at 13:15. The controller in the tower asked the pilot if he was declaring an emergency, to which the latter replied no. He then asked the pilot if he had a suitable landing site in sight. This time the pilot replied in the affirmative and that he was already landing. It was about 13:20.

Figure 1 shows the aircraft's path overlaid on a map of the area as determined by the radar data recorded by ATC stations.
