DATA SUMMARY

Date and time	4 September 2008; 15:38 UTC¹
Site	Seville Airport

Registration	F-GLEC
Type and model	AEROSPATIALE SN-601 Corvette S/N: 30
Operator	Airbus

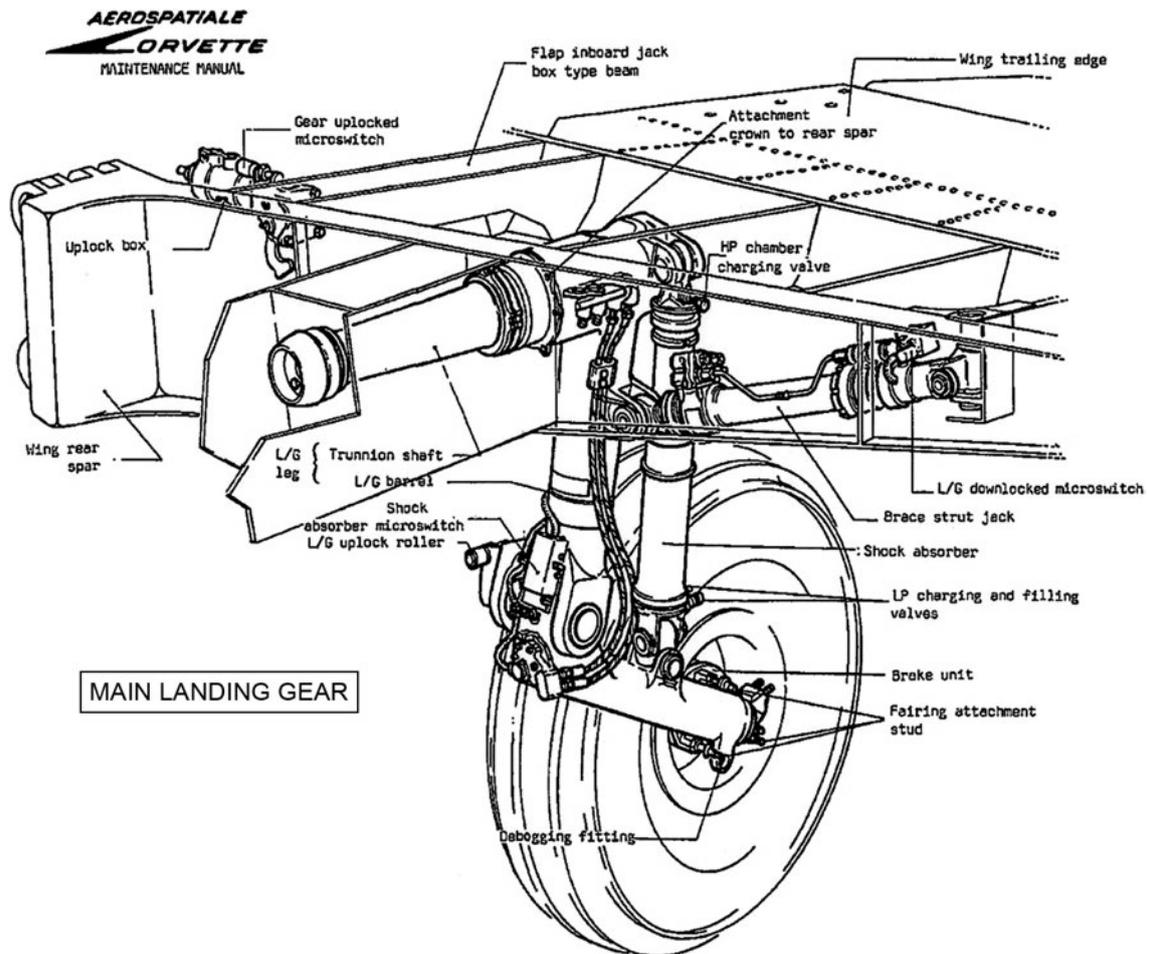
Figure 3. Diagram of main landing gear

The landing gear is a tricycle retractable design with a single wheel on each leg (Figure 3).

The main gear legs are hinged. Shock absorption is achieved by means of oil-pneumatic struts outfitted on each leg.

The gear is lowered and raised by means of a hydraulic actuator. In its full down position, the actuator activates a micro-switch that provides the "gear down and locked" signal. The "gear up and locked" signal is provided by another micro-switch that is engaged by the mechanical locking mechanism that is activated when the leg is housed in its compartment under the wing.

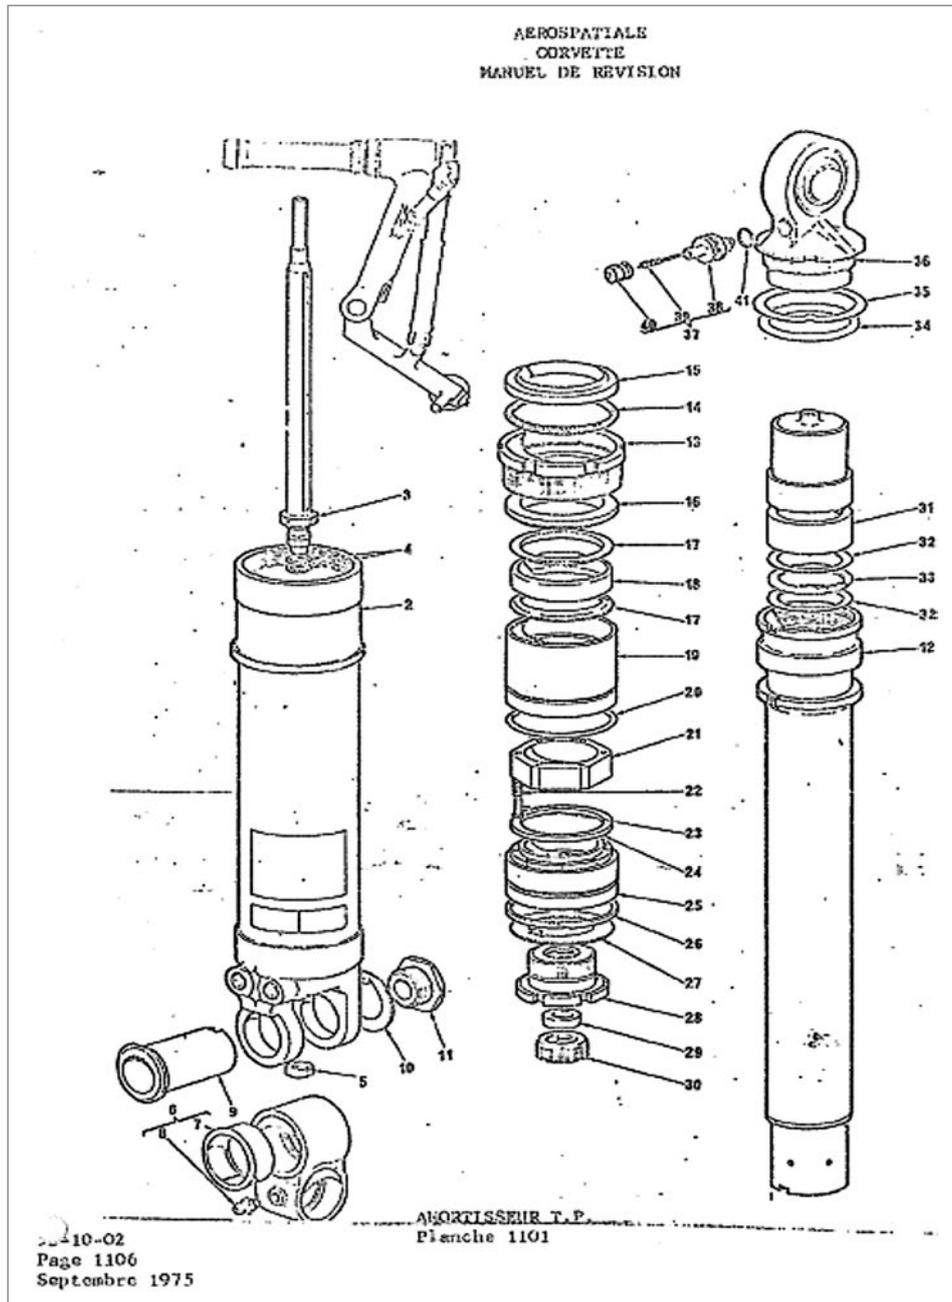
Figure 4. Parts of main gear shock absorber

The shock absorbers (Figure 4) consist of an outer cylinder and a hollow piston, or inner cylinder, that moves inside the outer cylinder (items no. 2 and no. 1). The inside of the piston is in turn divided into two chambers separated by an intermediate piston (item no. 31). The upper chamber is at high pressure (212-bar load pressure), and the lower chamber is at low pressure (41-bar load pressure).

The sealing assembly (seals, bearings and segments) attached to the outer cylinder was mounted in its correct position and held in place by the proper nut (item no. 13). The corresponding components on the inner piston, however, held by nut no. 28, had come loose and detached from the piston, falling to the bottom of the outer cylinder.

The nut used to hold the set of seals, bearings and segments firmly in place inside the inner cylinder (item no. 28) did not exhibit any marks or damage, either to the body or threads.
