DATA SUMMARY

Registration	EC-DMR
Type and model	CESSNA F-172-RG
Operator	Top Fly

Operation	General Aviation – Instruction
Phase of flight	Landing

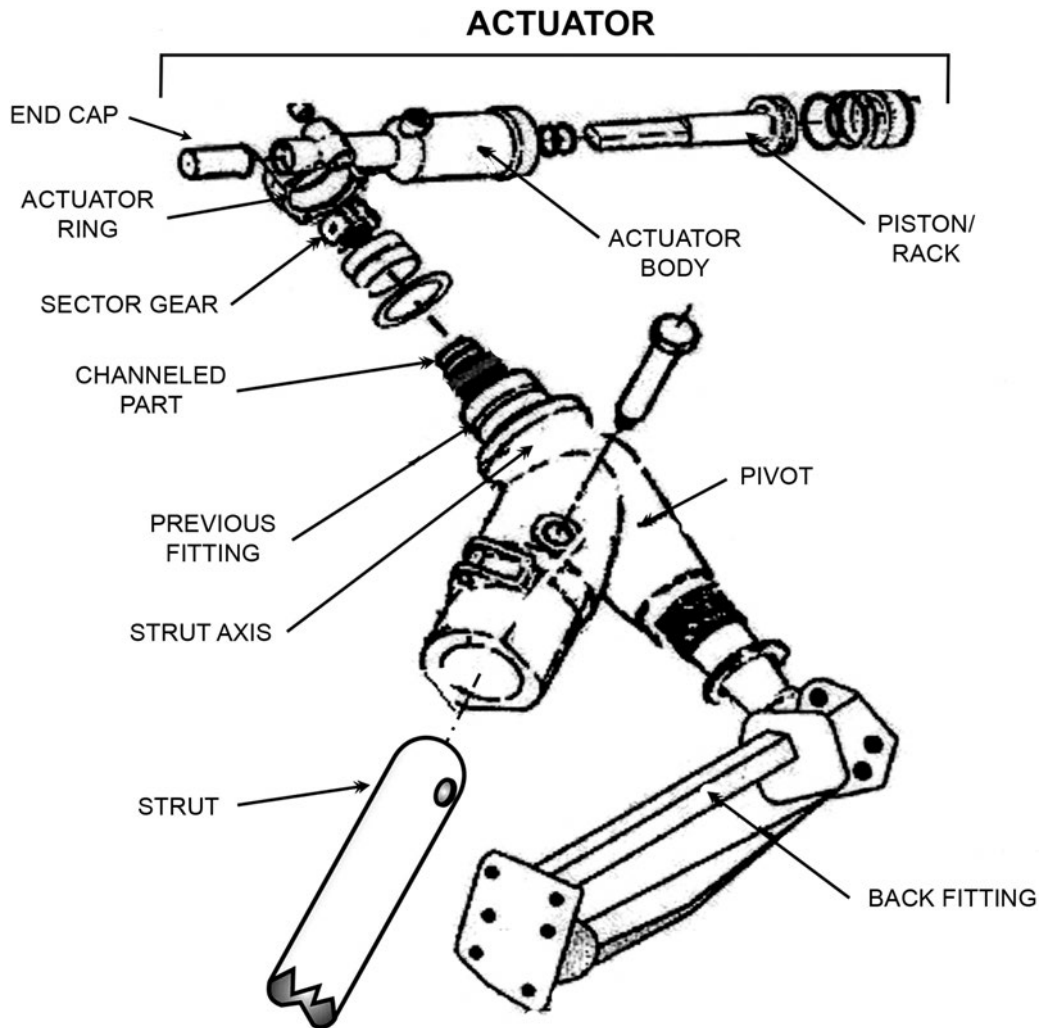
Figure 4. Leg actuator and pivot

A toothed piston that moves inside the actuator meshes with the circular section, allowing the pivot, and thus the gear leg, to move. See Figures 3 and 4.

Figure 4 shows a close-up of the gearing between the toothed piston and the toothed circular section.
