DATA SUMMARY

Registration	OE-KPC
Type and model	CESSNA TU 206 F
Operator	Private

Type and model	THIELERT, Centurion 4.0
Number	1

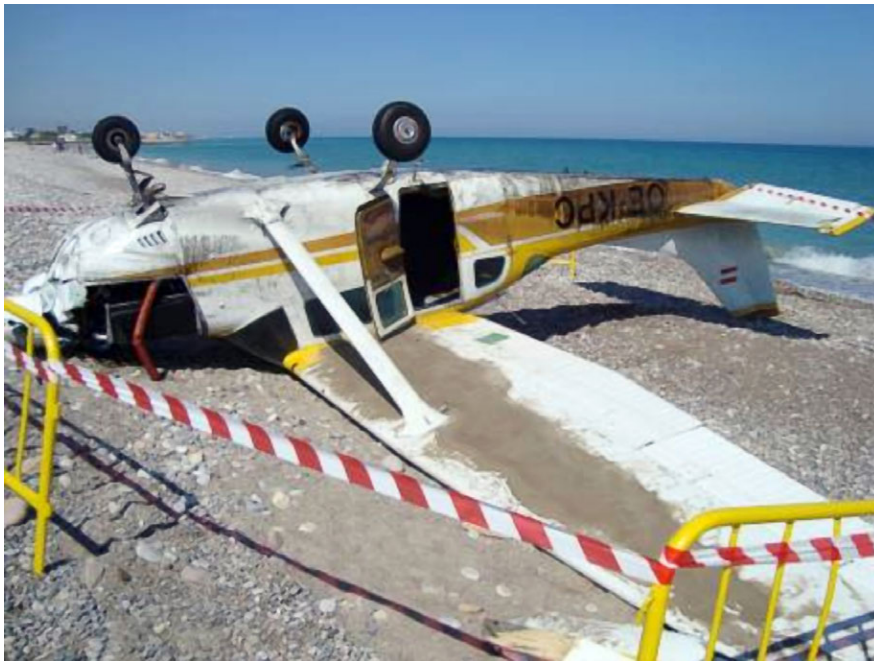
Figure 1. Aircraft

On 23 April 2009, a Cessna TU206F aircraft, registration OE-KPC, made a water landing at 11:20 near the beach in the town of Moncofa (Castellon) following an engine failure while flying at 7,000 ft over the coast. Both occupants onboard, the pilot and a passenger, were rescued by eyewitnesses to the event. The aircraft turned over during the maneuver and ended up floating upside down.

Once the aircraft was pulled from the ocean, the damage to the lower engine cowl and the propeller blades from the impact with the water became apparent. All of the aircraft's components were affected by salt water corrosion and the perforation of the engine block resulted in an oil stain that coated the lower surface of the fuselage.

The aircraft was heavily damaged as a result of the impact with the water surface, which affected the propeller, engine cowl and wing tips. The rest of the airframe was subsequently damaged by the salt water.
