REPORT IN-010/2011

Date and time	Saturday, 9 April 2011, at 12:59 UTC¹
Site	Menorca Airport (LEMH), Maó (Menorca)

Registration	EC-IJS
Type and model	Bombardier-CL600-2B19 CRJ 200
Operator	AIR NOSTRUM

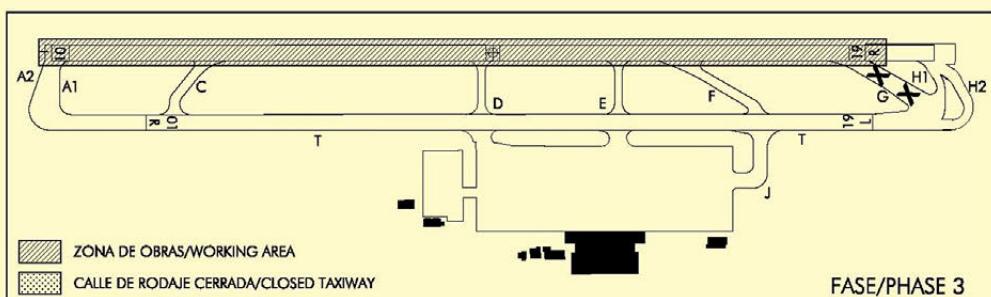
**FASE 3. Reparación del pavimento de la pista 01L/19R (Pista principal).**

PHASE 3. Repair of the runway 01L/19R pavement. (Main runway).

* Stands 2, 4, 6, 8, 10, 12, 14 and 16 and W zone of General Aviation Apron out of service.

- Limitation of use of the runway 01R/19L to maximum aircraft of 36 m.

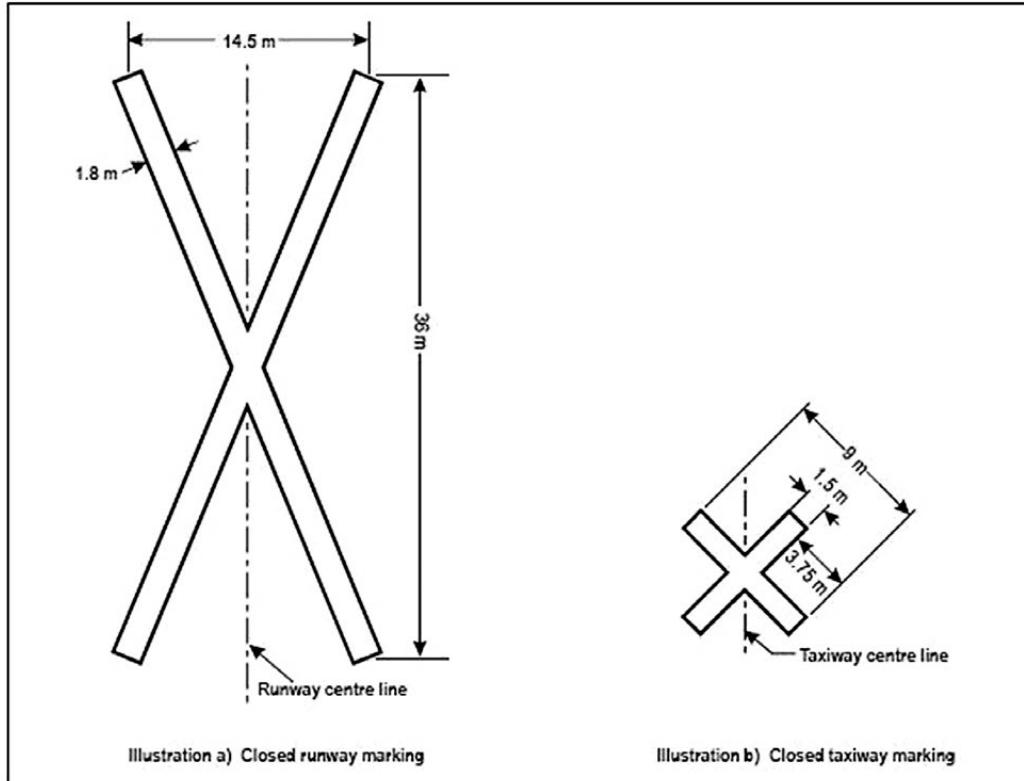
Figure 7-1. Closed runway and taxiway markings

- 7.1.4. The closed marking shall be of the form and proportions as detailed in Figure 7-1, Illustration a), when displayed on a runway, and shall be of the form and proportions as detailed in figure 7-1, Illustration b), when displayed on a taxiway. The marking shall be white when displayed on a runway and shall be yellow when displayed on a taxiway.
