**DATA SUMMARY**

Date and time	<b>Thursday, 9 June 2011 at 09:40 UTC<sup>1</sup></b>
Site	<b>Tenerife North Airport (GCXO), Tenerife</b>

Registration	<b>EC-KDP</b>
Type and model	<b>PIPER PA-34-200T "Seneca II"</b>
Operator	<b>Private</b>

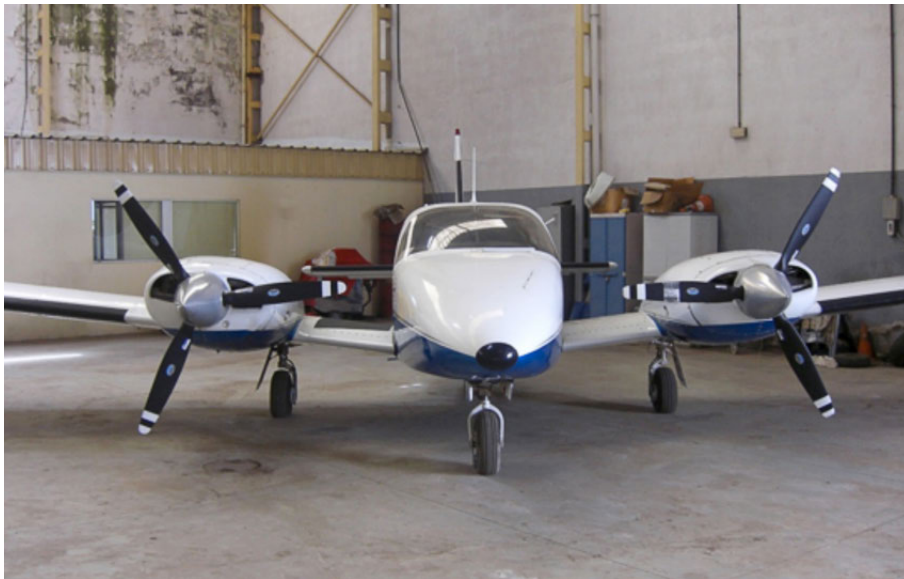
Figure 2. General view of the aircraft

The aircraft suffered damage mainly to its left wing (wingtip, aileron and flap). The pitot tube was also torn off and there were dents and scratches on the underside of the fuselage and on the rear horizontal stabilator.

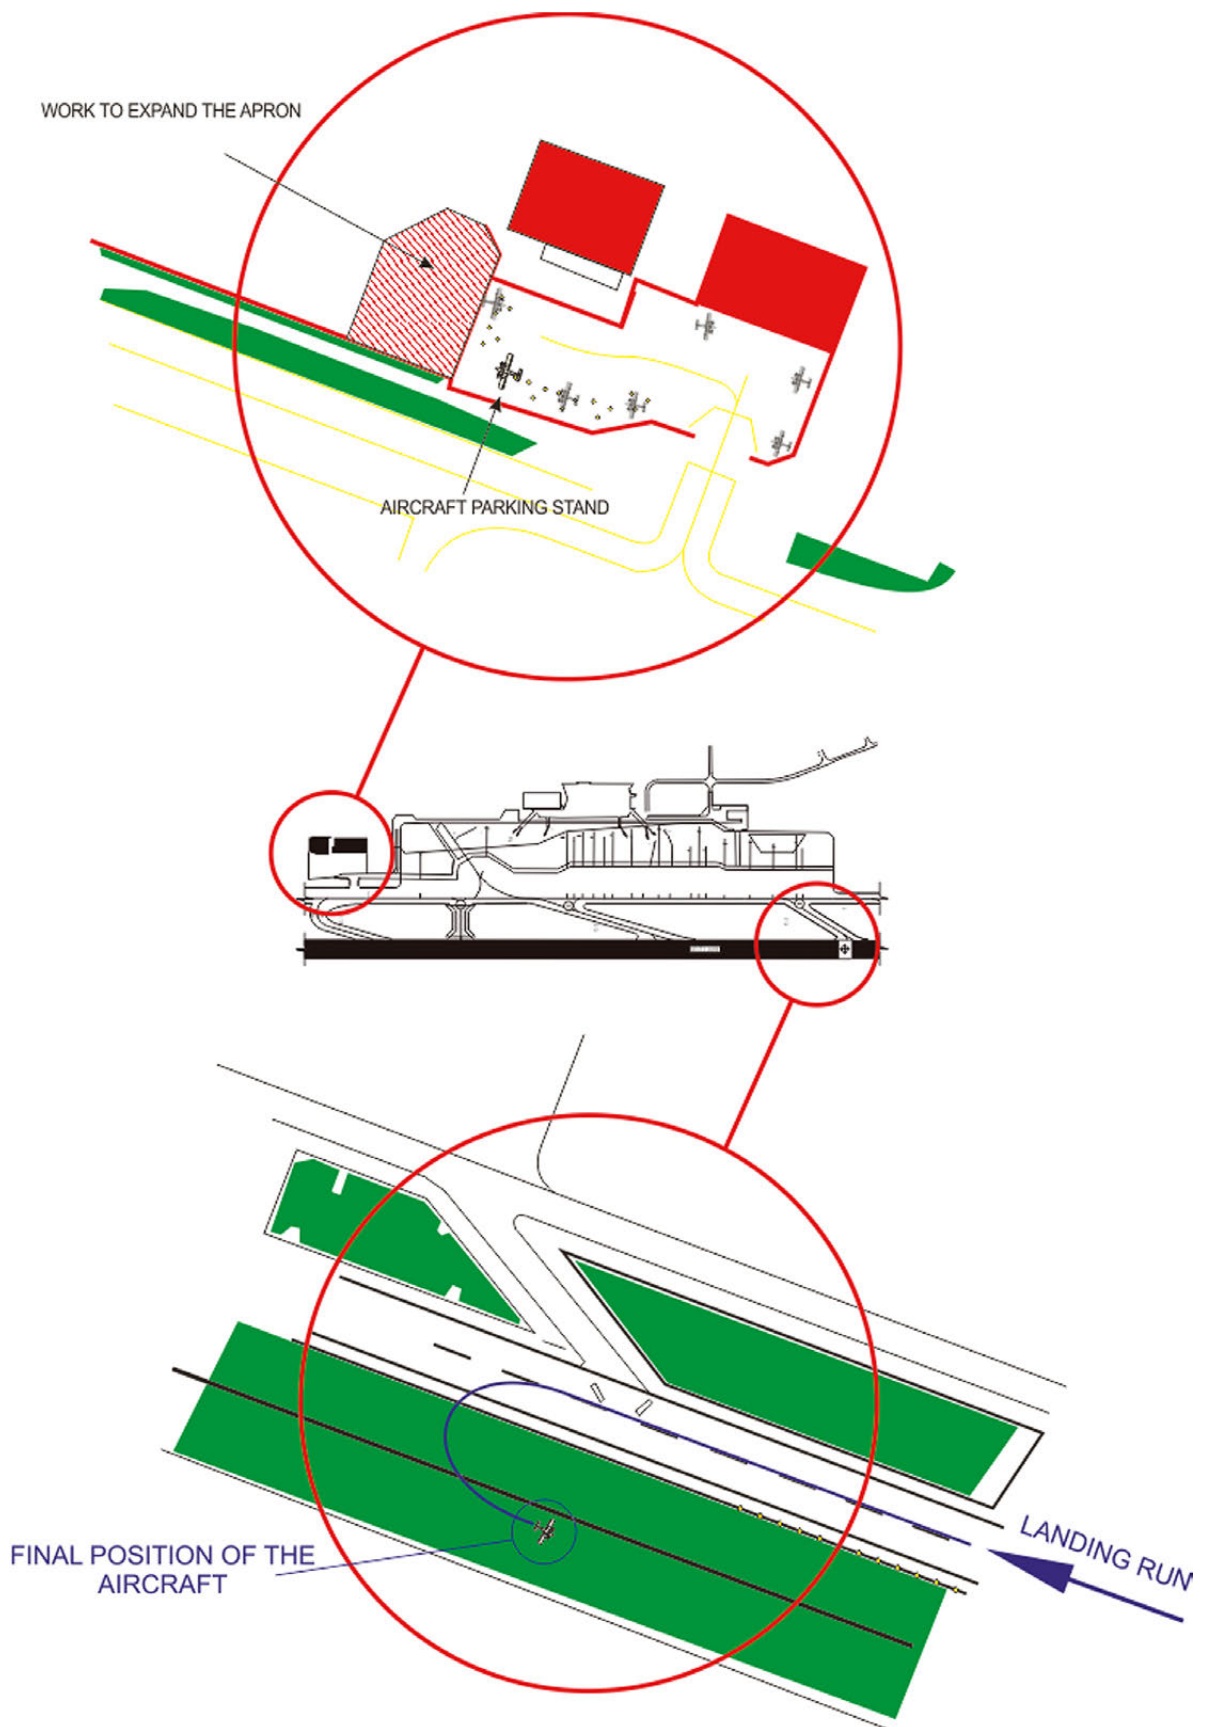
**Diagram showing the landing run of the aircraft  
and its normal parking position on the apron**

The aircraft was on a check flight departing from and landing at the Tenerife North Airport (GCXO). During the approach, the crew noticed by way of the lights and horns in the cockpit that the left gear was not in its proper down and locked position. The condition of the gear was verified visually with the aid of air traffic control personnel in the tower, who saw that the gear was down but could not confirm whether it was locked. After unsuccessfully cycling the gear several times, including once in emergency, the crew decided to land by touching down gently. During the landing run, the left gear collapsed as soon as it touched the ground, causing the aircraft to turn left and depart the runway, turning 180° from the original landing course.
