DATA SUMMARY

Date and time	Saturday, 9 June 2012; 12:15 local time
Site	Igualada Aerodrome (Barcelona, Spain)

Registration	EC-GGF
Type and model	PIPER PA-23-250 Aztec E
Operator	Private

On Saturday, 9 June 2012 at 12:15¹, a Piper PA-23-250 aircraft, registration EC-GGF, suffered a runway excursion and broke its left landing gear during the landing run at runway 17 of the Igualada Aerodrome (Barcelona).

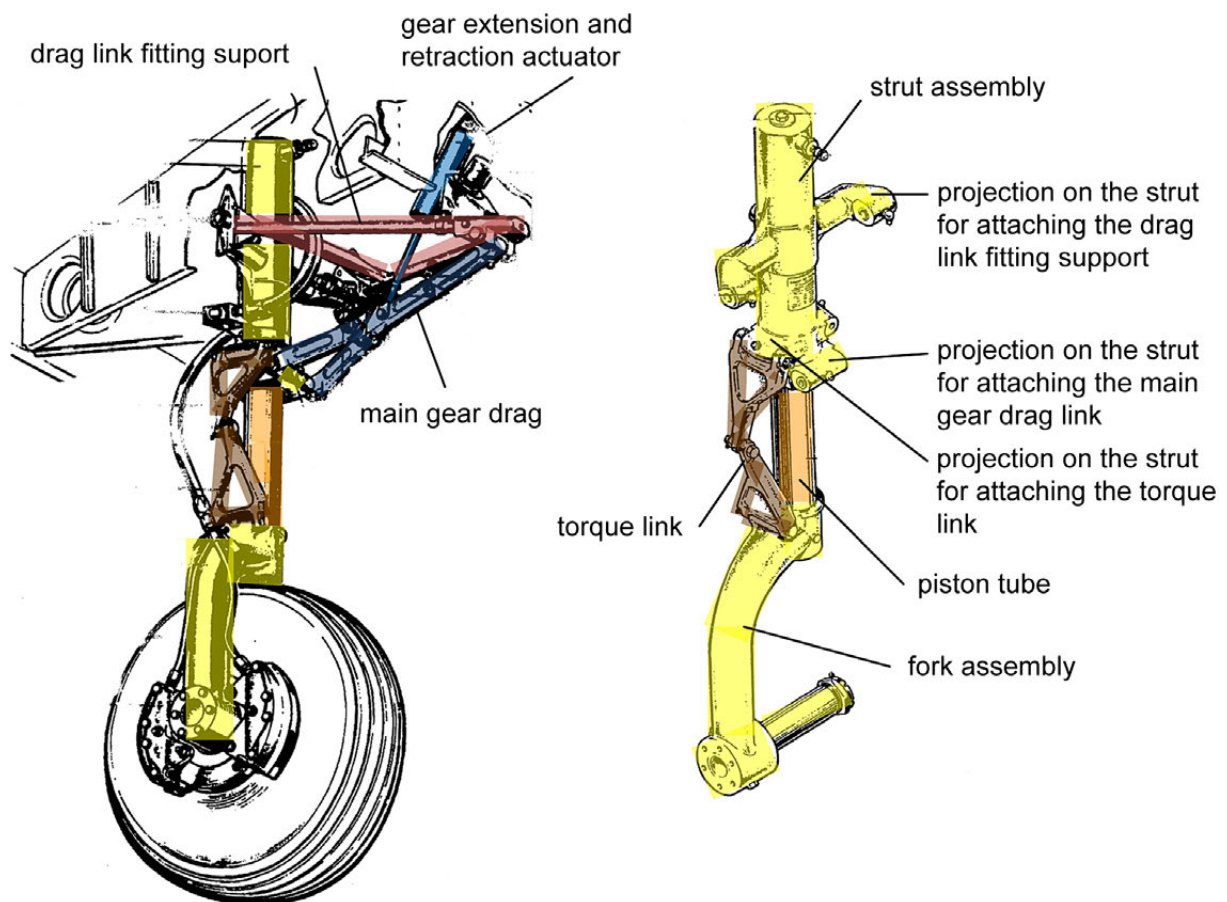
Figure 2. Parts of the main gear (view of left gear)

wheel is mounted. The strut assembly and the fork assembly are joined by a torque link that allows relative movement to dampen any vibrations. The piston travels inside the cylinder. During landings, before contacting the ground, the piston is fully extended. The main gear is retracted in the forward direction. The strut assembly has three projections machined into it for attaching:

- the main gear drag link,
 - the torque link that joins the strut and the fork, and
 - the drag link fitting support.
- The main gear drag link is used to retract, extend and lock the gear. The link is moved by an actuator. When the gear is down, the drag link is at approximately a 45° angle from the vertical.
 - The drag link fitting support attached the gear to the aircraft. The main gear drag link is also attached to it. The fitting support is parallel to the ground when the gear is extended.
