Report IN-027/2014

Incident involving a Boeing B737 aircraft, registration EI-EBC, operated by Ryanair, and a Boeing B737 aircraft, registration G-GDFR, operated by Jet2.com, at the Malaga-Costa del Sol Airport (Spain) on 17 September 2014

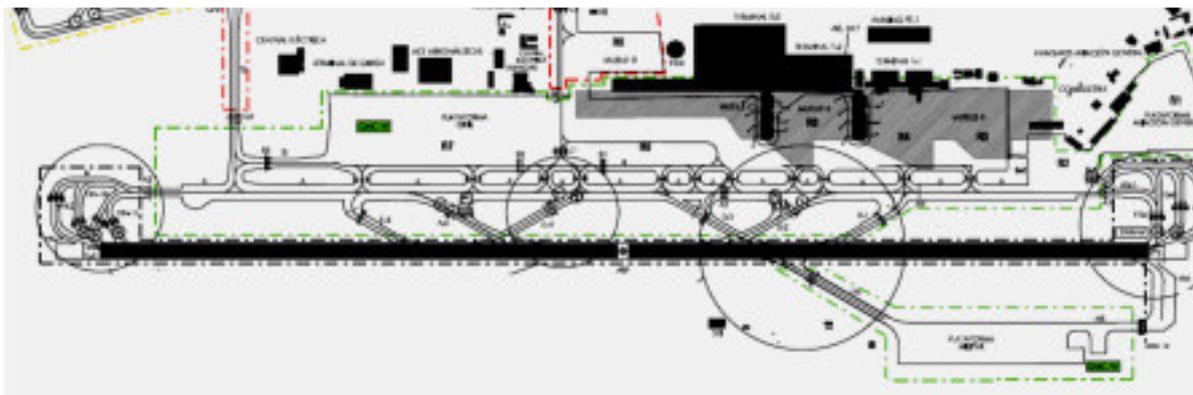
Figure 5: Runway at the LEMG airport

The Malaga-Costa del Sol Airport (LEMG) has two runways in 12/30 and 13/31 orientations. The airport is at an elevation of 16 m. At the time of the event it was operating in a single-runway configuration, with runway 13 being used for both landings and takeoffs. This is the preferred configuration when using a single runway.

Runway 13 is 3200 m long and 45 m wide.

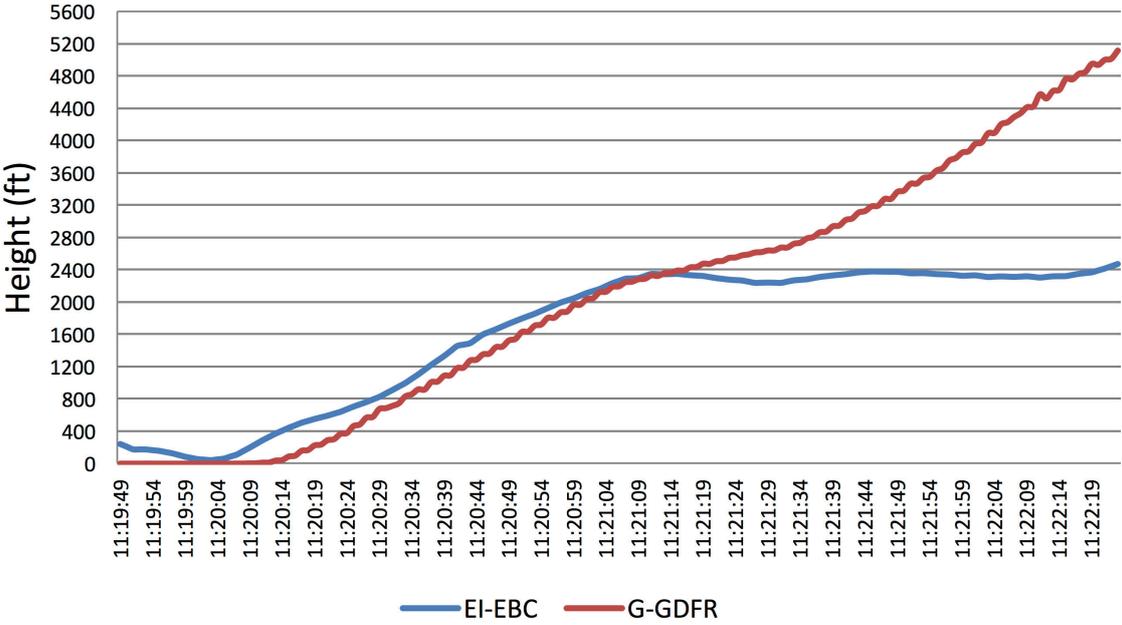
Figure 10: Vertical separations between the aircraft

The information from the surveillance radar, the FDR and QAR recorders and the ATC communications was used to reconstruct the flight paths of the two aircraft and to characterize the most significant events (Figures 9 and 10):
