Report IN-005/2015

Incident involving a Bombardier CRJ1000 (CL-600-2E25) aircraft, registration EC-LPG, operated by Air Nostrum, at the Adolfo Suárez Madrid-Barajas Airport (LEMD) on 1 February 2015

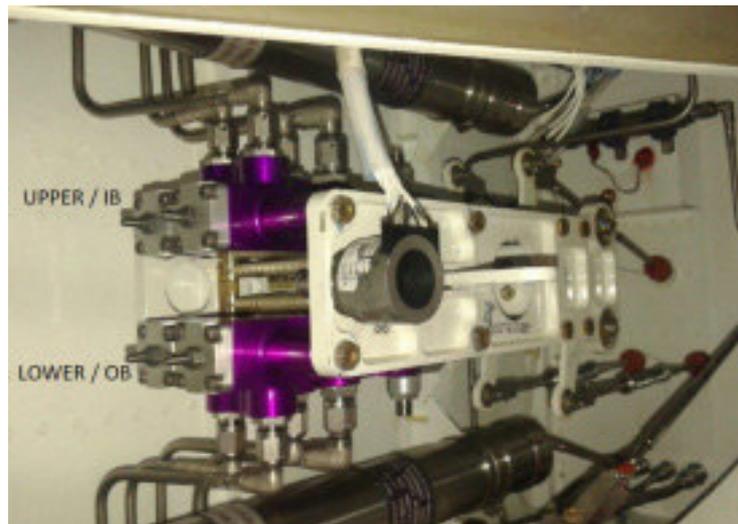
Photograph 5. Brake control valves (BCVs)

The brake system (see Figure 1) controls the hydraulic pressure that is routed to the brakes through two BCV (brake control valves). The inboard BCV receives pressure from the number 2 hydraulic system, and the outboard BCV from the number 3 hydraulic system. The OBD BCV controls the brakes on wheels 1 and 4, while the IBD BCV brakes wheels 2 and 3 (see Photograph 5).

Initially, the reason for the brakes locking and for the subsequent blowout of the no. 1 tire was thought to be a malfunction of the brake and anti-skid systems. Maintenance replaced the OBD BCV, which was common to the brakes on wheels 1 and 4, and
