Report A-008/2015

Accident involving an Airbus
helicopters AS 355 NP aircraft,
registration EC-KYJ, operated
by TAP Helicopters at the helipad
on the Catalonia Race Track
(Montmeló, Barcelona),
on 26 March 2015

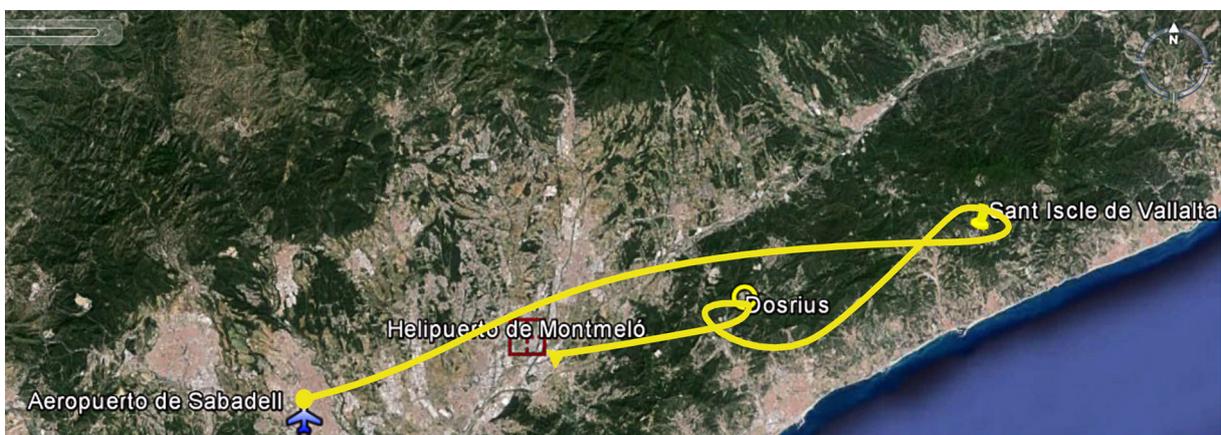
Figure 1. Approximate flight path of the helicopter

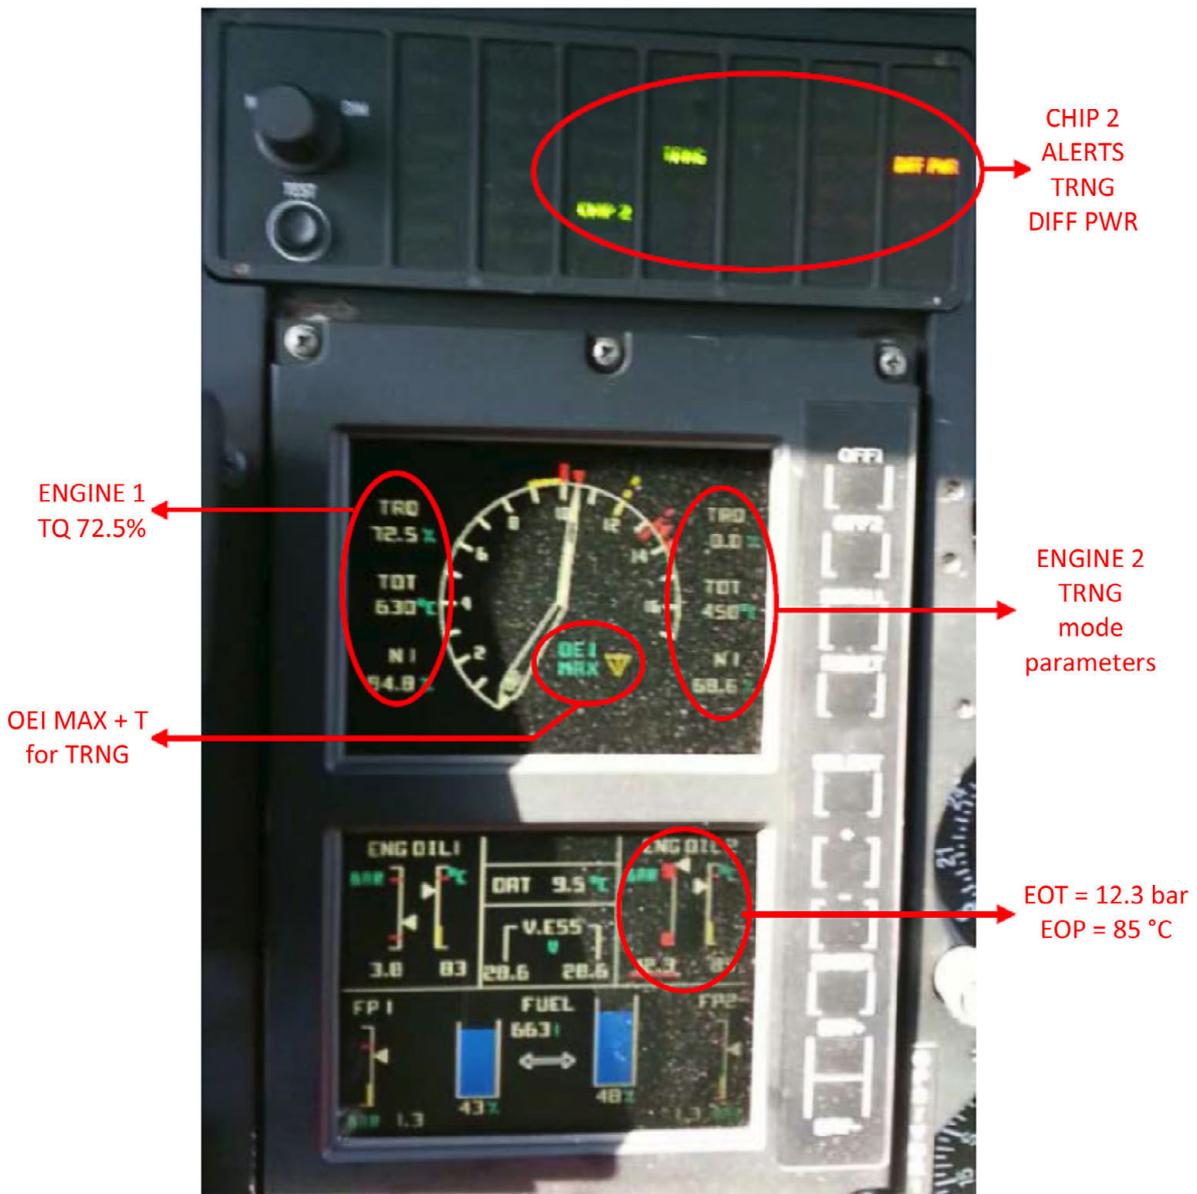
The helicopter did not have flight recorders onboard, nor were they required for the aircraft type. It did, however, have a GPS fleet tracking unit from which investigators obtained the flight path. The passengers also took some photographs of the VEMD display and the alerts shown on it as soon as the first warning was received, as shown in the figure below.

Figure 4. Photograph of the VEMD display taken during the flight
