Report A-010/2016

Accident involving a CESSNA 172R aircraft,
registration EC-JSM,
operated by a private operator,
in Perales de Tajuña (Madrid)
on 30 March 2016

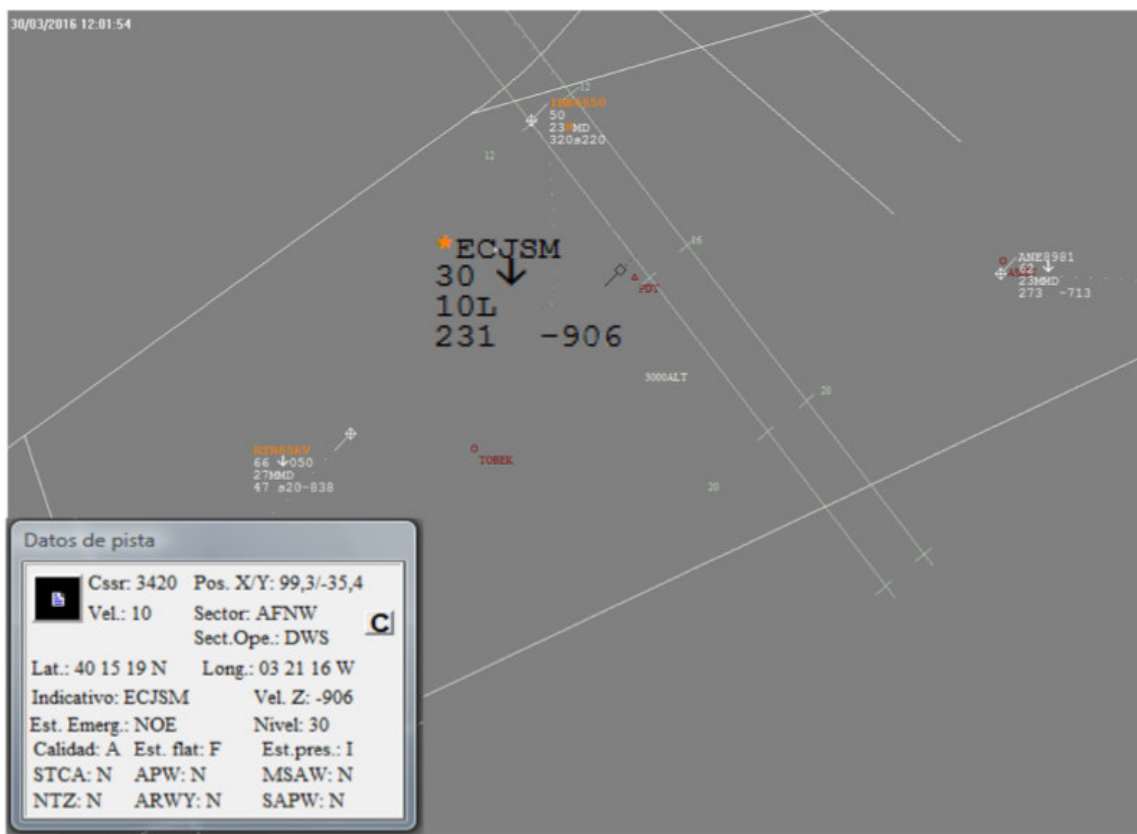
Figure 1. Last radar position of the aircraft

The last radar position for the aircraft before the accident is shown below (40° 15' 19" N, 3° 21' 16" W). At that time, the aircraft was flying at an altitude of 3000 ft at a ground speed of 100 knots.

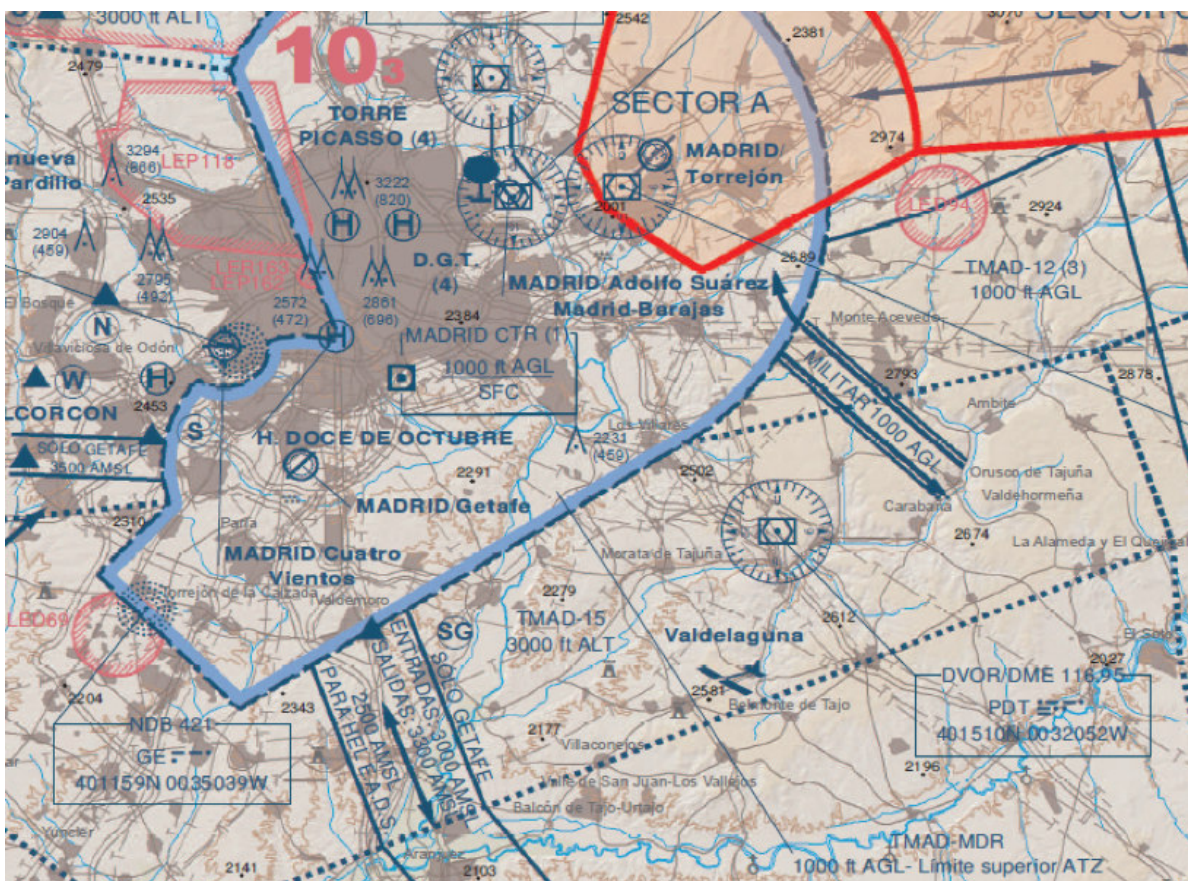
Figure 2. Segment of the VFR traffic chart for the Madrid TMA

The area where the accident took place is not labeled as a prohibited, restricted or hazardous area in the "VFR Procedures in the Madrid TMA" published in the AIP. It is also not identified as an area with sensitive wildlife.

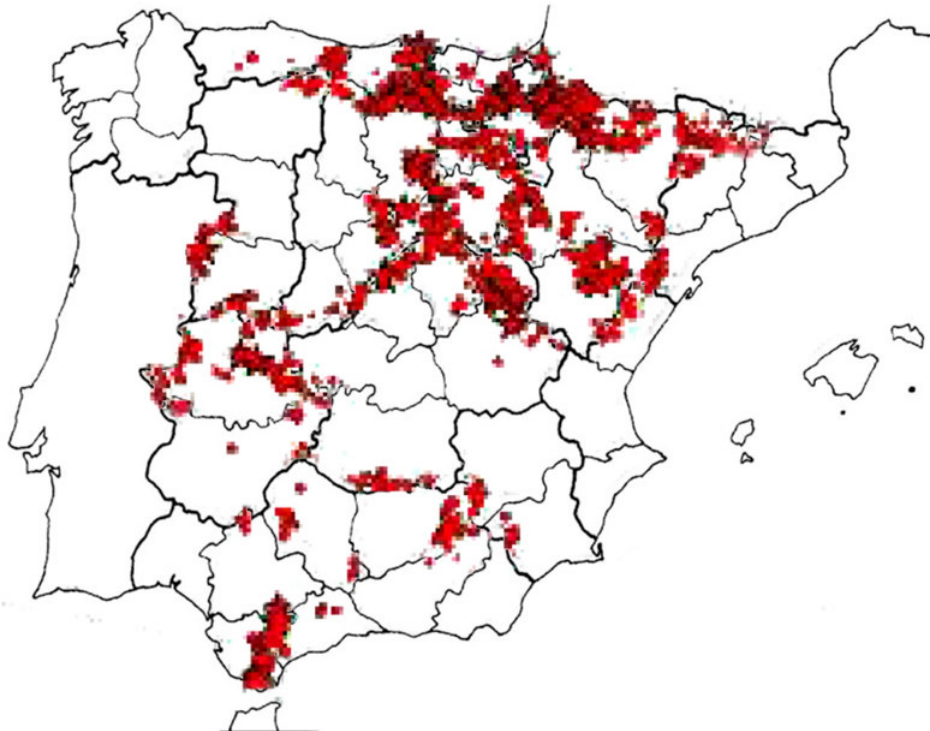
Figure 7. Distribution of the griffon vulture in Spain

In 2008 the SEO published the study “El buitre leonado en España. Población reproductora en 2008 y método de censo” [The griffon vulture in Spain. Breeding population in 2008 and census method]. At the time its population was estimated at between 91,000 and 95,000 birds and 1,560 colonies were identified. The map below, taken from this study, shows the distribution of the griffon vulture in Spain:

In the province of Madrid, the vulture colonies are located in the Guadarrama Mountains, concentrated in two areas. The main one is centered around La Pedriza de Manzanares, with the other one being between El Escorial and the San Juan Reservoir. Regardless of the locations of the colonies, we must bear in mind that a griffon vulture is capable of flying hundreds of kilometers in one day.

REC 58/16: It is recommended that ENAIRE update the bird activity chart and the migration route charts for larger bird species published in the AIP dated 26 December 2002, to reflect the current distribution of colonies of vultures and other birds that are suitable for inclusion in said chart, and their migratory routes.
