**DATA SUMMARY**

Date and time	<b>Monday, 11 April 2011; 14:00 local time</b>
Site	<b>Mijares (Ávila, Spain)</b>

Registration	<b>SP-SUH</b>
Type and model	<b>PZL W-3A, PZL W-3AS</b>
Operator	<b>LPU Heliseco Ltd.</b>

Date of approval	<b>28 November 2012</b>
------------------	-------------------------

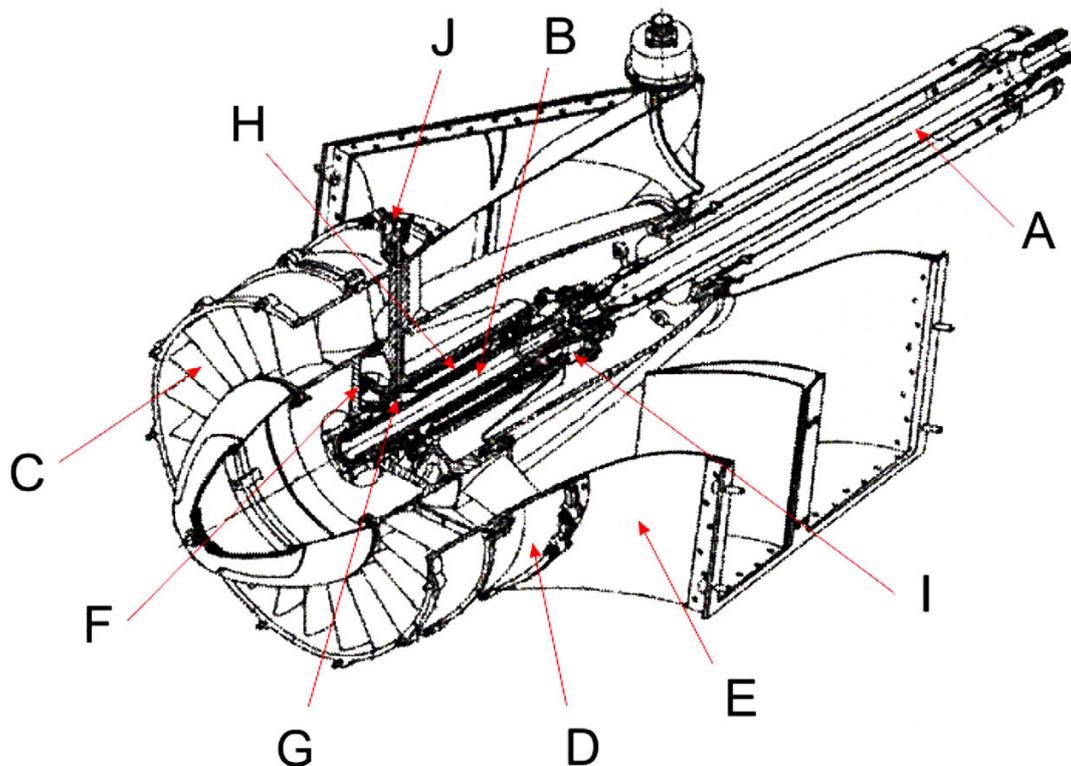
The accessory cooling system consists of a cooling fan with a diffuser and a system for distributing cooling air. Figure 2 shows the cooling assembly with the diffuser.

The aft end of the rotor shaft (B) is joined to a coupling (I) that doubles as a clutch and allows it to be connected to the drive shaft (A) that turns it. The coupling between the two shafts is designed to withstand a certain amount of longitudinal and transverse motion.

The lubrication system consists of a grease nipple (J) and a conduit that is used to direct the lubricant to the fan rotor shaft. Excess grease exits through two orifices<sup>1</sup> that serve to check that the filling is completed with new grease.

Figure 2. Fan and diffuser
