## Report A-029/2011

Accident involving a  
Bombardier CL-600-2B19  
(CRJ200), registration  
EC-ITU, operated by Air  
Nostrum, at the Barcelona  
Airport, on 30 July 2011

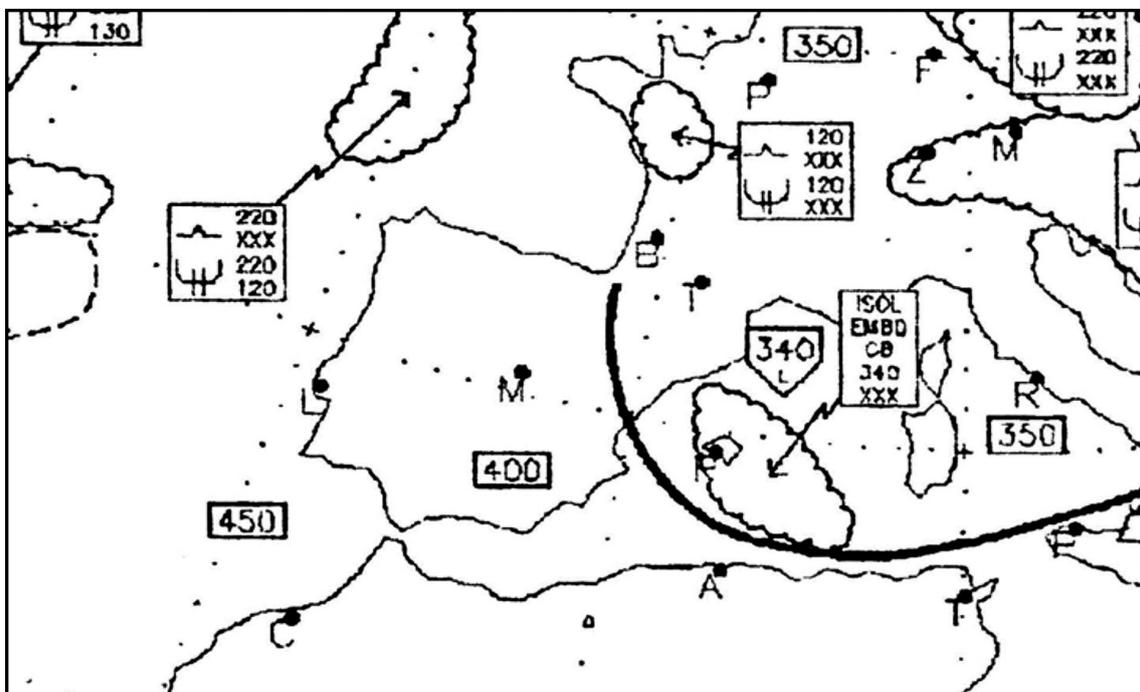
Figure 2. Significant weather chart for 12:00 UTC on 30 July 2011

The 12:00 UTC significant weather chart between flight levels 100 and 450 for 30 July (Figure 2) had information on a cloud formation on the Mediterranean coast that included the possibility of finding isolated cumulonimbus clouds embedded in it.

Interpretation: fourth Sigmet message, valid from 10:45 until 12:30 UTC on the 30th. Intense storms observed between the 38° 30' N and 40° 30' N parallels and east of the 01° 00' meridian, with cloud tops at FL390 moving east with no changes.

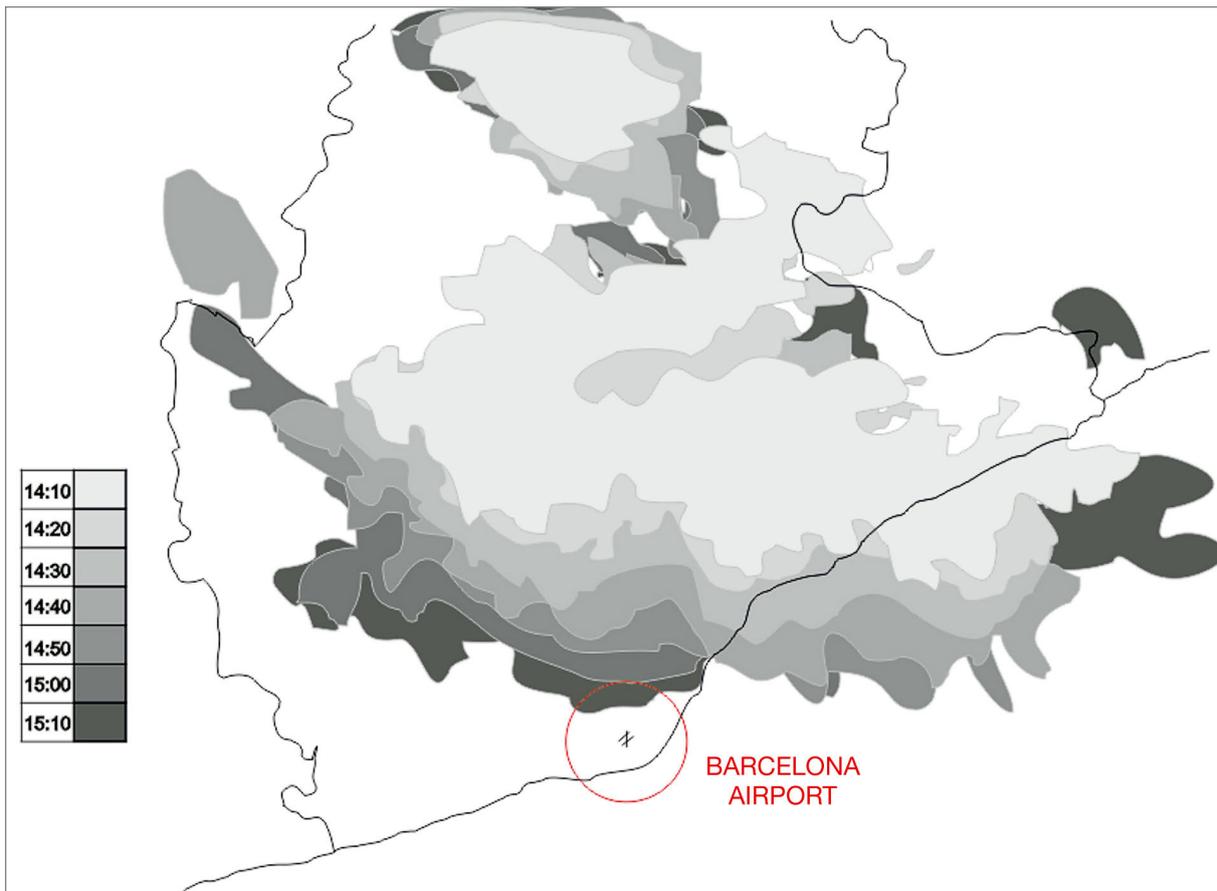
Figure 3. Sequence of weather radar images for the Barcelona Airport area

As Figure 3 shows, during this period of time the projected reflectivity area grew in scale as it moved southeast. At 15:10, approximately five minutes before the aircraft landed, the reflectivity projection area had not yet reached the airport.

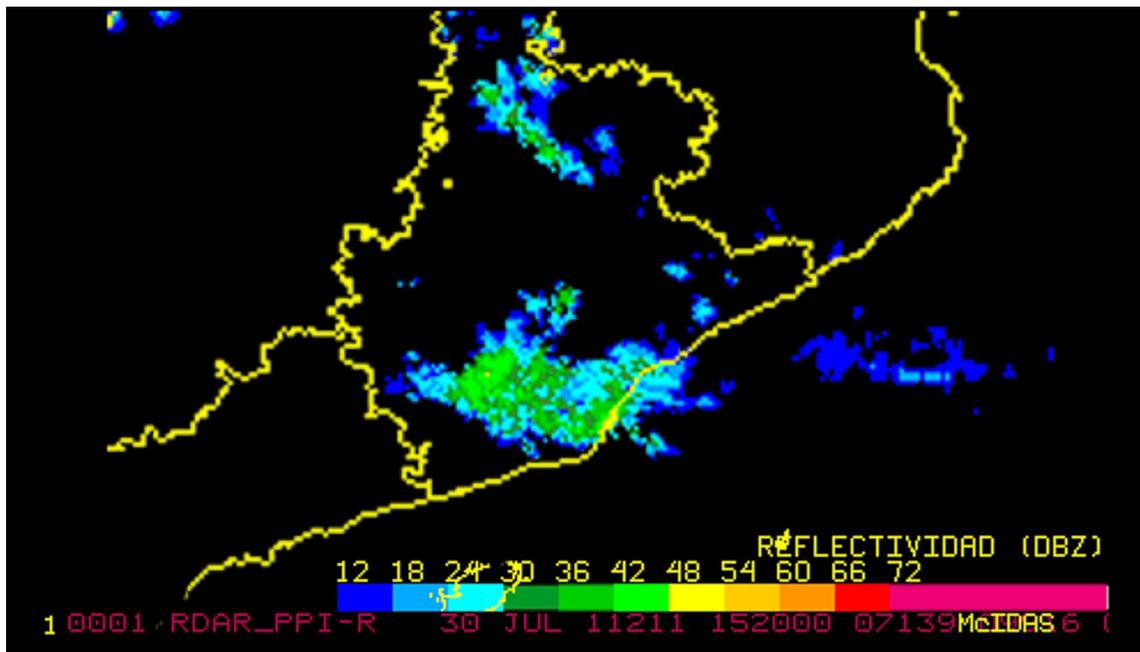
Figure 4. 15:20 UTC weather radar image

Figure 4 shows the weather radar image for 15:20, after the landing. By this time the reflectivity projection area was so close to the airport that it had practically reached it.

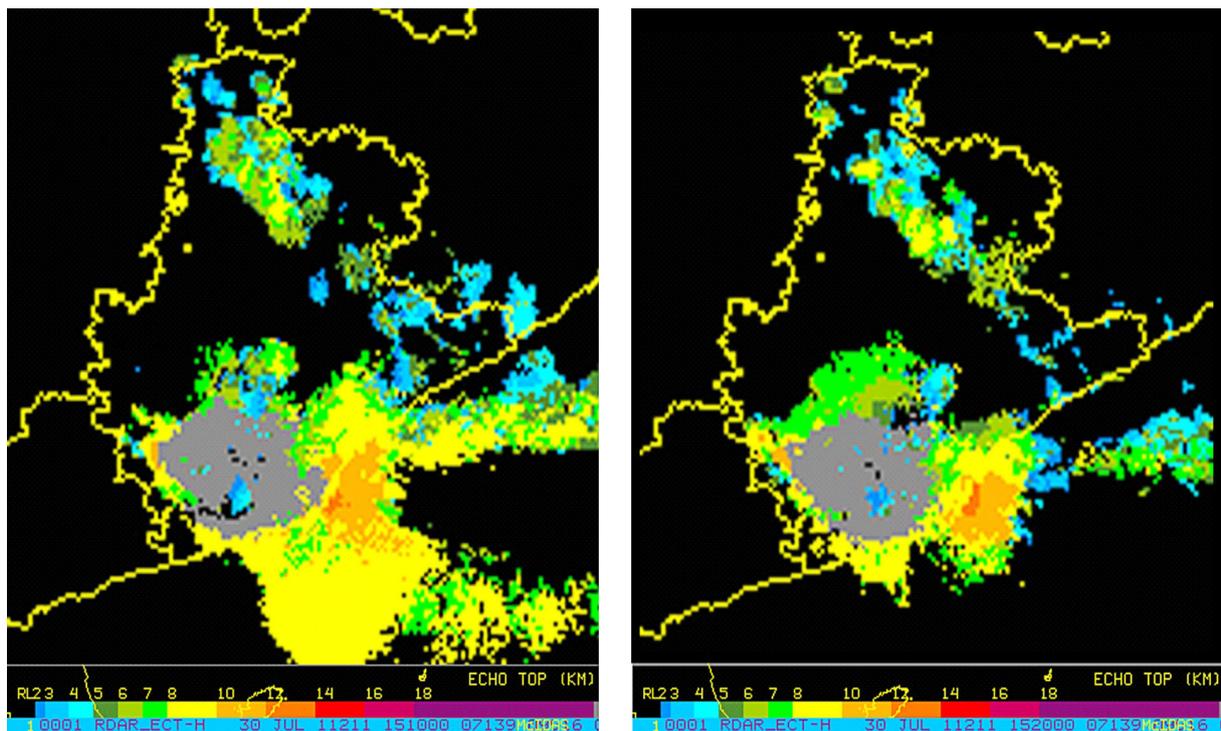
Figure 5. ECHO TOP weather radar images from 15:10 and 15:20 UTC

There are other weather radar images called ECHO TOP (Figure 5) that show the altitude of the cloud tops using a color code. The areas colored in gray are those for which there is no information.

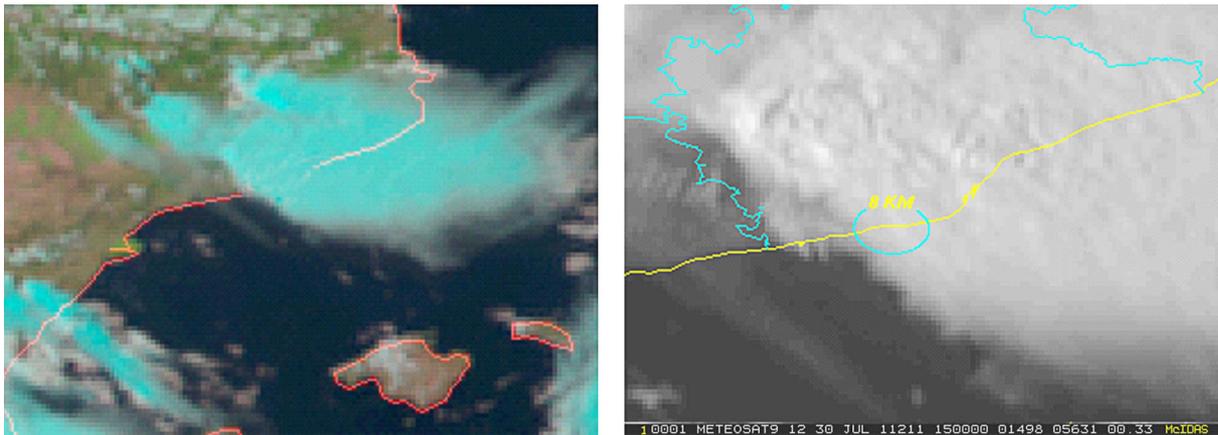
Figure 6. Satellite images: RGB (left) and HRV (right) from 15:00 UTC

Two types of satellite images are available: RGB and HVY. The former are colored images where cloudy areas shown in blue indicate the presence of very high cloud tops with ice formation. The latter are high-resolution visible satellite images where the pixels are tripled in order to improve the view. These show large vertical development convection clouds with very high tops.

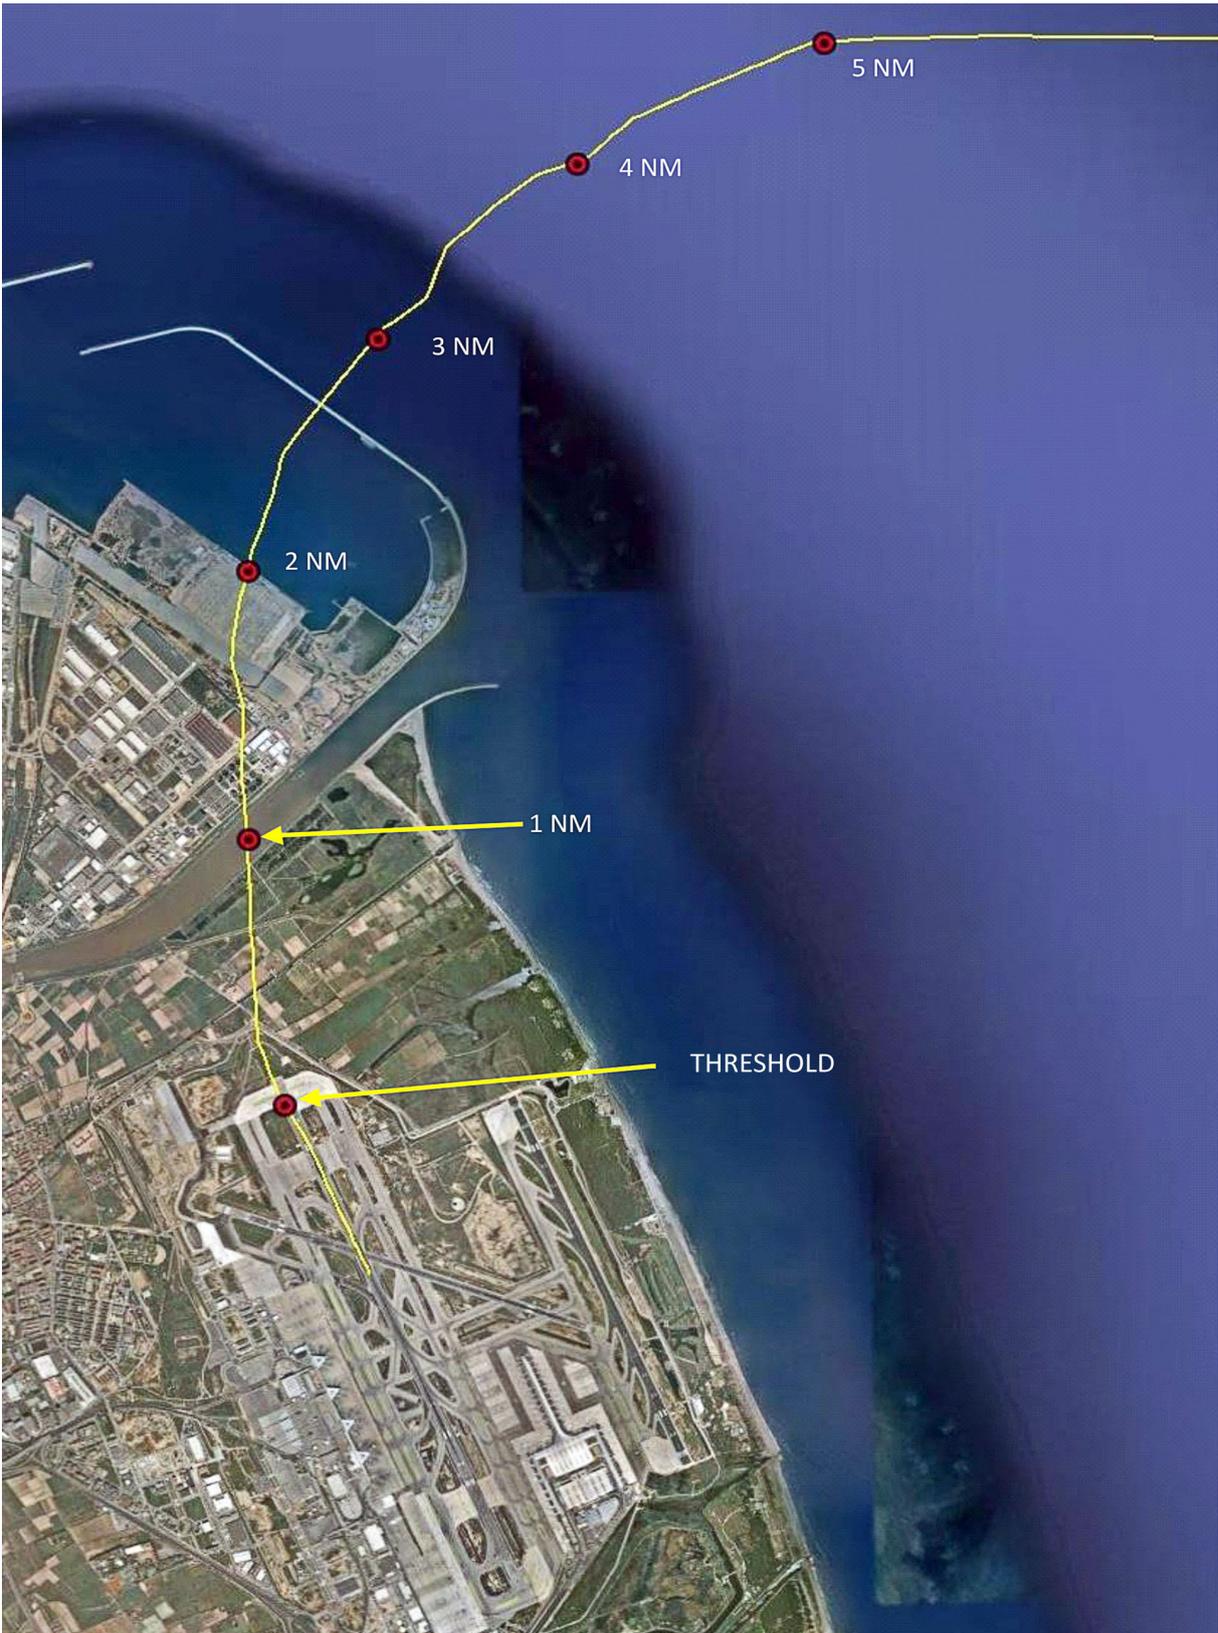
Figure 7. Top view of the last 5 NM of the aircraft's flight path. The distances shown are from the threshold and measured based on the aircraft's actual flight path

This information was then used to make Figure 7, which shows a top and side view of the aircraft's flight path.

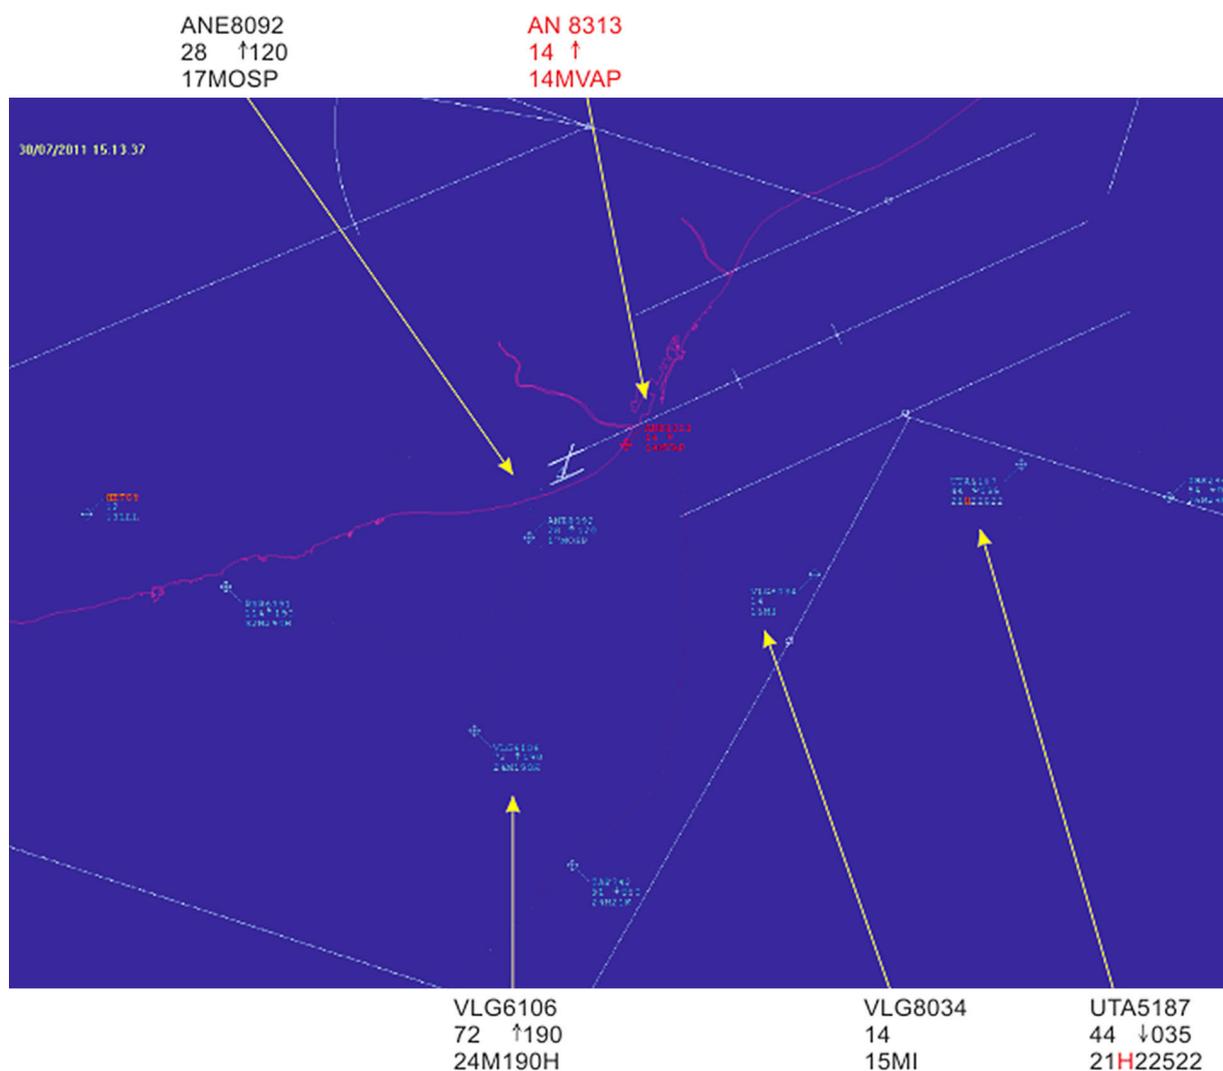
Figure 12 also shows a reproduction of the radar screen for time 15:13:37, which reveals the location of the accident aircraft (red label) as well as of the remaining aircraft that were flying in the vicinity of the airport.

Figure 12. Radar display showing the radar trace of ANE 8313 (five labels have been amplified for a better visualization)

Of these, only four, the data for which are shown below, could be regarded as being near the accident aircraft.

Though it does not appear in the radar image on Figure 12, it is convenient to mention also aircraft with call sign JKK 2851. It was the last one to take off from Barcelona during this period. It started its takeoff run at 15:15:45, that is, around 1:20 minutes after the landing of ANE 8313.
