Report A-037/2011

Accident involving
two Bell 212 aircraft,
registration EC-GIC and
CC-CIS, operated by INAER,
at Bienservida (Albacete),
on 30 September 2001

Final report

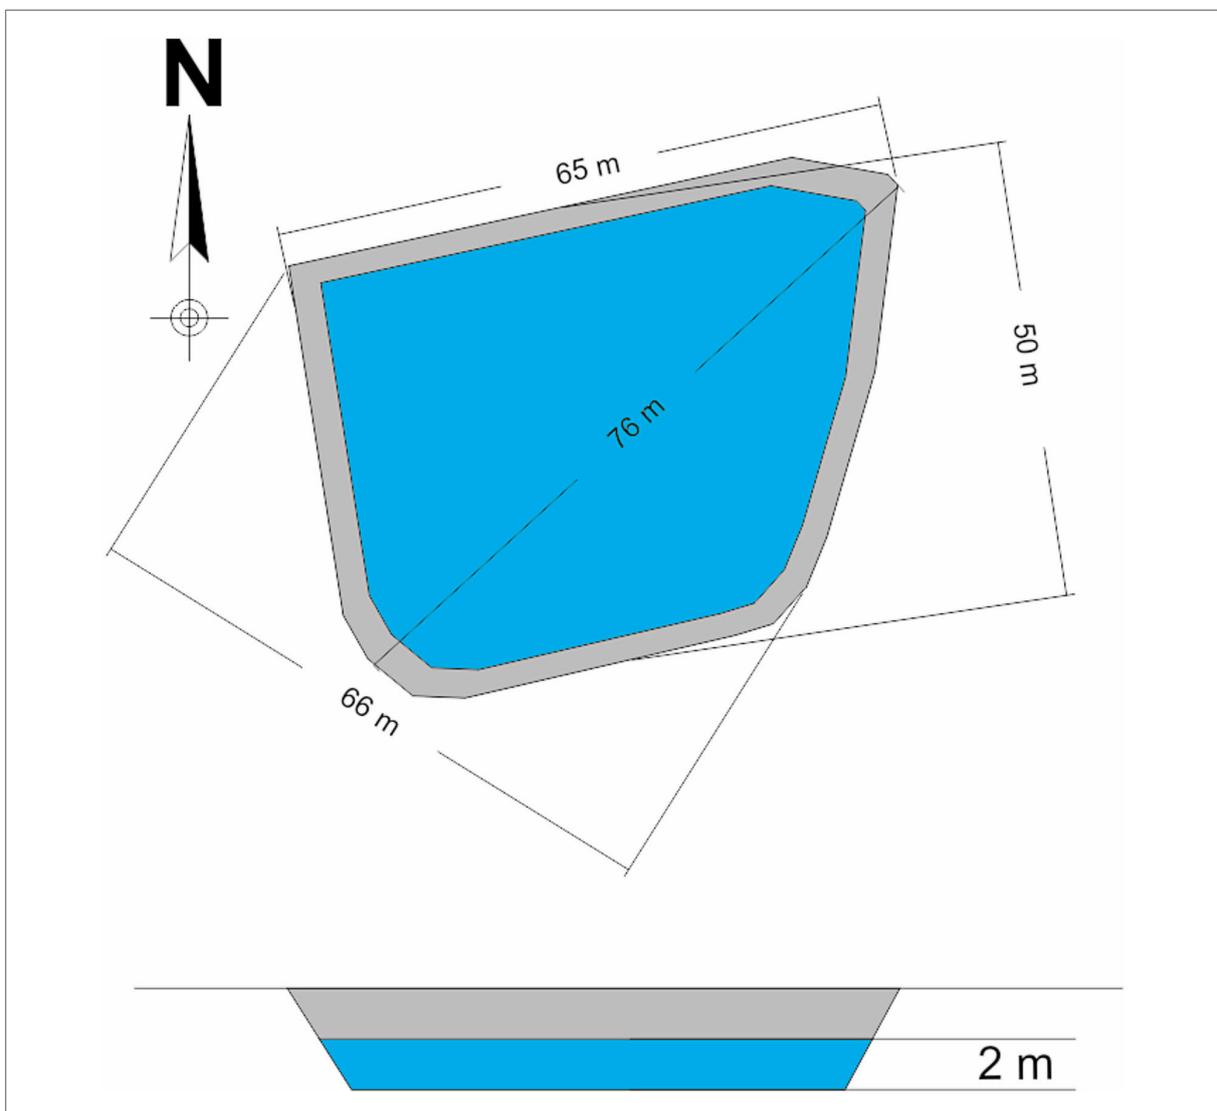
Figure 3. Balsa de Gómez

The pool, as a consequence of the fall of the aircraft into it (and their fragments projected with speed due to the collision), suffered various damages in the waterproof fabric that covers its structure and in its perimeter fence.

The Balsa de Gómez is located about 2 km NE of Bienservida. It has an approximate surface of 2,600 m² and the day of the accident it contained around 5,000 m³ of water.

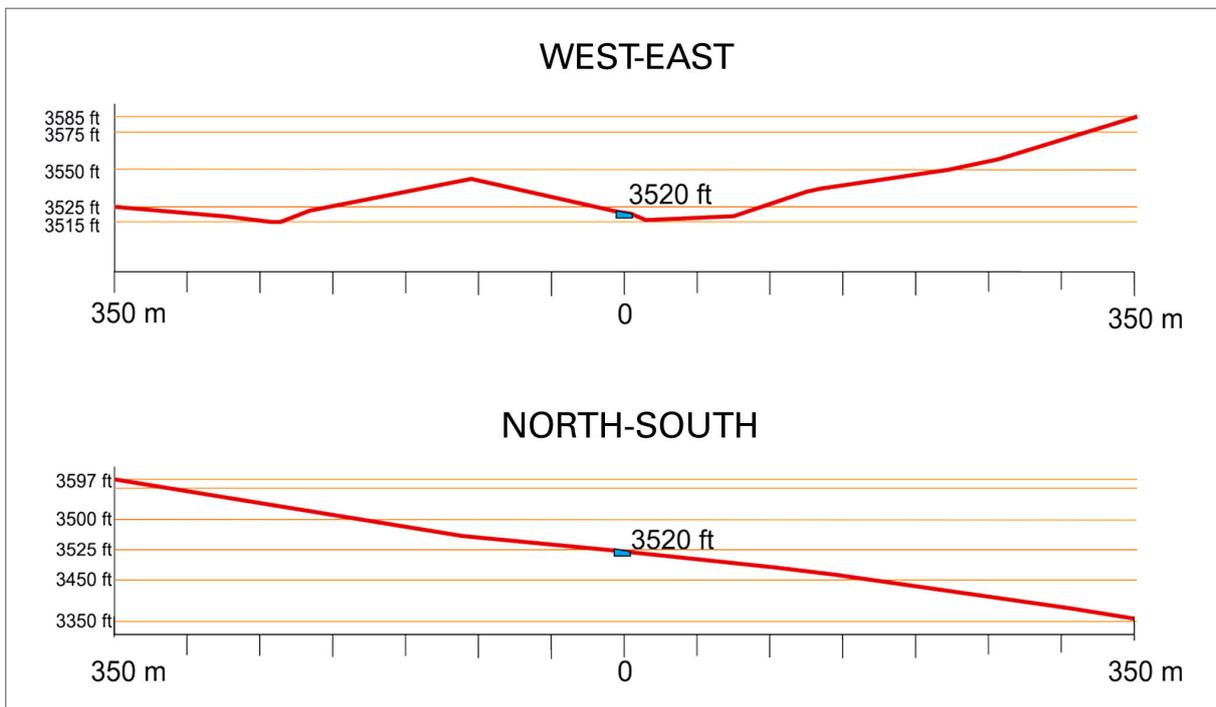
Figure 4. Sections of the field that contains the pool

Westbound of the pool the terrain is elevated around 10 m above it; north of the pool the terrain is uphill; south of the pool the terrain is downhill; and east of the pool the terrain has a smooth uphill slope elevation. Figure 4 shows two cross sections of the field that contains the pool:
