## Report A-043/2013

Accident involving a BOEING 767-332 ER aircraft, registration N-182DN, operated by DELTA AIR LINES, at the Madrid-Barajas Airport (Madrid, Spain) on 5 December 2013

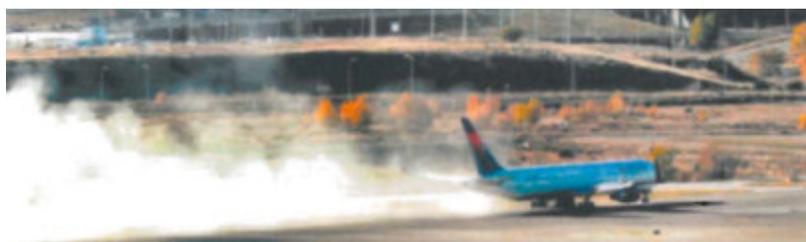
At the end of the landing run, the aircraft exited the runway via the last rapid exit taxiway on the left side (LA), via the paved area in the vicinity of LA and LB (holding points for 14R threshold), without the crew having any directional control, and headed toward taxiway J3, coming to a stop in a grassy area located halfway between the end of runway 32L and zone A of terminal T4, which is the one located further south.

Figure 2. Photograph of the aircraft just after exiting the runway

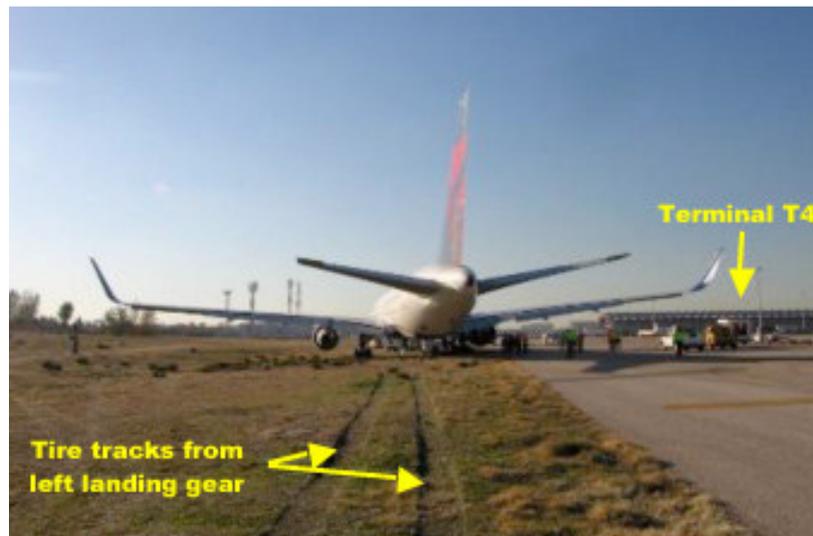
There was no fire during the landing, though the firefighters, who were the first to detect the explosion of the tire upon hearing a loud noise as the airplane passed in front of the station situated on the north side of the airport, had already been alerted. They accompanied the aircraft during its landing run and cooled off the landing gear once the airplane came to a stop.

Figure 3. Photograph of the aircraft shortly after stopping

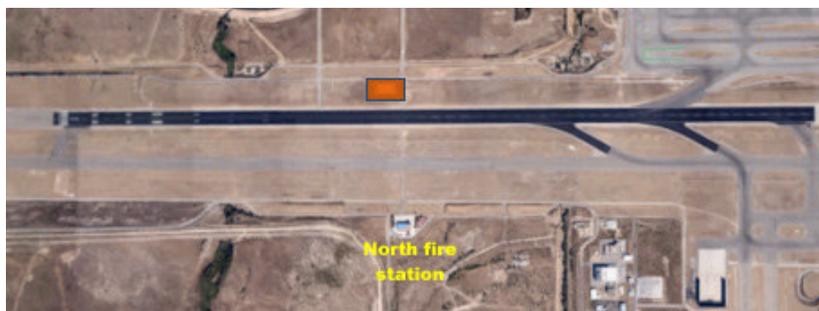
Figure 24. Section of runway 36L where debris was found

Figure 27 shows the 150-m long segment of runway 36L where the main components of the tire that blew out, as well as other debris from the aircraft, were found.
